LIMITED OCCURRENCE INVESTIGATION REPORT – FINAL
--

Reference Number		CA18/2/3/10495					
Classification	Accident	Date	16 September 2024	Time	1520Z		
Type of Operation	Private (Part 91)						
Location							
Place of Departure	Doornhaag Farm near Vryburg, North West Province		Place of Intended Landing	Tswalu Nature Reserve, Northern Cape Province			
Place of Occurrence	Uneven terrain at Doornhaag Farm						
GPS Co-ordinates	Latitude	27°01'37.69" S	Longitude	024°31'11.52" E	Elevation	4 165 ft	
Aircraft Information							
Registration	ZT-RBY						
Make; Model; S/N	Robinson Helicopter Company; R44 Raven II (Serial Number: 14074)						
Damage to Helicopter	Substantial		Total Aircraft Hours	2259.01			
Pilot-in-command							
Licence Type	Commercial Pilot Licence (CPL)		Gender	Male	Age	29	
Licence Valid	Yes	Total Hours	3018.7	Total Hours on Type	2 700		
Total Hours Past 30 Days	103.3		Total Flying Hours on Type Past 90 Days	170.4			
People On-board	1 + 1	Injuries	0	Fatalities	0	Other (on ground)	0

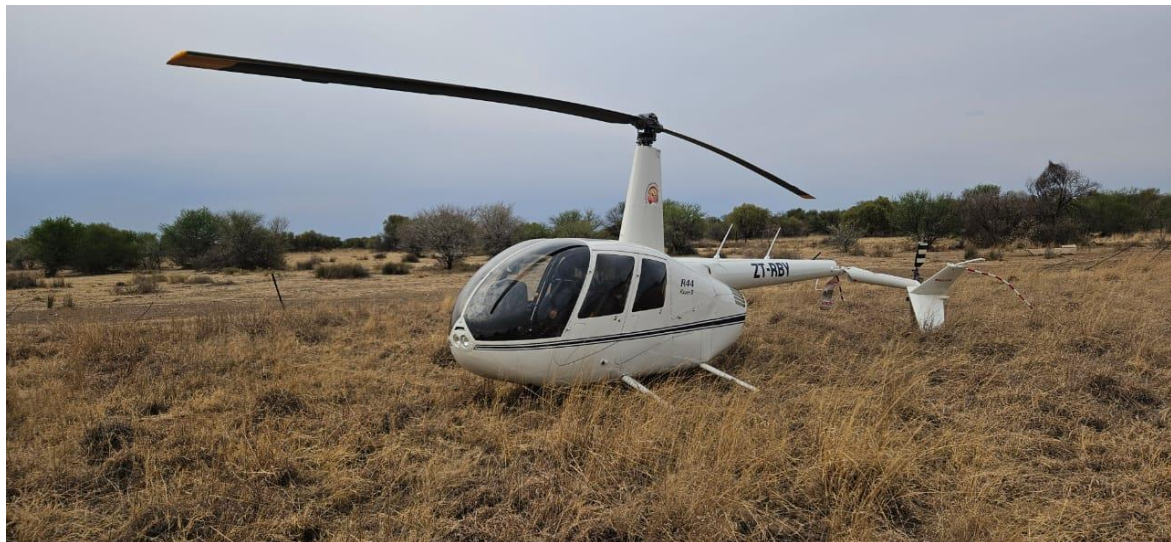
Figure 2: The helicopter post-accident. (Source: Operator)

Unsuccessful forced landing after take-off due to loss of engine rotor RPM as a result of high-density altitude. The helicopter landed hard, and the tail rotor struck the tail boom.

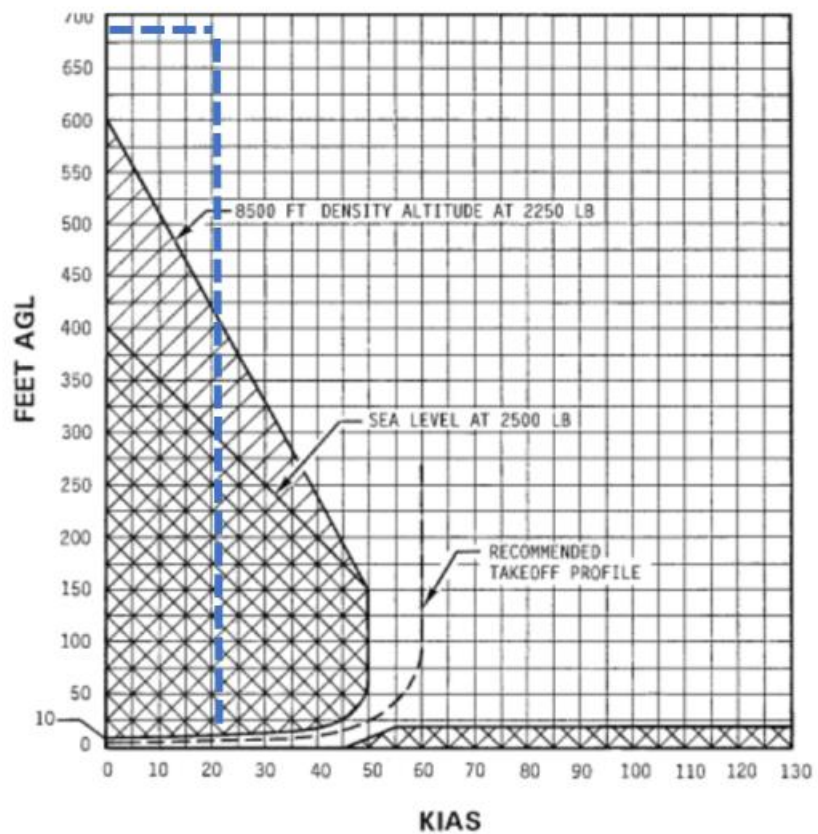
Graph 1: Height Velocity Diagram.

The blue line in the graph indicate that the pilot initiated a climb into the dead man's curve before he could attain the recommended speed of climb at 50 or 60 kts.

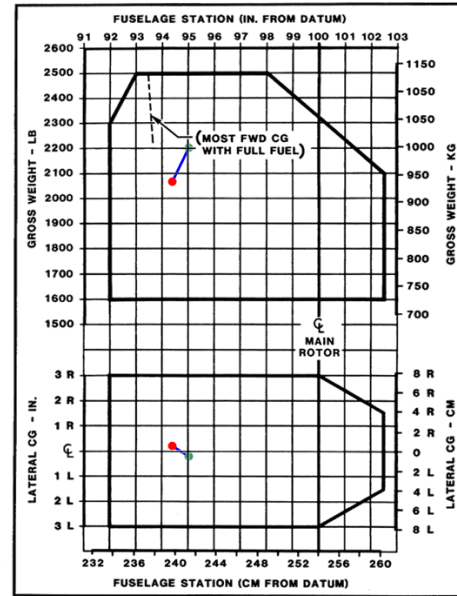
Graph 2: Weight and Balance

The above table is for weight and balance calculations. Although it was within weight limits as per the helicopter design specifications, the required weight limits at given condition were exceeded.

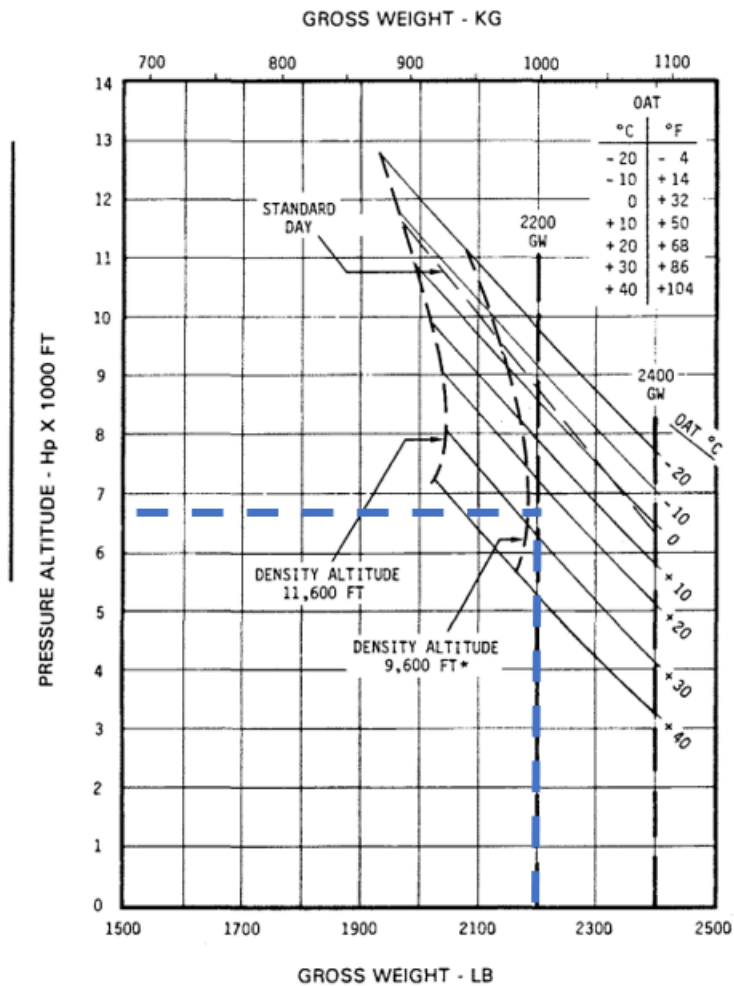
Graph 3: Shows in effect ground hover vs gross weight

Total = 713kg + 118kg + 169kg = 1000kg or 2204lb

7. Loss of engine power was caused by excessive power demand (demanded power exceeded the available power) at high-density altitude. The significantly increased density altitude impaired the helicopter's lift capabilities, which led to low rotor RPM.

8. The total weight at the high-end of operational limitations may have exacerbated performance issues in a high-density altitude environment.
