**LIMITED OCCURRENCE INVESTIGATION REPORT – FINAL**

<b>Reference Number</b>	CA18/2/3/10496						
<b>Classification</b>	Accident	<b>Date</b>	16 September 2024	<b>Time</b>	1400Z		
<b>Type of Operation</b>	Helicopter Aerial Work (Part 128)						
<b>Location</b>							
Place of Departure	Sterkfontein Farm near Petrusburg, Free State Province		Place of Intended Landing	Sterkfontein Farm near Petrusburg, Free State Province			
Place of Occurrence	Sterkfontein Farm near Petrusburg, Free State Province						
GPS Co-ordinates	Latitude	29°03'08.96" S	Longitude	025°04'37.15" E	Elevation	3 821 feet	
<b>Aircraft Information</b>							
Registration	ZS-RWU						
Make; Model; S/N	Robinson Helicopter Company; R22 Beta II (Serial number: 3846)						
Damage to Aircraft	Substantial		Total Aircraft Hours	3 553.5			
<b>Pilot-in-command</b>							
Licence Type	Commercial Pilot Licence		Gender	Male		Age	51
Licence Valid	Yes	Total Hours	4 849.3		Total Hours on Type	4 849.3	
Total Hours Past 30 Days	24.0		Total Hours on Type Past 90 Days	61.6

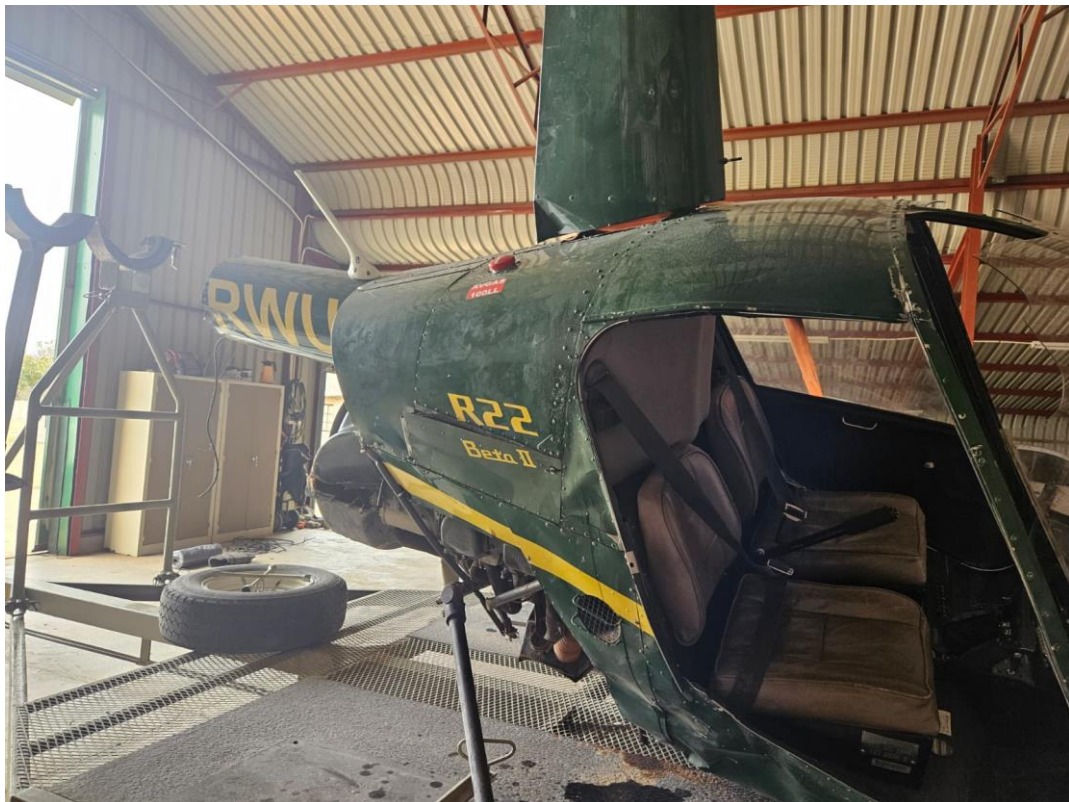
**Figure 2:** The helicopter rolled on to its right side during the accident. (Source: Pilot)

The left front skid gear hooked the upper boma cable whilst the pilot manoeuvred the helicopter to direct gate towards the boma. As he applied power (increase collective pitch) the helicopter rolled over to the right and crashed.

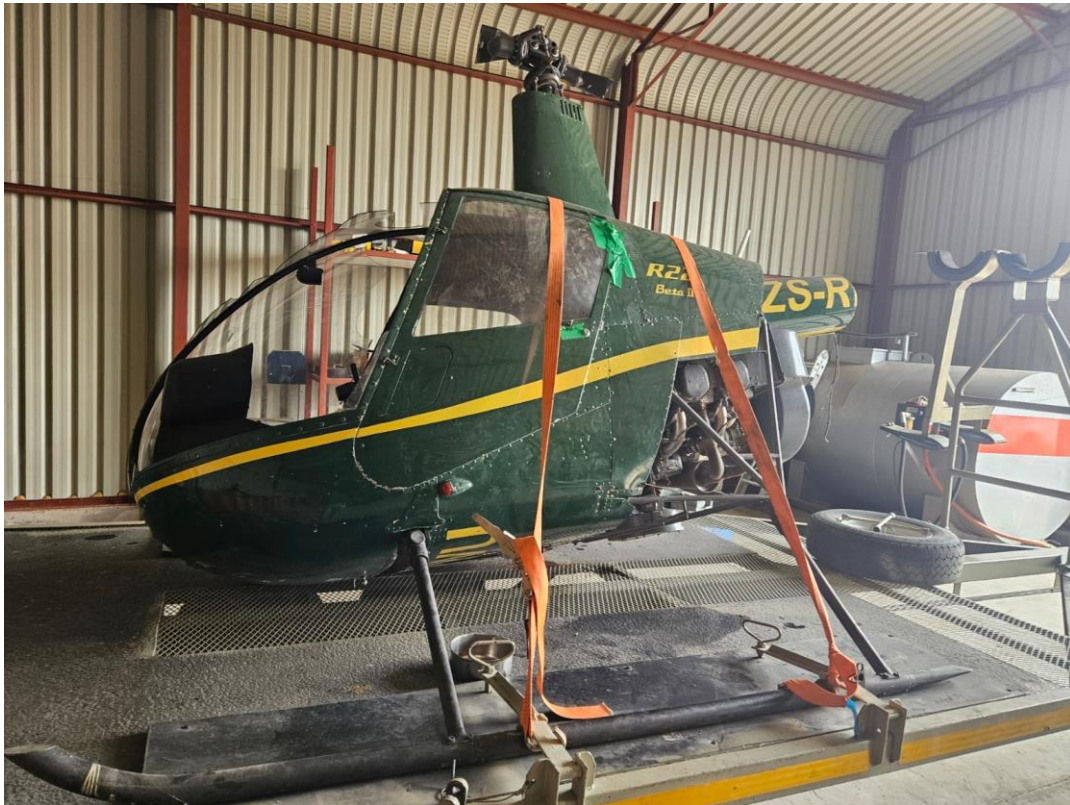
**Figure 3:** The left side of the helicopter. (Source: Pilot)
