LIMITED OCCURRENCE INVESTIGATION REPORT – FINAL

Reference Number	CA18/2/3/10497							
Classification	Accident			Date	6 May 2024		Time	0700Z
Type of Operation	Private (Part 94)							
Location								
Place of Departure	Pietermaritzburg Airport (FAPM), KwaZulu-Natal Province			Place of Intended Landing	Pietermaritzburg Airport (FAPM), KwaZulu-Natal Province			
Place of Occurrence	Runway 16 at Pietermaritzburg Airport (FAPM)							
GPS Co-ordinates	Latitude	29°38'42.63"S	Longitude	30°23'43.85"E	Elevation	2 423ft		
Aircraft Information								
Registration	ZU-WES							
Make; Model; S/N	Sling Aircraft Factory, Sling 2 LSA (Serial Number: 061)							
Damage to Aircraft	Minor			Total Aircraft Hours	2 444.0			
Pilot-in-command								
Licence Type	Private Pilot Licence (PPL)			Gender	Male		Age	25
Licence Valid	Yes	Total Hours	90.6		Total Hours on Type	4.2		
Total Hours 30 Days	1.6			Total Flying on Type Past 90 Days	4.2			
People On-board	1+1	Injuries	0	Fatalities	0	Other (on the ground)	0

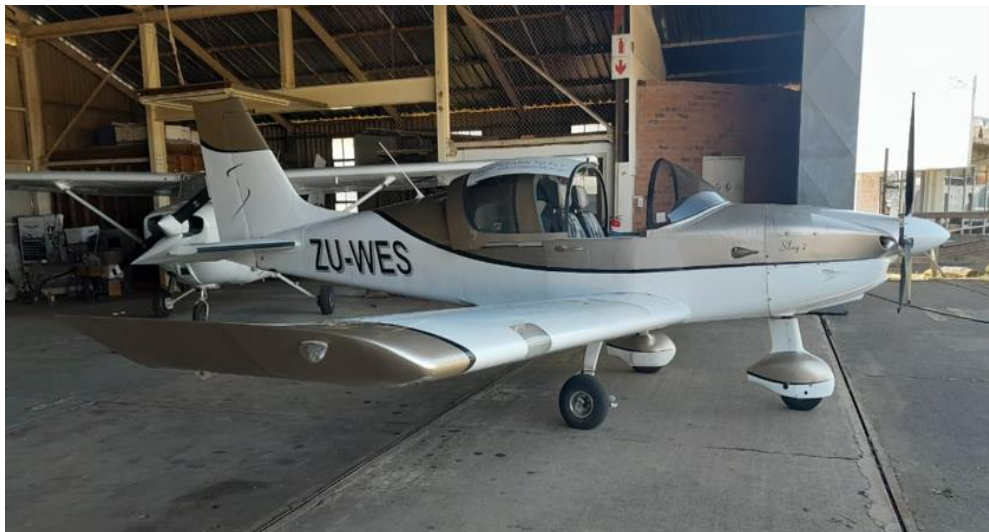
Figure 2: ZU-WES after recovery with the right main wheel fairing missing. (Source: Operator)

Unstable approach which resulted in the aircraft landing hard with the nose wheel first, followed by the main wheels; consequently, the right main wheel fairing separated and the propeller struck the ground.

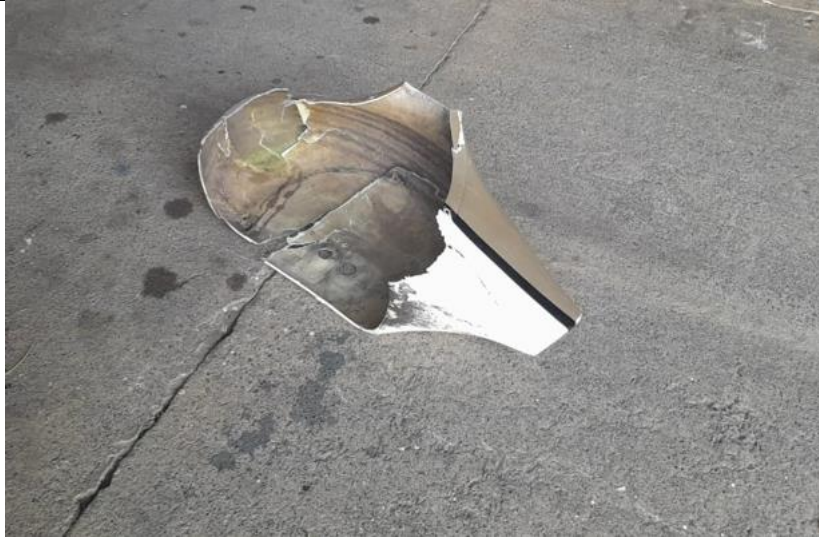
Figure 3: The separated right main landing wheel fairing. (Source: Operator)

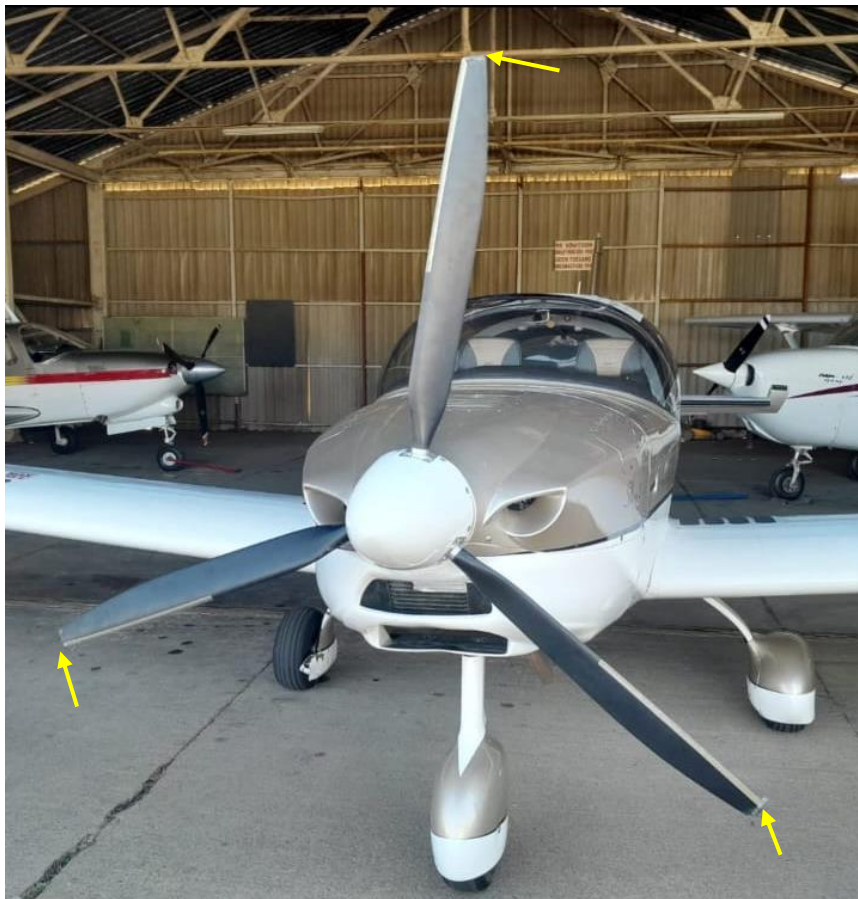
Figure 4: The damage on the propeller blade tips. (Source: Operator)

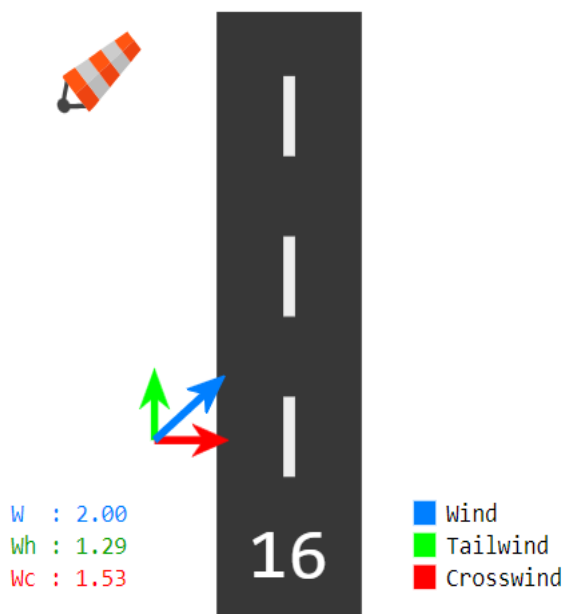
Figure 5: The crosswind component as per the weather report. (Source: <https://e6bx.com>)

- The weather profile indicates constant wind speed at the time of landing, and no low-level wind shear turbulence.
- The crosswind component for the Sling 2 LSA is 15 knots (kts). The crosswind component refers to the maximum crosswind velocity an aircraft can effectively withstand during take-off and landing.
