**LIMITED OCCURRENCE INVESTIGATION REPORT – FINAL**

<b>Reference Number</b>	CA18/2/3/10498						
<b>Classification</b>	Accident	<b>Date</b>	25 September 2024	<b>Time</b>	1330Z		
<b>Type of Operation</b>	Private (Part 94)						
<b>Location</b>							
<b>Place of Departure</b>	Wings Park Aerodrome, Eastern Cape Province		<b>Place of Intended Landing</b>		Wings Park Aerodrome, Eastern Cape Province		
<b>Place of Occurrence</b>	RWY09 at Wings Park Aerodrome, approximately 12 nautical miles north of East London Airport (FAEL)						
<b>GPS Co-ordinates</b>	<b>Latitude</b>	32°49'00" S	<b>Longitude</b>	027°50' 11" E	<b>Elevation</b>	1200ft	
<b>Aircraft Information</b>							
<b>Registration</b>	ZU-JOG						
<b>Make; Model; S/N</b>	Kitplanes for Africa; Kitplanes Safari (Serial Number: 031-11-16 SAF 2)						
<b>Damage to Aircraft</b>	Substantial			<b>Total Aircraft Hours</b>	228.0		
<b>Pilot-in-command</b>							
<b>Licence Type</b>	Airline Transport Pilot Licence (ATPL)		<b>Gender</b>	Male		<b>Age</b>	30

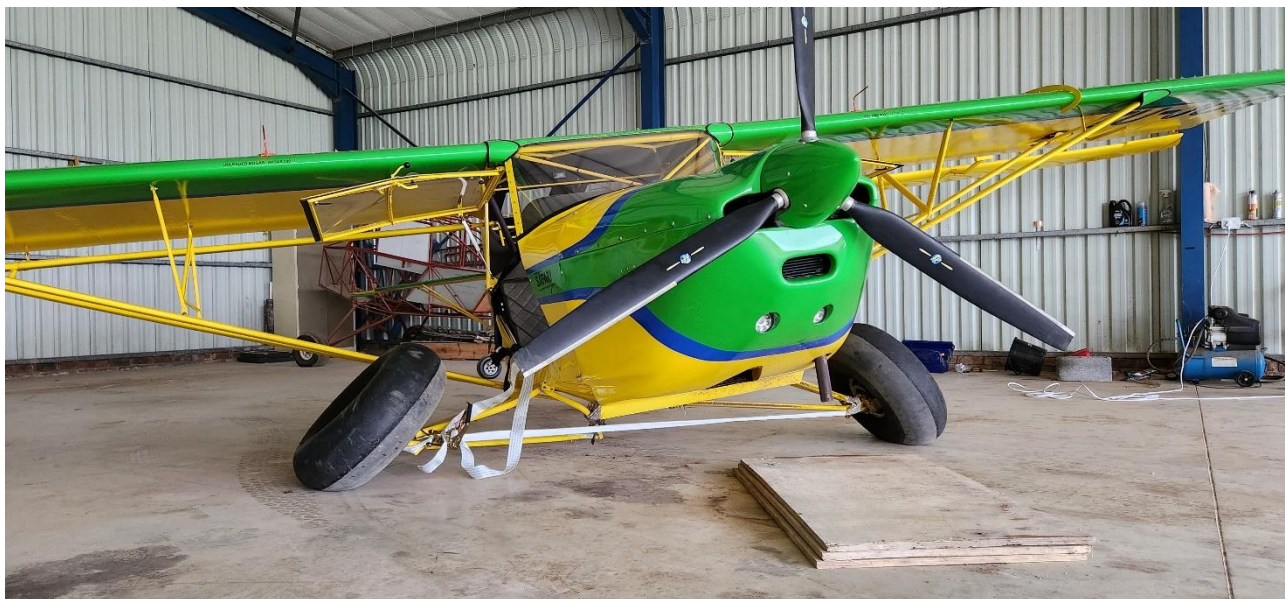
Despite the hard landing and whilst oblivious to the damage sustained to the main gear, the pilot applied full power, and the aircraft was airborne again. The pilot flew a circuit and landed on the runway; this further damaged the main gear.

**Figure 1:** The aircraft after recovery. (Source: Pilot)

8. The pilot did not maintain the glide speed after the simulated engine failure which resulted in a high sink rate and the subsequent hard landing; this damaged the main gear.

The pilot did not maintain the glide speed after the simulated engine failure was initiated which resulted in a high sink rate and the subsequent hard landing; this caused damaged to the main gear.

Pilots should not conduct simulated engine failures outside a training environment with passengers on-board.
