**LIMITED OCCURRENCE INVESTIGATION REPORT – FINAL**

<b>Reference Number</b>	CA18/2/3/10499						
<b>Classification</b>	Accident	<b>Date</b>	26 September 2024		<b>Time</b>	0700Z	
<b>Type of Operation</b>	Training (Part 141)						
<b>Location</b>							
Place of Departure	Brakpan Aerodrome (FABB), Gauteng Province		Place of Intended Landing	Brakpan Aerodrome (FABB), Gauteng Province			
Place of Occurrence	Right side of Runway 36, at Brakpan Aerodrome (FABB)						
GPS Co-ordinates	Latitude	26°14'17"S	Longitude	028°18'21" E	Elevation	5 300ft	
<b>Aircraft Information</b>							
Registration	ZS-FTB						
Make; Model; S/N	Piper Aircraft Corporation; PA28-180 Cherokee (Serial Number: 28-24110)						
Damage to Aircraft	Substantial		Total Aircraft Hours	18 777.96			
<b>Pilot-in-command</b>							
Licence Type	Student Pilot Licence (SPL)		Gender	Male		Age	19
Licence Valid	Yes	Total Hours	32.3		Total Hours on Type	31.8	
Total Hours 30 Days	3.6		Total Flying on Type Past 90 Days		17

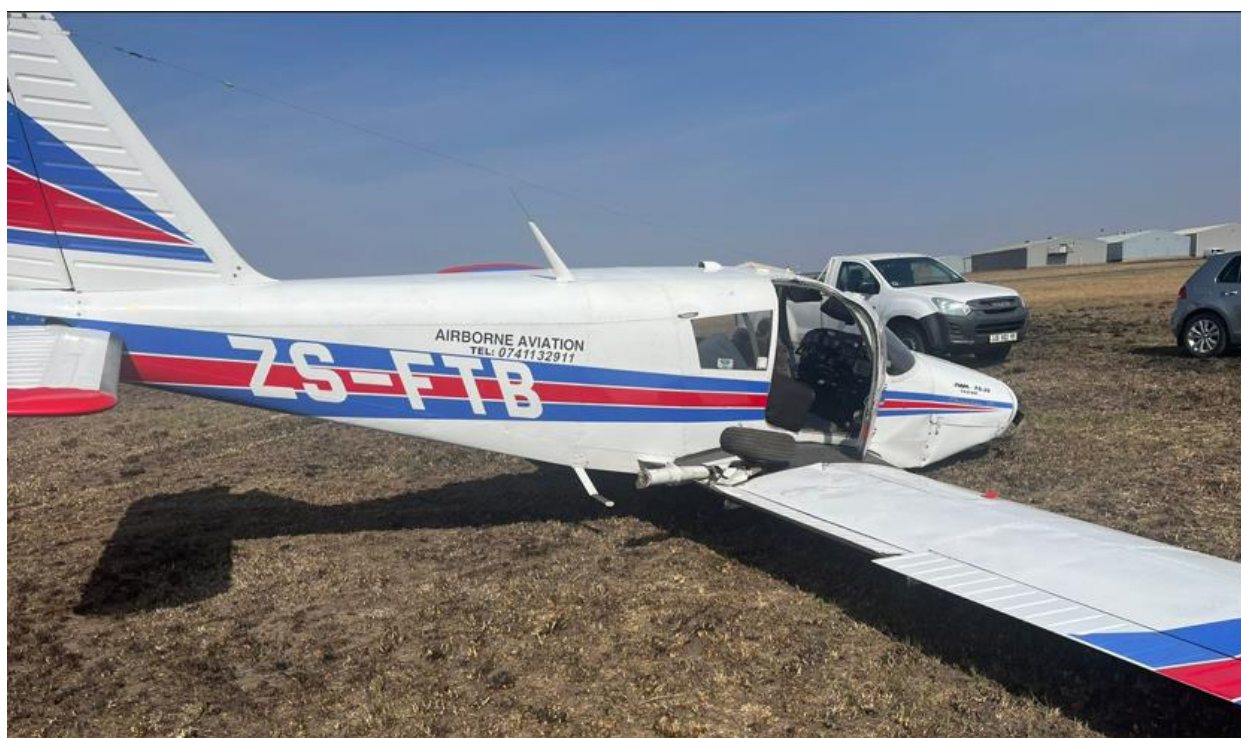
<b>People On-board</b>	1+0	<b>Injuries</b>	0	<b>Fatalities</b>	0	<b>Other (on the ground)</b>	0
<b>What Happened</b>							
<p>On Thursday morning, 26 September 2024, a student pilot on-board a Piper PA28-180 Cherokee aircraft with registration ZS-FTB took off on a training flight from Brakpan Aerodrome (FABB) in Gauteng province with the intention to land back at the same aerodrome. Visual meteorological conditions (VMC) by day prevailed at the time of the flight which was conducted under the provisions of Part 141 of the Civil Aviation Regulations (CAR) 2011 as amended.</p> <p>The student pilot stated that he took off from Runway (RWY) 36 and performed three successful circuits of touch-and-go landings. On the fourth circuit, the aircraft approached RWY 36 at approximately 85 knots indicated airspeed (KIAS). Due to the high speed, the aircraft landed hard on its main wheels which caused the right main gear to separate from the fuselage; the nose landing gear collapsed and the propeller blades struck the ground. At this point, the student pilot lost directional control of the aircraft which veered off to the right of the runway. It came to a stop 51 metres (m) from the edge of the runway.</p> <p>The aircraft sustained substantial damage; the student pilot was not injured.</p>

**Figure 2:** ZS-FTB at the accident site. (Source: Operator)

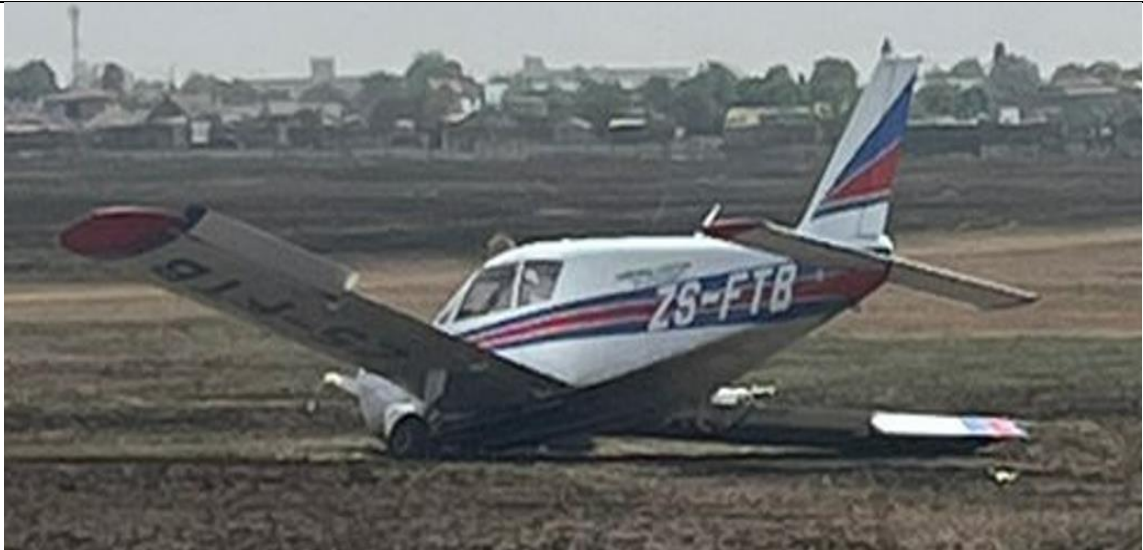
**Figure 3:** ZS-FTB's left side post-incident. (Source: Operator)

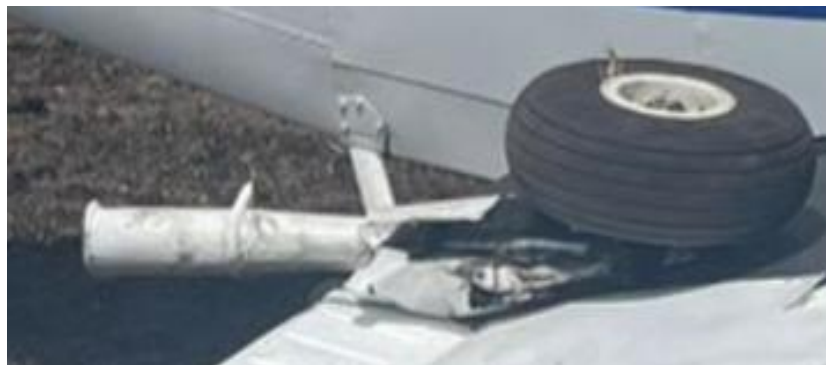
**Figure 4:** The right main landing gear strut. (Source: Operator)

The aircraft's excessive speed during landing resulted in a hard touch down which caused the separation of the right main landing gear and the collapse of the nose gear. This led to loss of directional control.

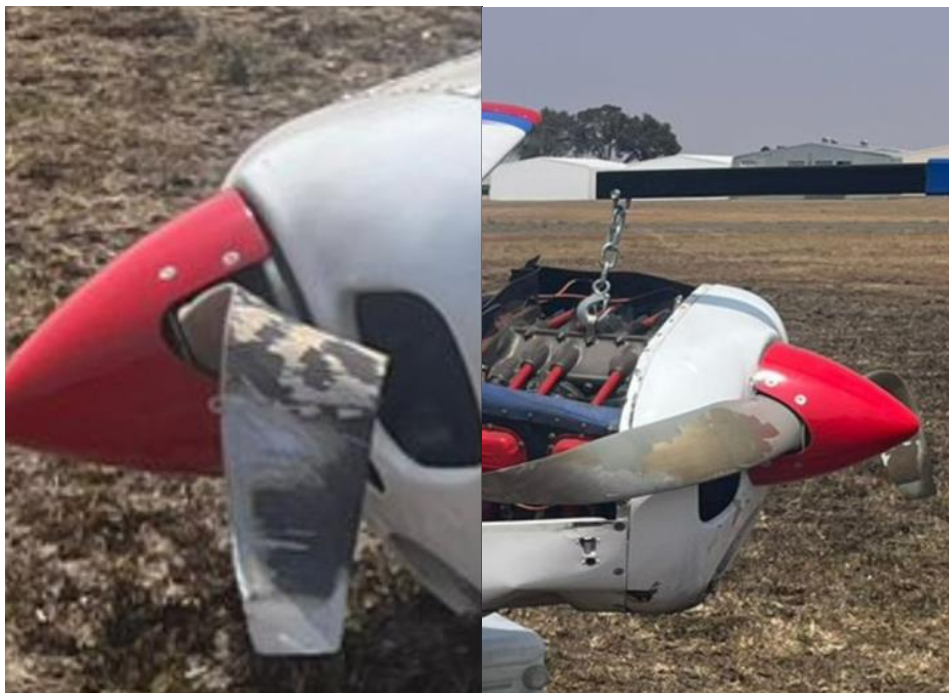
**Figures 5 and 6:** The bent propeller blades. (Source: Operator)

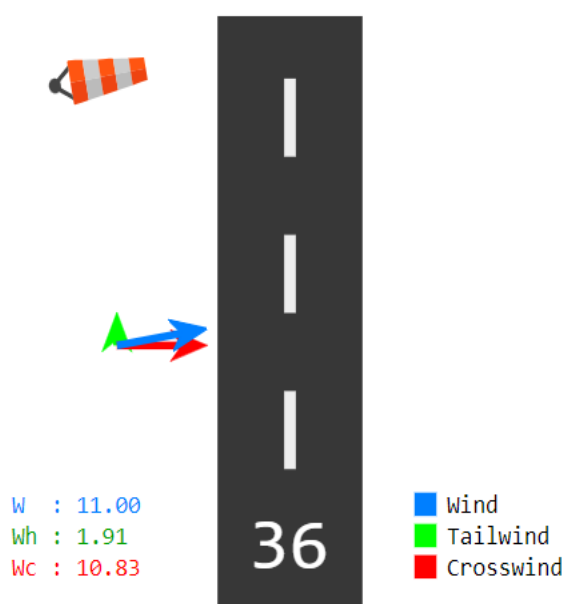
**Figure 7:** The crosswind component as per the weather report. (Source: <https://e6bx.com>)

- The meteorological conditions above show a crosswind from the left. Crosswind component calculations were made using an automated formular available at <https://e6bx.com> website.
- Calculations show that the aircraft was affected by a crosswind component of 10.83 knots (kts) during landing.
- According to the POH, the Piper Cherokee PA28-180 can withstand a crosswind component of 15-17 knots (kts). The crosswind refers to the maximum crosswind velocity an aircraft can effectively withstand during take-off and landing.

8. Although the crosswind component of 10.89 knots was within the aircraft's limits, it might have affected the student pilot's ability to maintain directional control during landing. The cumulative effect of the wind and the excessive speed likely made it difficult for the student pilot to align the aircraft to the runway.
