LIMITED OCCURRENCE INVESTIGATION REPORT – FINAL

Reference Number	CA18/2/3/10500					
Classification	Accident	Date	23 September 2024	Time	0830Z	
Type of Operation	Private (Part 94)					
Location						
Place of Departure	Dundi Lodge Private Airstrip, Northern Cape Province		Place of Intended Landing	Raap en Skraap Private Airstrip, Northern Cape Province		
Place of Occurrence	Raap en Skraap Private Airstrip, 29.5 nautical miles (nm) south-west of Pofadder, Northern Cape Province					
GPS Co-ordinates	Latitude	28°40'30" S	Longitude	019°31'02" E	Elevation	1620 ft
Aircraft Information						
Registration	ZU-FOA					
Make; Model; S/N	Skystar Aircraft Company; Kit Fox 7 SS (Serial Number: KAO8175135)					
Damage to Aircraft	Substantial		Total Aircraft Hours	602.2		
Pilot-in-command						
Licence Type	Private Pilot Licence (PPL) Aeroplane		Gender	Male	Age	57
Licence Valid	Yes	Total Hours	1551.1	Total Hours on Type	727.8	
Total Hours 30 Days	6.5		Total Flying on Type Past 90 Days	15.6

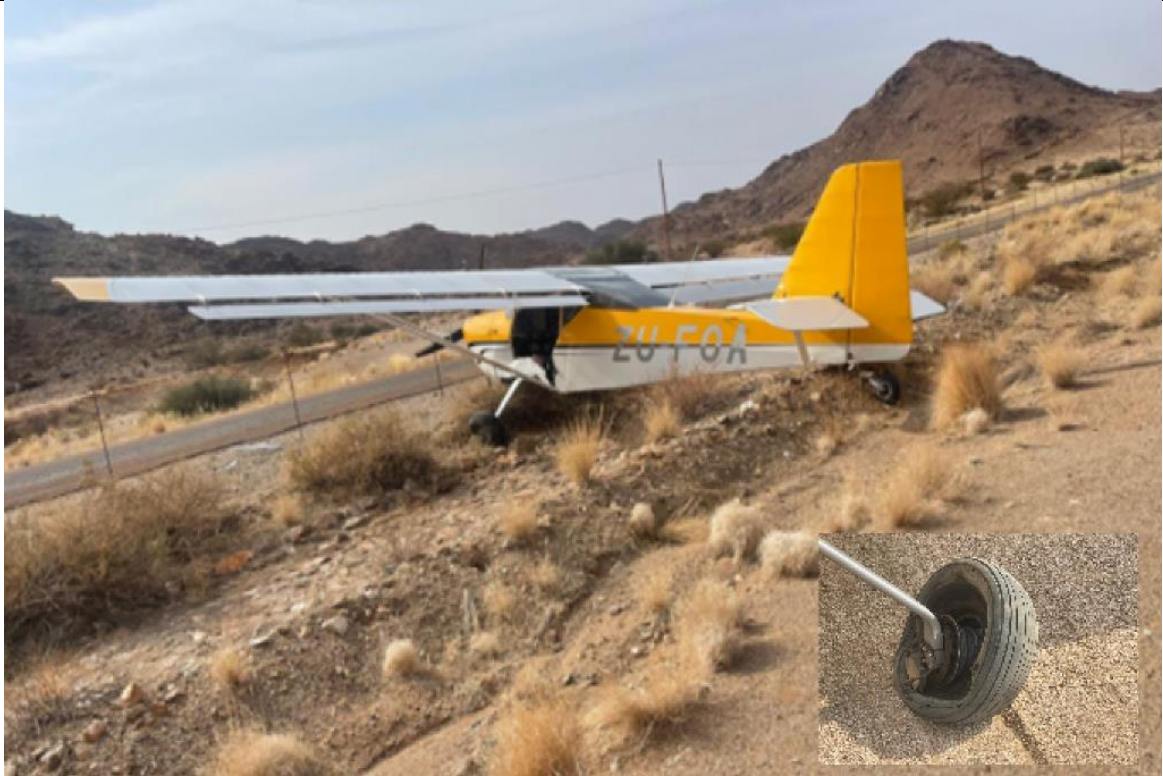
Figure 1: The aircraft stopped on the left side of RWY 01. The inset picture shows the damaged right-side tyre. (Source: Owner)

2.3 The aircraft's Certificate of Registration (C of R) was issued to the present owner on 4 October 2016.
2.4 During touch down, the aircraft experienced a crosswind from the right and, as the main wheels contacted the ground, the pilot lost directional control of the aircraft.

2.5 According to the pilot's questionnaire, the crosswind was calculated at 14.34 kts and the maximum demonstrated crosswind is 15 kts.
Probable Cause(s)
The pilot lost directional control of the aircraft due to a high crosswind from the right which caused it to ground-loop after touch down.
Contributing Factor(s)
None.
Safety Action(s)
None.
Safety Message and/or Safety Recommendation/s
None.
About this Report
<i>The decision to conduct a limited investigation is based on factors including whether the cause is known and the evidence supporting the cause is clear, the level of safety benefit likely to be obtained from an investigation and that will determine the scope of an investigation. For this occurrence, a limited investigation has been conducted, and the Accident and Incident Investigations Division (AIID) has relied on the information submitted by the affected person/s and organisation/s to compile this limited report. The report has been compiled using information supplied in the initial notification, as well as from follow-up desk top enquiries to bring awareness of potential safety issues to the industry in respect of this occurrence, as well as possible safety action/s that the industry might want to consider in preventing a recurrence of a similar occurrence.</i>

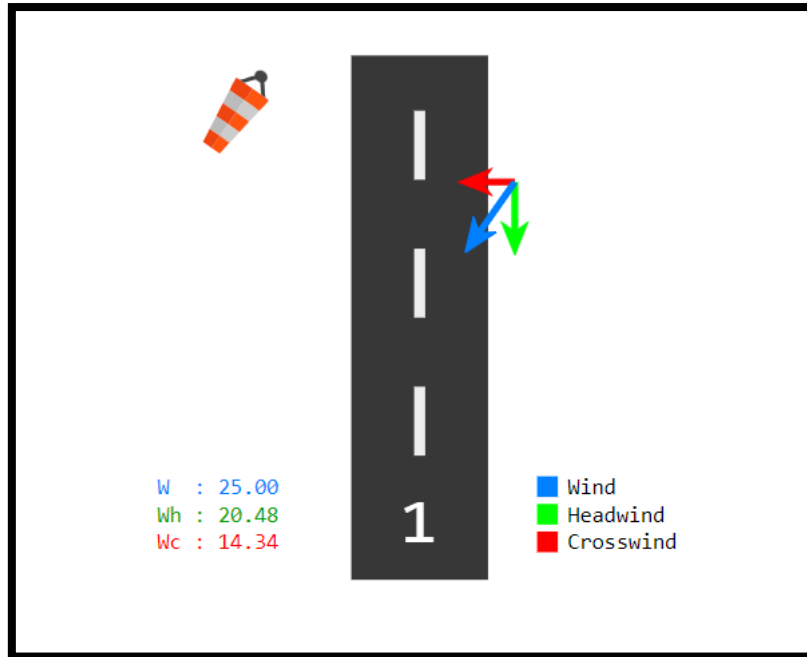
Figure 4: Crosswind on RWY 01 was 14.34 knots. The wind value was taken from the pilot questionnaire. (Source: <https://e6bx.com/wind>)

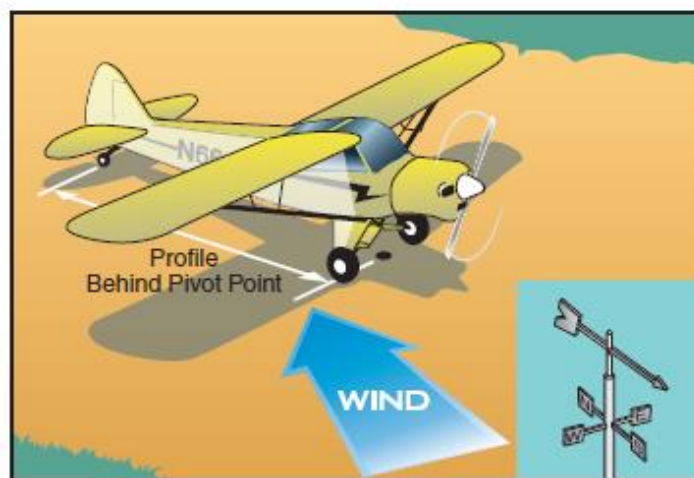
Figure 7: Weather vaning tendency. (Source: FAA-Airplane Flying Handbook)
