AIRCRAFT ACCIDENT REPORT AND EXECUTIVE SUMMARY

Reference:		CA18/2/3/10501			
Aircraft Registration	ZS-BGN	Date of Accident	28 September 2024	Time of Accident	0815Z		
Type of Aircraft	De Havilland DH82A		Type of Operation	Private (Part 94)			
Pilot-in-command Licence Type	Private Pilot Licence (PPL)		Age	81	Licence Valid	Yes	
Pilot-in-command Flying Experience	Total Flying Hours		6 508	Hours on Type	13.5		
Last Point of Departure	Heidelberg Airfield (FAHG), Gauteng Province						
Next Point of Intended Landing	Vereeniging Airfield (FAVV), Gauteng Province						
Damage to Aircraft	Substantial						
Location of the accident site with reference to easily defined geographical points (GPS readings if possible)							
Dirt road at Global Positioning System co-ordinates: 26°32'49" South 028°14' 18.1" East, at an elevation of 4 846 feet (ft)							
Meteorological Information	Surface wind: 300° / 9 kt; temperature: 28°C; dew point: 0°C; visibility: CAVOK

Reference Number : CA18/2/3/10501
Occurrence Category : Accident (Category 1)
Type of Operation : Private (Part 94)
Name of Operator : JA Earle
Aircraft Registration : ZS-BGN
Aircraft Make and Model : De Havilland Aircraft Company, DH-82A

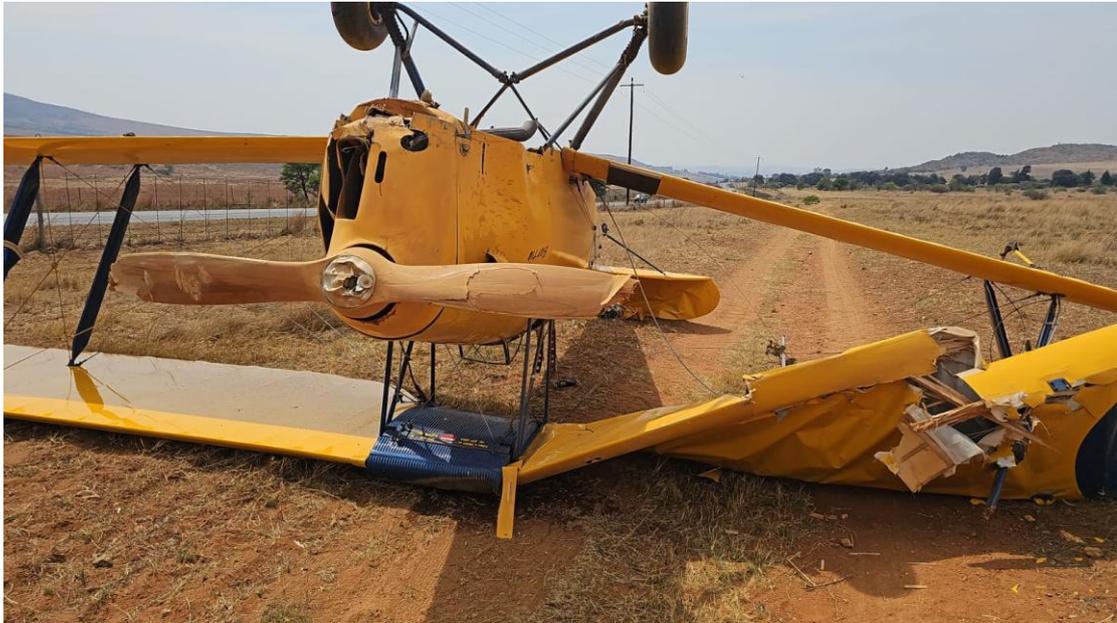
1.3.1. The aircraft's right wing, rudder, fin, propeller and the front engine mount were substantially damaged.

Figure 2: The aircraft post-accident. (Source: Pilot)

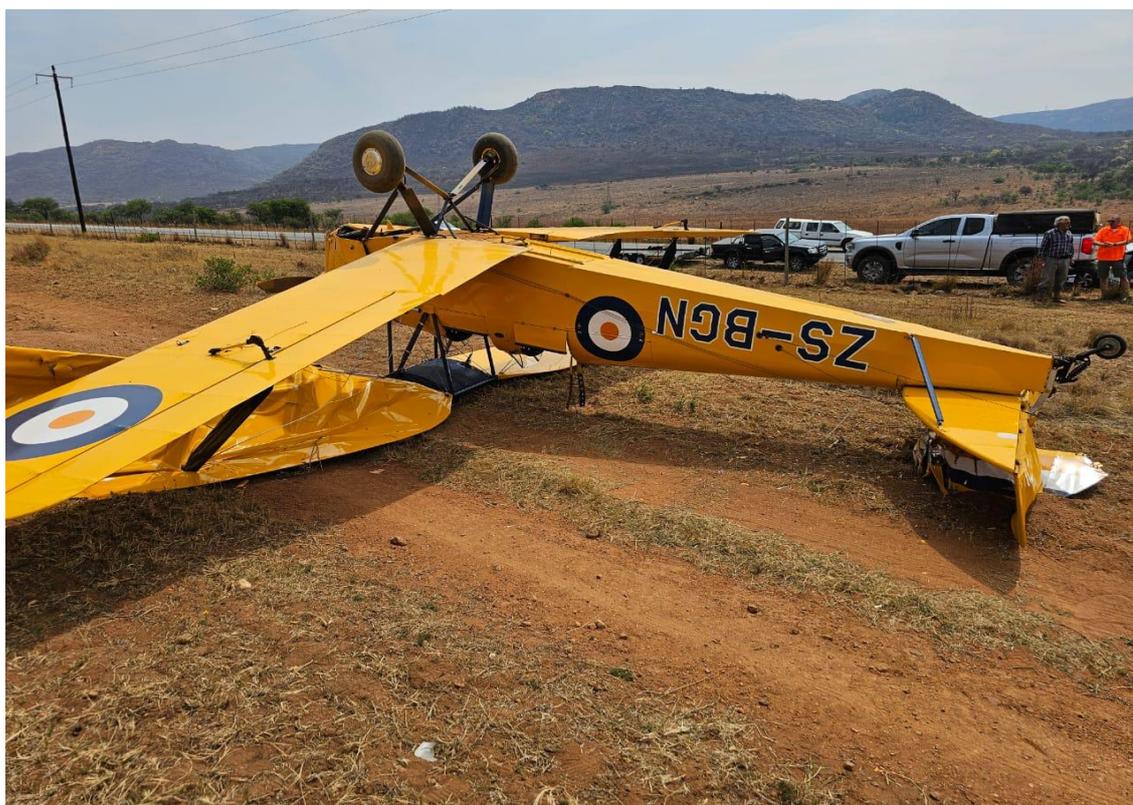
1.12.1 The accident occurred on a gravel road which was uneven and unfavourable to perform a safe landing. The wreckage distribution was fairly localised. The aircraft was found in an inverted attitude. The bottom side of the nose section was damaged which was consistent with the aircraft's impact with the ground (see Figure 2). The propeller was found broken, and the engine mountings were found bent. The right upper wing was damaged during the accident sequence, indicative of impact with a solid surface. The tail fin and rudder were substantially damaged due to the hard impact with the ground during the accident sequence (when the aircraft flipped over).

Figure 3: The aircraft in an inverted position post-accident. (Source: Pilot)
