Section/division Accident and Incident Investigations Division

LIMITED OCCURRENCE INVESTIGATION REPORT - FINAL

Reference Number	CA18/2/3/10502													
Classification	A	Accident			Dat	e 2	29 September 2024			Time	1500Z			
Type of Operation Private (Part 94)														
Location														
Place of Departure	ace oi Reestekraal n			Private Airstrip in ear Brits, North				Place of Intended Landing			Bush n Buck Private Airstrip in Beestekraal near Brits, North West Province			
Place of Occurrence	Bush n Buck Private Airstrip in Beestekraal near Brits													
GPS Co-ordinates		Latitud	le	25° 22' 29.00		00" S	Lo	Longitude		027° 34' 49.00" E		Elevat	Elevation 3 800	
Aircraft Information														
Registration	stration ZU-DFP													
Make; Model; S/N Jabiru; J400 (S/N: 109)														
Damage to Aircraft S			Substantial					Tot	Total Aircraft Hours			3977.7		
Pilot-in-command														
Licence Type	e Private Pilot Li			cence (PPL)			Gender		Ма	Male		Age	70	
Licence Valid	Yes			Total Hours		6	600		Total Ho		urs on Type		20.3

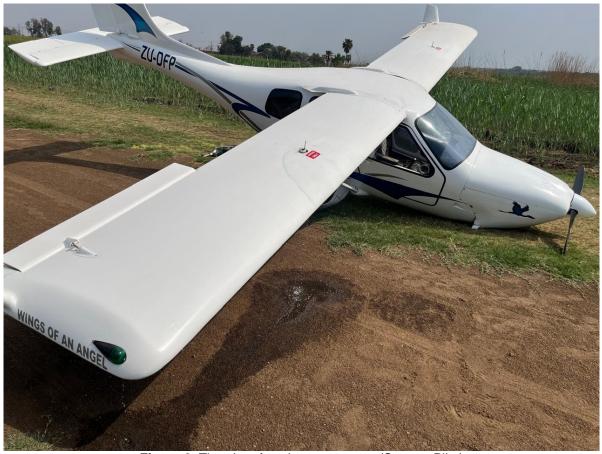
The pilot reported that he conducted the pre-flight checks with no anomalies noted. He then took off from Runway 22 and executed three uneventful touch-and-go landings. The pilot then elected to make the fourth circuit a full-stop landing. The aircraft approached at a speed of 65 knots (kts) with flaps set at 30 degrees. The pilot initiated the flare too high, which resulted in a stall and a hard landing. As a result, the nose gear and the right main landing gear failed and, subsequently, the propeller, engine cowling and right wing were damaged. The aircraft came to a stop on the runway. The pilot was unharmed during the accident sequence.

Figure 2: The aircraft as it came to rest. (Source: Pilot)

It is likely that the aircraft's height on approached was too high, and the pilot reduced the engine power and flared the aircraft. This caused the aircraft to drop on the runway and touch down hard, which damaged the aircraft.

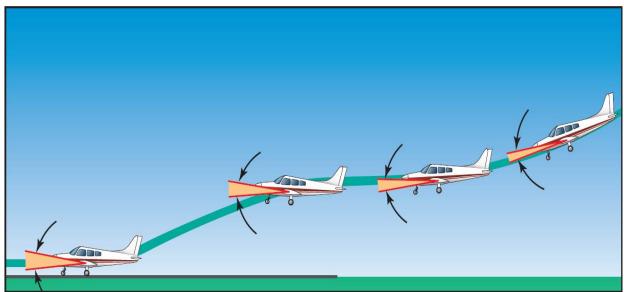
Sometimes when the airplane appears to temporarily stop moving downward, the round out has been made too rapidly and the airplane is flying level, too high above the runway. Continuing the round out would further reduce the airspeed, resulting in an increase in angle of attack to the critical angle. This would result in the airplane stalling and dropping hard onto the runway.

Illustration 1: High round illustration. (Source: FAA-8083-3A)
