**LIMITED OCCURRENCE INVESTIGATION REPORT – FINAL**

<b>Reference Number</b>	CA18/2/3/10503						
<b>Classification</b>	Accident		<b>Date</b>	1 October 2024		<b>Time</b>	0755Z
<b>Type of Operation</b>	Training Part 141						
<b>Location</b>							
<b>Place of Departure</b>	Mafikeng Aerodrome (FAMM), North West Province			<b>Place of Intended Landing</b>	Mafikeng Aerodrome (FAMM), North West Province		
<b>Place of Occurrence</b>	Runway 22 at Mafikeng Aerodrome (FAMM)						
<b>GPS Co-ordinates</b>	<b>Latitude</b>	25° 47' 35.2" S	<b>Longitude</b>	025° 33' 02.1" E	<b>Elevation</b>	4200 ft	
<b>Aircraft Information</b>							
<b>Registration</b>	ZS-LCC						
<b>Make; Model; S/N</b>	Piper Aircraft Corporation; Piper PA-28-181 (Serial Number: 28-8190301)						
<b>Damage to Aircraft</b>	Substantial			<b>Total Aircraft Hours</b>	5036.1		
<b>Pilot-in-command</b>							
<b>Licence Type</b>	Student Pilot Licence (SPL)		<b>Gender</b>	Female		<b>Age</b>	19
<b>Licence Valid</b>	Yes	<b>Total Hours</b>	46.9	<b>Total Hours on Type</b>	46.9

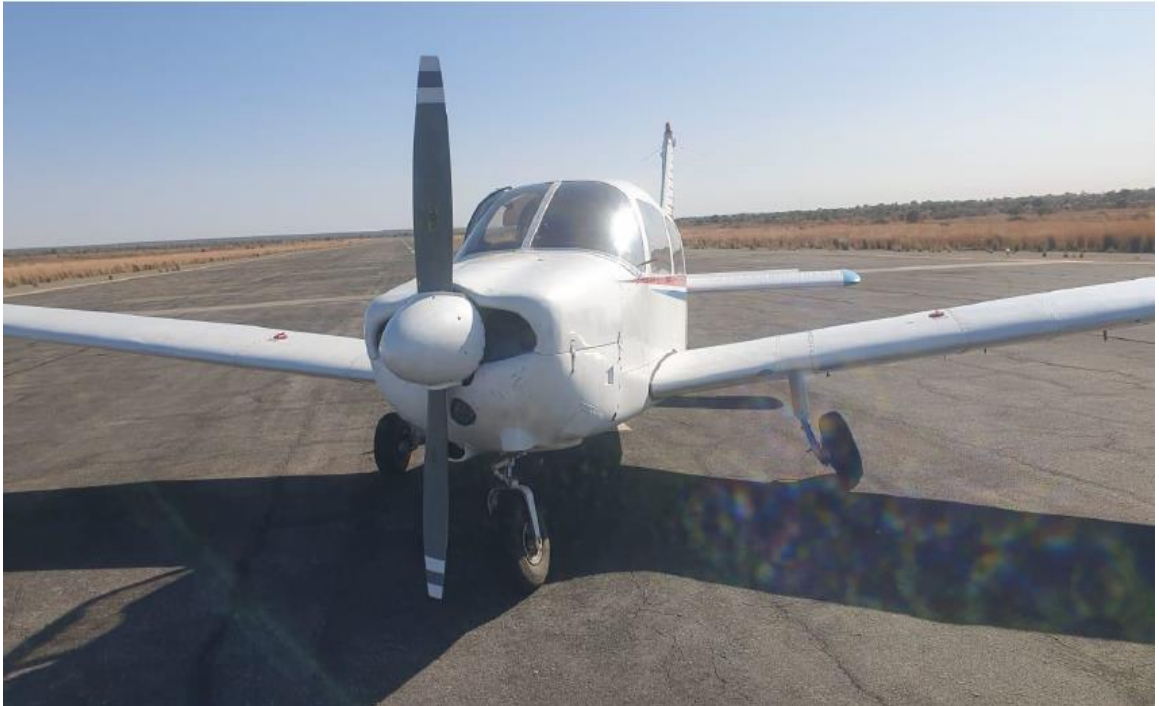
<b>Total Hours 30 Days</b>	5.7		<b>Total Flying on Type Past 90 Days</b>	16.2			
<b>People On-board</b>	1+0	<b>Injuries</b>	0	<b>Fatalities</b>	0	<b>Other (on ground)</b>	0
<b>What Happened</b>							
<p>On Tuesday morning, 1 October 2024 at approximately 0635Z, a student pilot (SP) on-board a Piper PA-28-181 Cherokee with registration ZS-LCC took off on a solo training flight from Mafikeng Aerodrome (FAMM) in North West province to the general flying area (GFA). Visual meteorological conditions (VMC) by day prevailed at the time of the flight which was conducted under the provisions of Part 141 of the Civil Aviation Regulations (CAR) 2011 as amended.</p> <p>The SP reported that the take-off phase and the flight to the GFA were uneventful. Upon reaching the GFA, she conducted Exercises 15 (steep turns), 16 (forced landing) and 17 (precautionary landing). After completing the exercises, she returned to FAMM for a full-stop landing. FAMM has a single asphalt runway orientated 04/22 and is 4.5 kilometres long. Approximately 5 nautical miles (nm) from the aerodrome, the SP reported her position and her intention to conduct a full-stop landing to the air traffic control (ATC) officer. The ATC cleared the SP to join the right-side circuit for landing on Runway (RWY) 22 and to report downwind. The ATC advised the SP of the prevailing weather conditions which were as follows: wind direction: 210 degrees, velocity: 18 knots (kts), and ceiling and visibility okay (CAVOK).</p> <p>According to the SP, the wind was strong whilst she was on the downwind leg. She reported final approach and was cleared for landing. During approach whilst flying at a speed of 75 kts, a gust of wind from the left pushed the aircraft slightly to the right of the runway's centreline. The SP brought the aircraft back to the centreline; however, she positioned it slightly to the left of the centreline. She then flared the aircraft, which was too early and high, and it touched down hard with the left main landing gear first; it bounced before it came to a stop on the runway's centreline facing slightly to the right. The aircraft sustained damage to the left main landing gear. The SP was not injured during the accident.</p>

**Figure 1:** The aircraft after it had stopped. (Source: Operator)

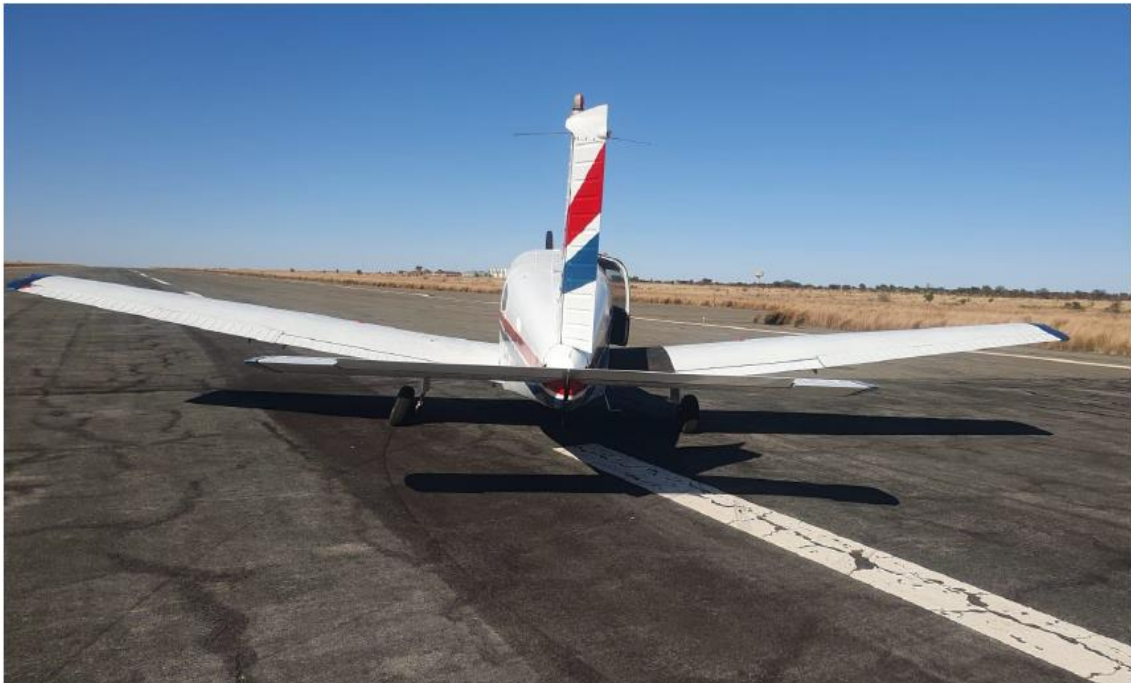
**Figure 2:** The damage on the left main undercarriage. (Source: Operator)

8. The aircraft's approach speed of 75 kts was higher than the recommended speed of 66 kts. An early flare increased the aircraft's descent rate prematurely which caused it to drop too fast and, subsequently, landed hard. This may have been due to poor judgment or overcompensation after the wind gust.

<p><u>Environment</u></p> <p>9. The reported wind conditions (210° at 18 knots) on the final approach were a significant contributing factor. The strong wind from the side (left gust pushing the aircraft to the right) affected the aircraft's stability during approach and landing.</p>
<p><b>Probable Cause(s)</b></p> <p>The aircraft landed hard due to strong wind conditions.</p>
<p><b>Contributing Factor(s)</b></p> <ol style="list-style-type: none"> <li>1. The SP's lack of experience resulted in the failure to execute a go-around.</li> <li>2. Strong wind conditions prevailed at the time of landing.</li> </ol>
<p><b>Safety Action(s)</b></p> <p>The ATOs must conduct and regularly review and distribute updates on best practices for landing in strong winds to all student pilots and instructors.</p>
<p><b>Safety Message</b></p> <p>None.</p>
<p><b>About this Report</b></p> <p><i>The decision to conduct a limited investigation is based on factors including whether the cause is known and the evidence supporting the cause is clear, the level of safety benefit likely to be obtained from an investigation and that will determine the scope of an investigation. For this occurrence, a limited investigation has been conducted, and the Accident and Incident Investigations Division (AIID) has relied on the information submitted by the affected person/s and organisation/s to compile this limited report. The report has been compiled using information supplied in the initial notification, as well as from follow-up desktop inquiries to bring awareness of potential safety issues to the industry in respect of this occurrence, as well as possible safety action/s that the industry might want to consider in preventing a recurrence of a similar occurrence.</i></p> <p><i>All times given in this report are Co-ordinated Universal Time (UTC) and will be denoted by (Z). South African Standard Time is UTC plus 2 hours.</i></p>
