**LIMITED OCCURRENCE INVESTIGATION REPORT – FINAL**

<b>Reference Number</b>	CA18/2/3/10504					
<b>Classification</b>	Accident	<b>Date</b>	30 September 2024	<b>Time</b>	0544Z	
<b>Type of Operation</b>	Training (Part 141)					
<b>Location</b>						
<b>Place of Departure</b>	Wonderboom Aerodrome (FAWB), Gauteng Province		<b>Place of Intended Landing</b>	Wonderboom Aerodrome (FAWB), Gauteng Province		
<b>Place of Occurrence</b>	Runway 11 at Wonderboom Aerodrome (FAWB)					
<b>GPS Co-ordinates</b>	<b>Latitude</b>	25°39'12.23" S	<b>Longitude</b>	028°13'05.55" E	<b>Elevation</b>	4 095 feet
<b>Aircraft Information</b>						
<b>Registration</b>	ZS-FPX					
<b>Make; Model; S/N</b>	Cessna Aircraft Company; 172E (Serial number: 172-51388)					
<b>Damage to Aircraft</b>	Substantial		<b>Total Aircraft Hours</b>	7 651.7		
<b>Pilot-in-command</b>						
<b>Licence Type</b>	Student Pilot Licence (SPL)		<b>Gender</b>	Male	<b>Age</b>	21
<b>Licence Valid</b>	Yes	<b>Total Hours</b>	37.8	<b>Total Hours on Type</b>	14.5

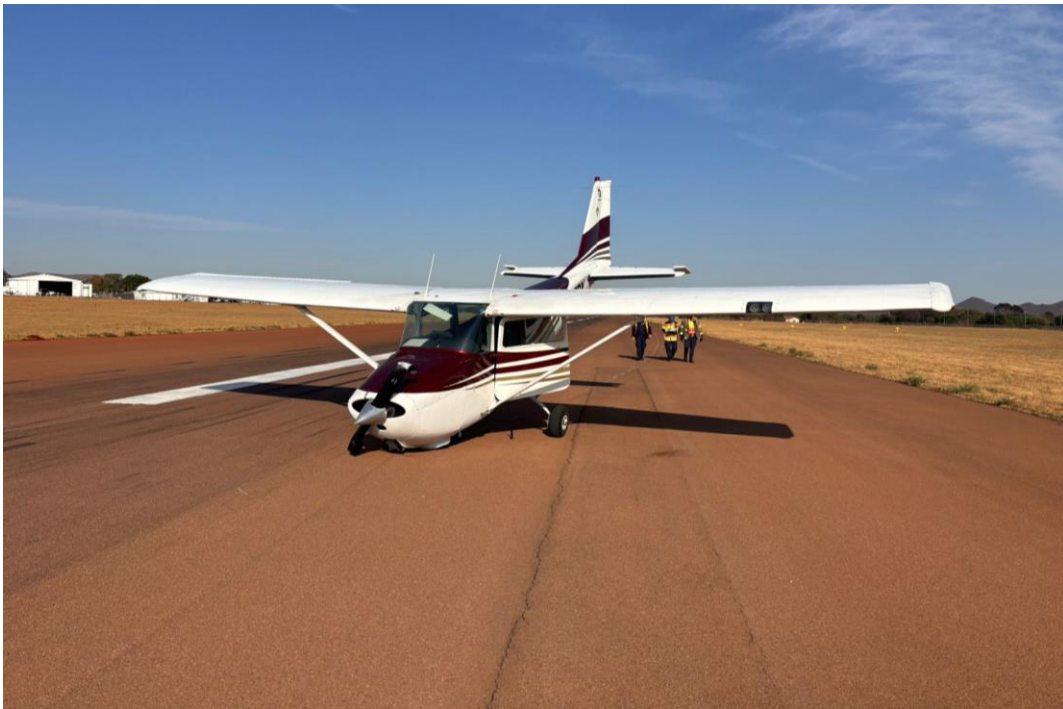
to a stop in a nosed-down attitude. The ATC officer activated the crash alarm and the ARFF team responded swiftly to the scene. The student pilot was not injured. The aircraft sustained damage to the propeller, lower engine cowlings and the nose landing gear which had collapsed.

**Figure 1:** The aircraft as it came to rest on Runway 11. (Source: ATO)

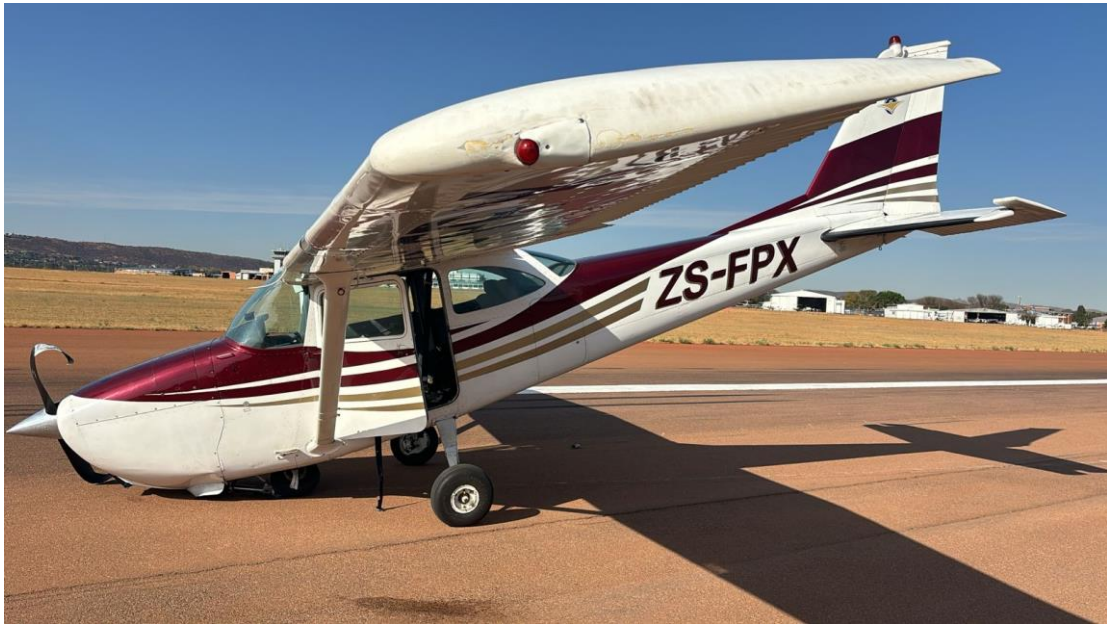
**Figure 2:** A side view of the aircraft after the occurrence. (Source: ATO)

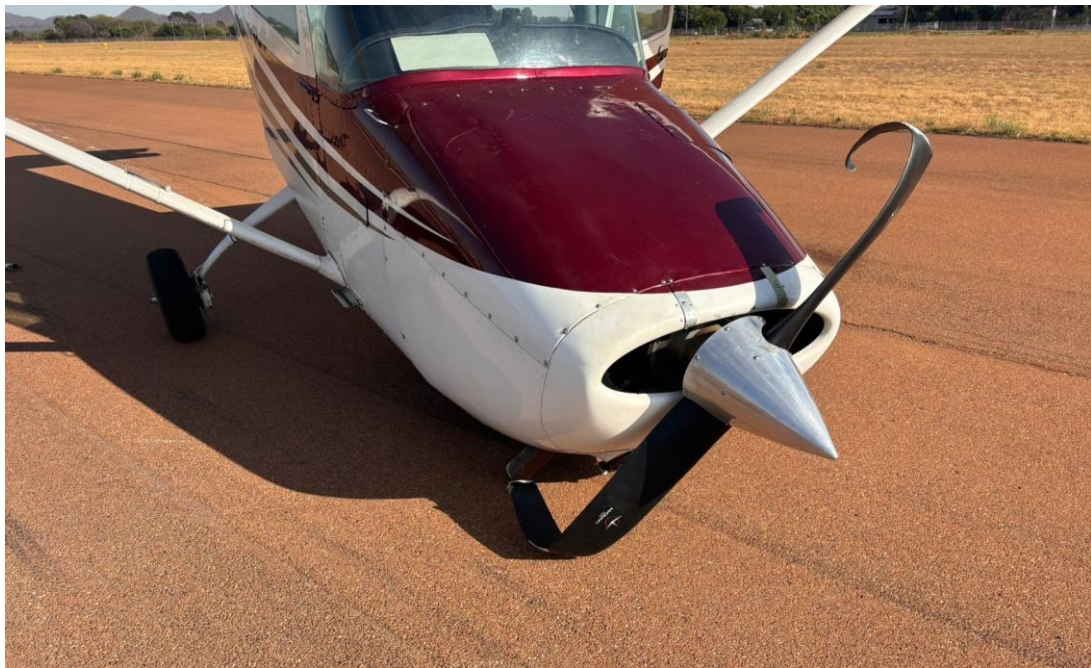
**Figure 3:** The deformed propeller blades indicate that the engine was delivering power during landing. (Source: ATO)

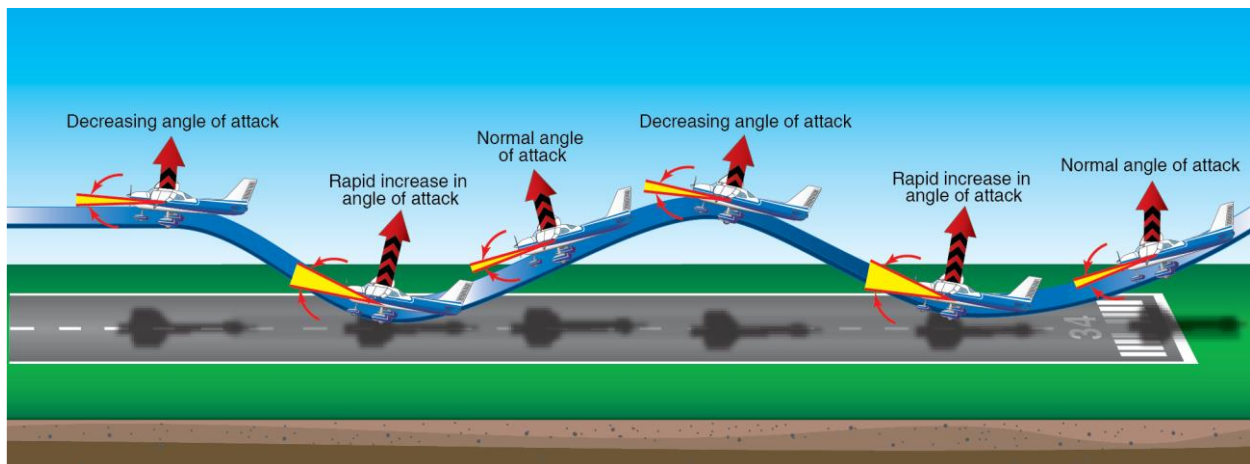
*“In a bounced landing that is improperly recovered, the airplane comes in nose first, initiating a series of motions imitating the jumps and dives of a porpoise. [Figure 4] The improper airplane attitude at touchdown may be caused by inattention, not knowing where the ground is, miss-trimming, or forcing the airplane onto the runway.*

**Figure 4:** Illustration of an aircraft when it is porpoising.

When pilots attempt to correct a severe porpoise with flight control and power inputs, the inputs are often untimely may increase the severity of each successive contact with the surface. These unintentional and increasing pilot-induced oscillations may lead to damage or collapse of the nose gear. When porpoising is severe or seems to be getting worse, the safest procedure is to execute a go-around immediately by applying full power while simultaneously maintaining directional control and lowering the nose to a safe climb attitude.”
