LIMITED OCCURRENCE INVESTIGATION REPORT – FINAL

Reference Number	CA18/2/3/10505						
Classification	Accident	Date	28 September 2024		Time	1050Z	
Type of Operation	Private (Part 91)						
Location							
Place of Departure	Bundu Inn Airfield, North West Province		Place of Intended Landing	Middleburg Airfield (FAMB), Mpumalanga Province			
Place of Occurrence	Left of Runway 32 at Middleburg Airfield (FAMB), Mpumalanga Province						
GPS Co-ordinates	Latitude	25° 41.14' S	Longitude	029° 26.43' E	Elevation	4 886 ft	
Aircraft Information							
Registration	ZS-JUA						
Make; Model; S/N	Piper Aircraft; Cherokee PA-28-181 (S/N: 28-7690106)						
Damage to Aircraft	Substantial		Total Aircraft Hours	7 337.87			
Pilot-in-command							
Licence Type	Private Pilot Licence (PPL)		Gender	Male		Age	23
Licence Valid	Yes	Total Hours	95.8		Total Hours on Type	23.2	
Total Hours 30 Days	5.3		Total Flying on Type Past 90 Days	8.8			
People On-board	1 + 1	Injuries	0	Fatalities	0	Other (on ground)	0

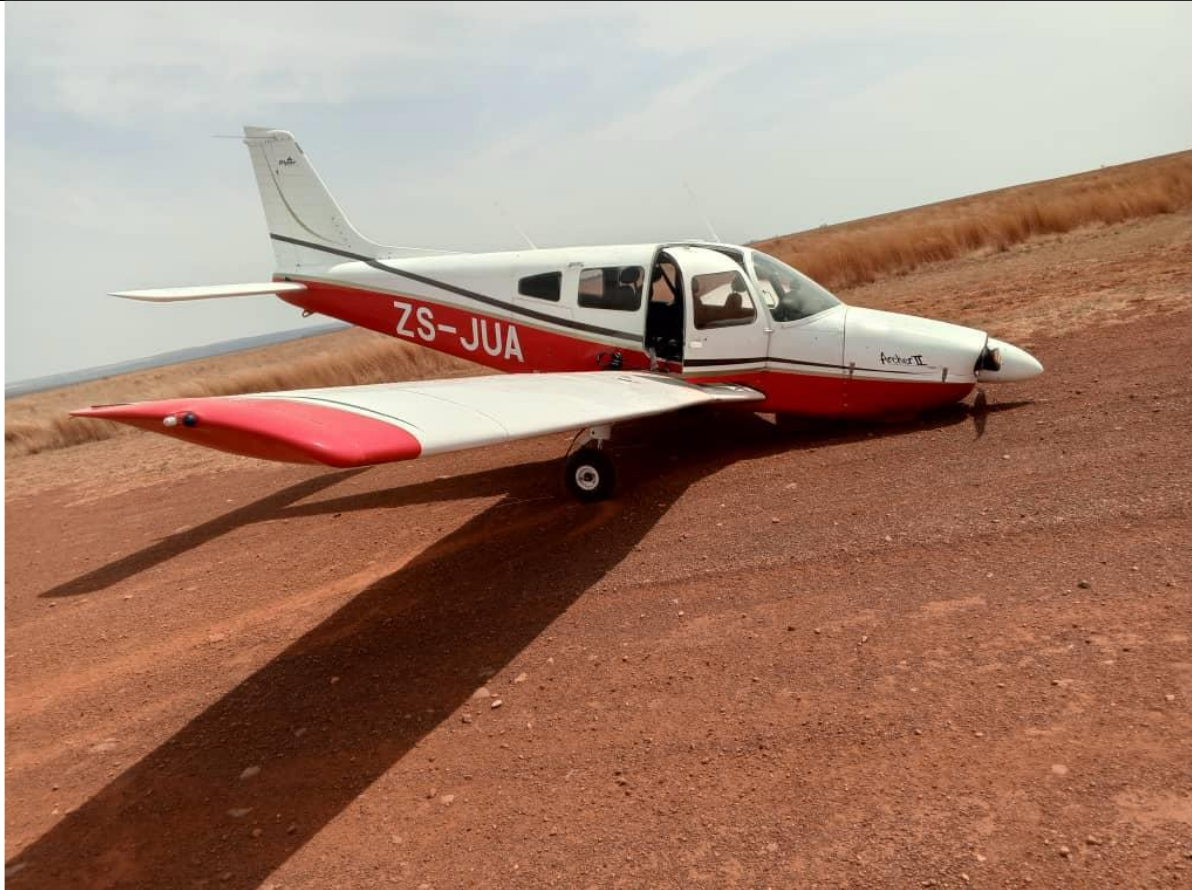
pilot lost directional control, and the nose gear impacted the taxiway sign. As a result, the nose gear strut broke off and the propeller struck the ground. The aircraft came to a stop on the gravel area approximately 7 metres (m) to the left of the runway. The pilot and the passenger were not injured; however, the aircraft sustained substantial damage to the nose gear, propeller and lower engine cowling.

Figure 2: The aircraft as it came to rest. (Source: Pilot)

2.5 The aircraft drifted to the left of the runway and landed hard; the pilot lost directional control and the aircraft veered off and impacted a taxiway sign. Consequently, the nose gear strut broke off. The pilot and the passenger were not injured during the accident sequence.

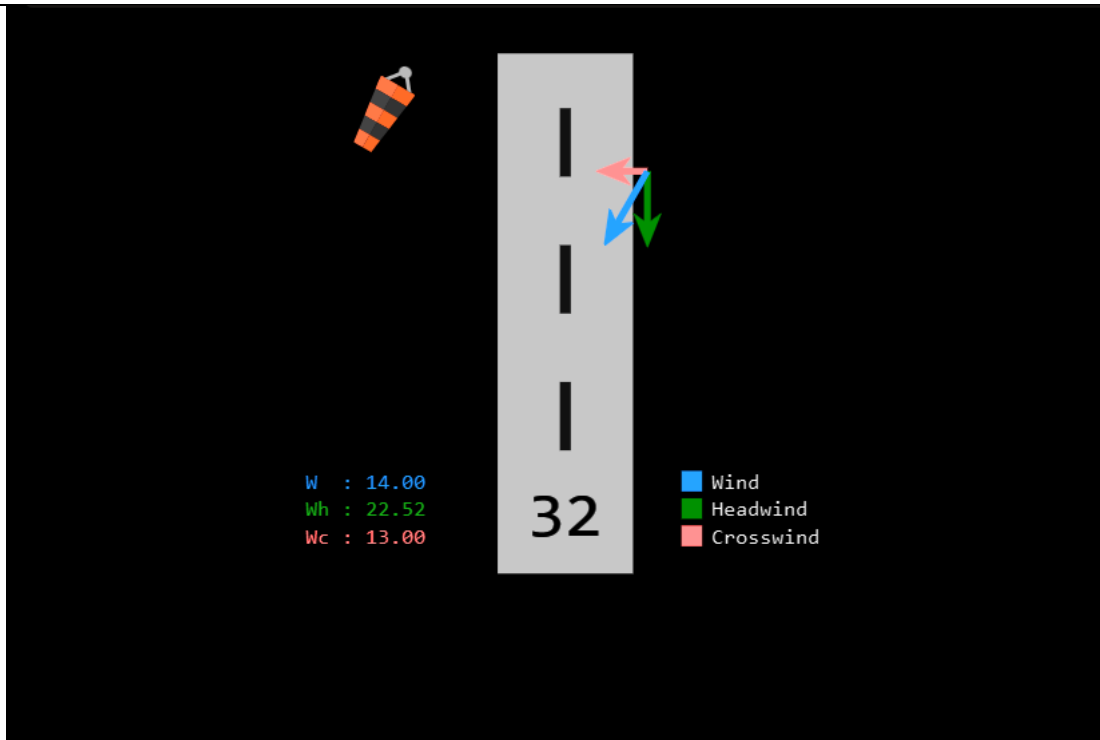
The crosswind component at the time of the accident was calculated to be approximately 13 kts. The aircraft had a demonstrated crosswind component of 17 kts.

Figure 3: The wind component during landing. (Source: <https://e6bx.com/wind-components/>)

The reported wind condition on the day was 350° at 14 kts, gusting 26 kts with a calculated crosswind of 13 knots.
