LIMITED OCCURRENCE INVESTIGATION REPORT – FINAL

Reference Number		CA18/2/3/10506					
Classification	Accident	Date	3 October 2024		Time	1230Z	
Type of Operation	Private (Part 91)						
Location							
Place of Departure	Dibeng Airfield, Northern Cape Province		Place of Intended Landing	Dibeng Airfield, Northern Cape Province			
Place of Occurrence	On Runway 16 at Dibeng Airfield, Northern Cape Province						
GPS Co-ordinates	Latitude	27°35'32.25"	Longitude	22°52'03.18"E	Elevation	3 686ft	
Aircraft Information							
Registration	ZU-RHN						
Make; Model; S/N	Autogyro GMBH; Calidus (Serial Number: C00192)						
Damage to Aircraft	Destroyed		Total Aircraft Hours	432			
Pilot-in-command							
Licence Type	National Pilot Licence (NPL)		Gender	Male	Age	66	
Licence Valid	Yes	Total Hours	220	Total Hours on Type	200		
Total Hours 30 Days	6.5		Total Flying on Type Past 90 Days	11.5			
People On-board	1+0	Injuries	0	Fatalities	0	Other (on the ground)	0
What Happened

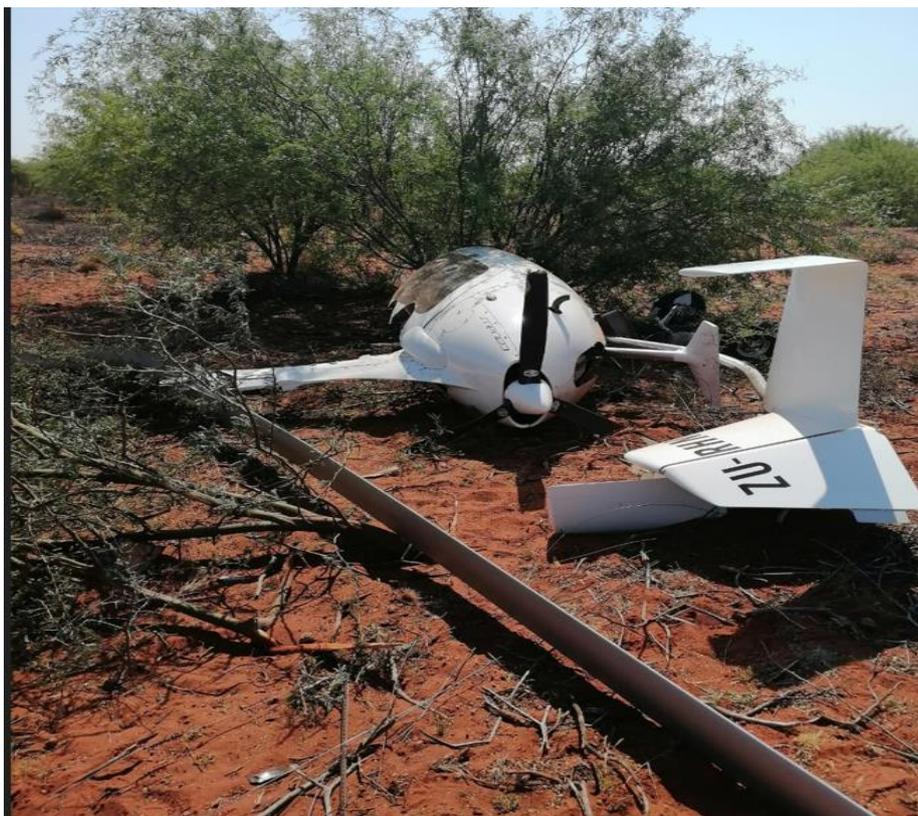
Figure 2: ZU-RHN at the accident site. (Source: Operator)

Post-accident investigation revealed that the tail section had separated from the gyrocopter and the propeller blades were damaged at the tips; the cockpit glass also shattered during the accident (see Figure 2).

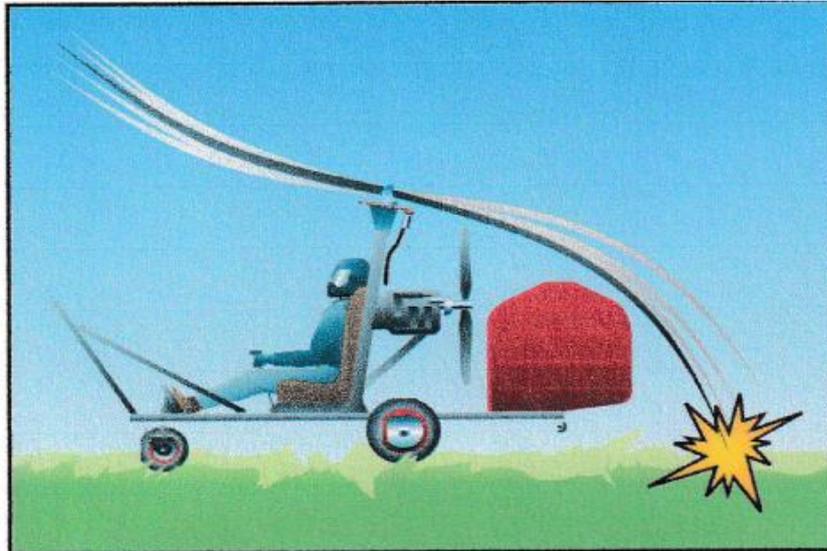
Figure 3: Illustration of the blade flap.

On a gyroplane with a semi-rigid, teeter-head rotor system, blade flap may develop if too much airflow passes through the rotor system while it is operating at low rpm. This is most often the result of taxiing too fast for a given rotor speed. Unequal lift acting on the advancing and retreating blades can cause the blades to teeter to the maximum allowed by the rotor head design. The blades then hit the teeter stops, creating a vibration that may be felt in the cyclic control. The frequency of the vibration corresponds to the speed of the rotor with the blades hitting the stops twice during each revolution. If the flapping is not controlled, the situation can grow worse as the blades begin to flex and bend. Because the system is operating at low rpm, there is not enough centrifugal force acting on the blades to keep them rigid. The shock of hitting the teeter stops combined with uneven lift along the length of the blade causes an undulation to begin, which can increase in severity if allowed to progress- In extreme cases, a rotor blade may strike the ground or propeller.

Figure 20-2. Taxiing too fast or gusting winds can cause blade flap in a slow turning rotor. If not controlled, a rotor blade may strike the ground.

To avoid the onset of blade flap, always taxi the gyroplane at slow speeds when the rotor system is at low RPM. Consideration must also be given to wind speed and direction. If taxiing into a 10-knot headwind, for example, the airflow through the rotor will be 10 knots faster than the forward speed of the gyroplane, so the taxi speed should be adjusted accordingly. When pre-rotating the rotor by taxiing with the rotor disc tilted aft, allow the rotor to accelerate slowly and smoothly. In the event the blade flap is encountered, apply forward cyclic to reduce the rotor disc angle and slow the gyroplane by reducing the throttle and applying the brakes, if needed.

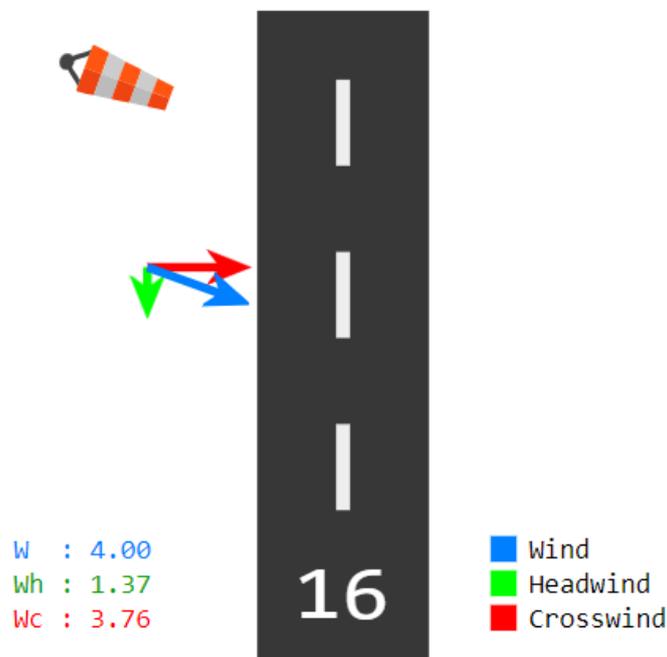
Figure 4: The crosswind component as per the weather report. (Source: <https://e6bx.com>)

- The meteorological conditions show a 4 knots (kts) crosswind from the left at the time of the accident. The crosswind component was calculated using <https://e6bx.com> website.
- According to the POH, the crosswind component which refers to the maximum crosswind velocity a gyrocopter can effectively withstand during take-off and landing is 22 knots (kts).
