LIMITED OCCURRENCE INVESTIGATION REPORT – FINAL

Reference Number	CA18/2/3/10507						
Classification	Accident	Date	3 October 2024	Time	1230Z		
Type of Operation	Private (Part 91)						
Location							
Place of Departure	Dibeng Airfield, Northern Cape Province		Place of Intended Landing	Dibeng Airfield, Northern Cape Province			
Place of Occurrence	On Runway 16 at Dibeng Airfield, Northern Cape Province						
GPS Co-ordinates	Latitude	27°35'32.25"	Longitude	22°52'03.18"E	Elevation	3 686ft	
Aircraft Information							
Registration	ZU-RHN						
Make; Model; S/N	Autogyro GMBH; Calidus (Serial Number: C00192)						
Damage to Aircraft	Destroyed		Total Aircraft Hours	432			
Pilot-in-command							
Licence Type	National Pilot Licence (NPL)		Gender	Male	Age	66	
Licence Valid	Yes	Total Hours	220	Total Hours on Type	200		
Total Hours 30 Days	6.5		Total Flying on Type Past 90 Days	11.5			
People On-board	1+0	Injuries	0	Fatalities	0	Other (on the ground)	0
What Happened

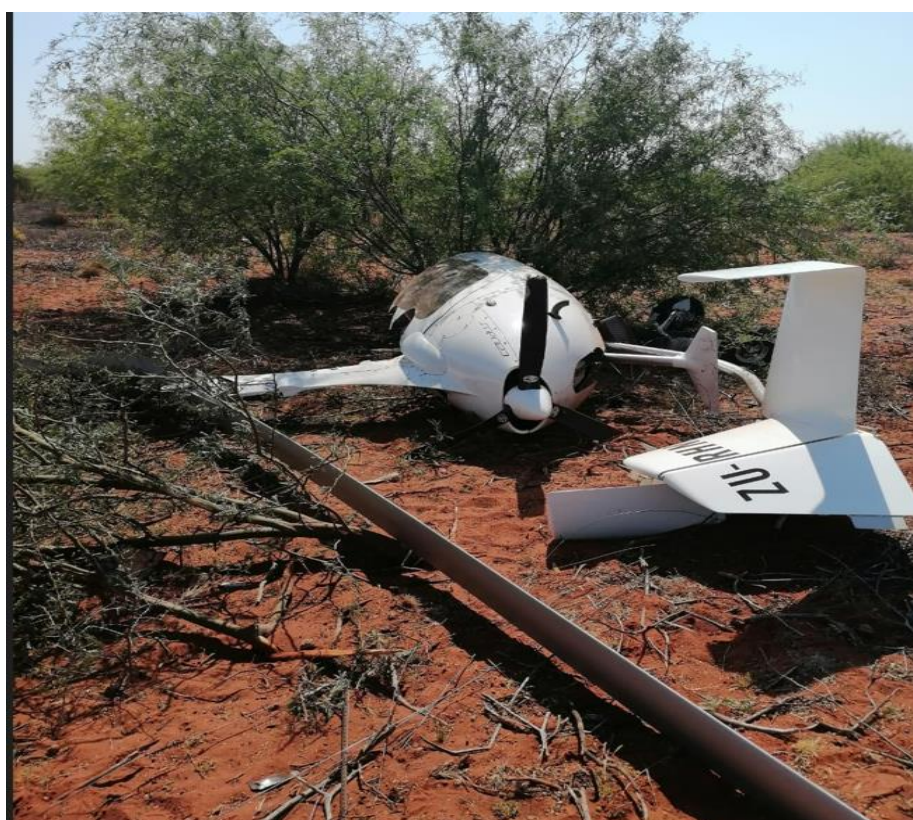
Figure 2: ZU-RHN at the accident site. (Source: Operator)

Post-accident investigation revealed that the tail section had separated from the gyrocopter and the propeller blades were damaged at the tips; the cockpit glass also shattered during the accident (see Figure 2).

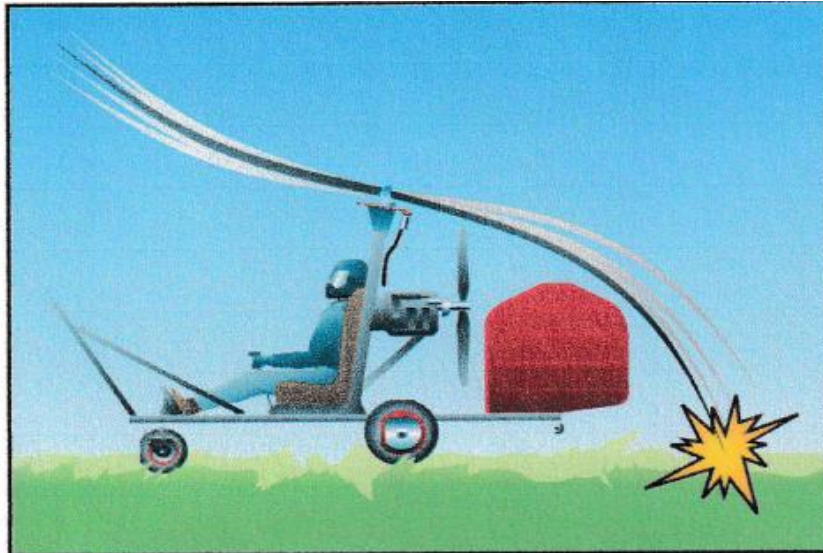
Figure 3: Illustration of the blade flap.

Figure 20-2. Taxiing too fast or gusting winds can cause blade flap in a slow turning rotor. If not controlled, a rotor blade may strike the ground.

To avoid the onset of blade flap, always taxi the gyroplane at slow speeds when the rotor system is at low RPM. Consideration must also be given to wind speed and direction. If taxiing into a 10-knot headwind, for example, the airflow through the rotor will be 10 knots faster than the forward speed of the gyroplane, so the taxi speed should be adjusted accordingly. When pre-rotating the rotor by taxiing with the rotor disc tilted aft, allow the rotor to accelerate slowly and smoothly. In the event the blade flap is encountered, apply forward cyclic to reduce the rotor disc angle and slow the gyroplane by reducing the throttle and applying the brakes, if needed.

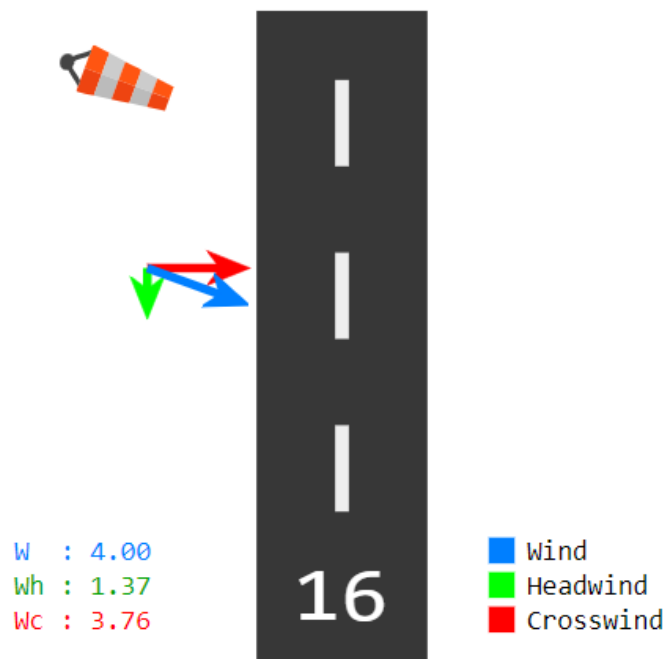
Figure 4: The crosswind component as per the weather report. (Source: <https://e6bx.com>)

- The meteorological conditions show a 4 knots (kts) crosswind from the left at the time of the accident. The crosswind component was calculated using <https://e6bx.com> website.
- According to the POH, the crosswind component which refers to the maximum crosswind velocity a gyrocopter can effectively withstand during take-off and landing is 22 knots (kts).
