LIMITED OCCURRENCE INVESTIGATION REPORT – FINAL

Reference Number	CA18/2/3/10508						
Classification	Accident	Date	6 October 2024		Time	1050Z	
Type of Operation	Training (Part 141)						
Location							
Place of Departure	Rand Airport (FAGM), Gauteng Province		Place of Intended Landing		Rand Airport (FAGM), Gauteng Province		
Place of Occurrence	On Runway 13 at Baragwanath Airfield, Gauteng Province						
GPS Co-ordinates	Latitude	26°20'57" S	Longitude	027°46'28" E	Elevation	5460ft	
Aircraft Information							
Registration	ZS-OBD						
Make; Model; S/N	Cessna Aircraft Company; C172P (Serial Number: 172-75121)						
Damage to Aircraft	Substantial			Total Aircraft Hours	1 302.9		
Pilot-in-command							
Licence Type	Airline Transport Pilot Licence (ATPL)		Gender	Male		Age	48
Licence Valid	Yes	Total Hours	14 400		Total Hours on Type	120	
Total Hours 30 Days	32.3		Total Flying on Type Past 90 Days	20			
People On-board	2+0	Injuries	0	Fatalities	0	Other (on ground)	0

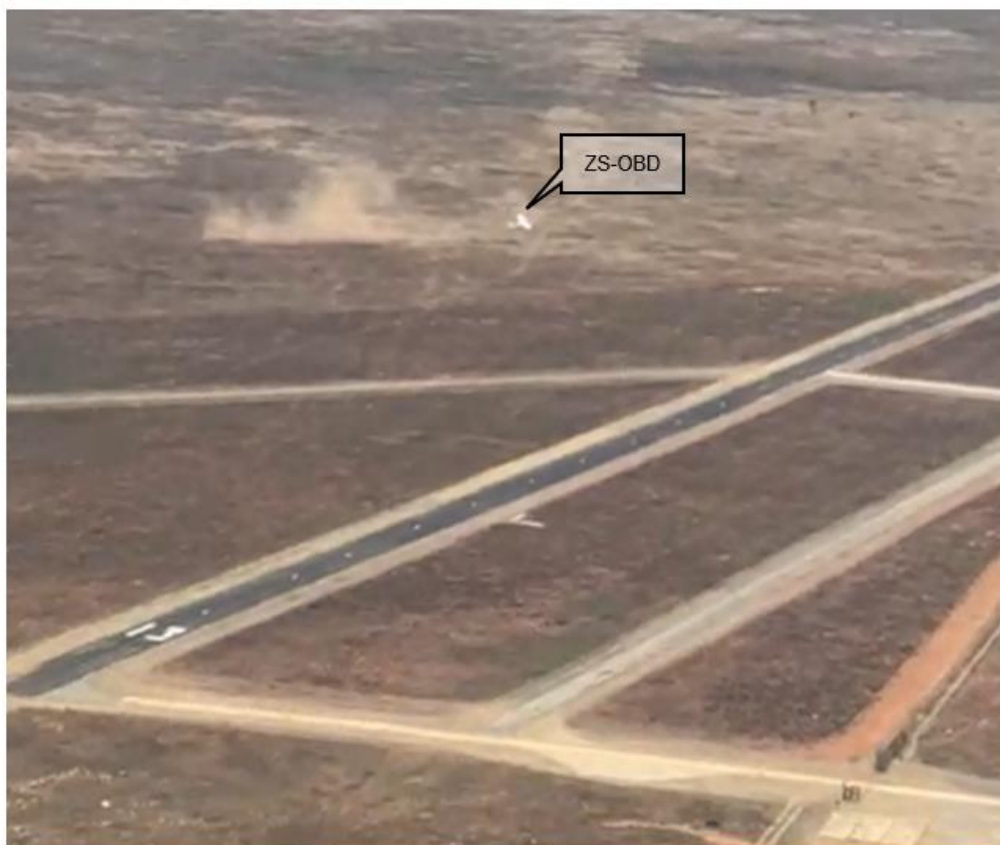
The FI had little time to respond and had to rely on Upset Prevention and Recovery Training (UPRT) principles. He applied forward pressure on the controls to reverse the stall of the left wing; he followed this with a small but crucial input of the opposite rudder to achieve a level flight. Despite the attempt to recover the aircraft, it drifted significantly to the left of RWY 13 and impacted the unprepared surface of the airfield.

Figure 1: Aerial photo taken by a pilot of another aircraft in the circuit. (Source: Student pilot)

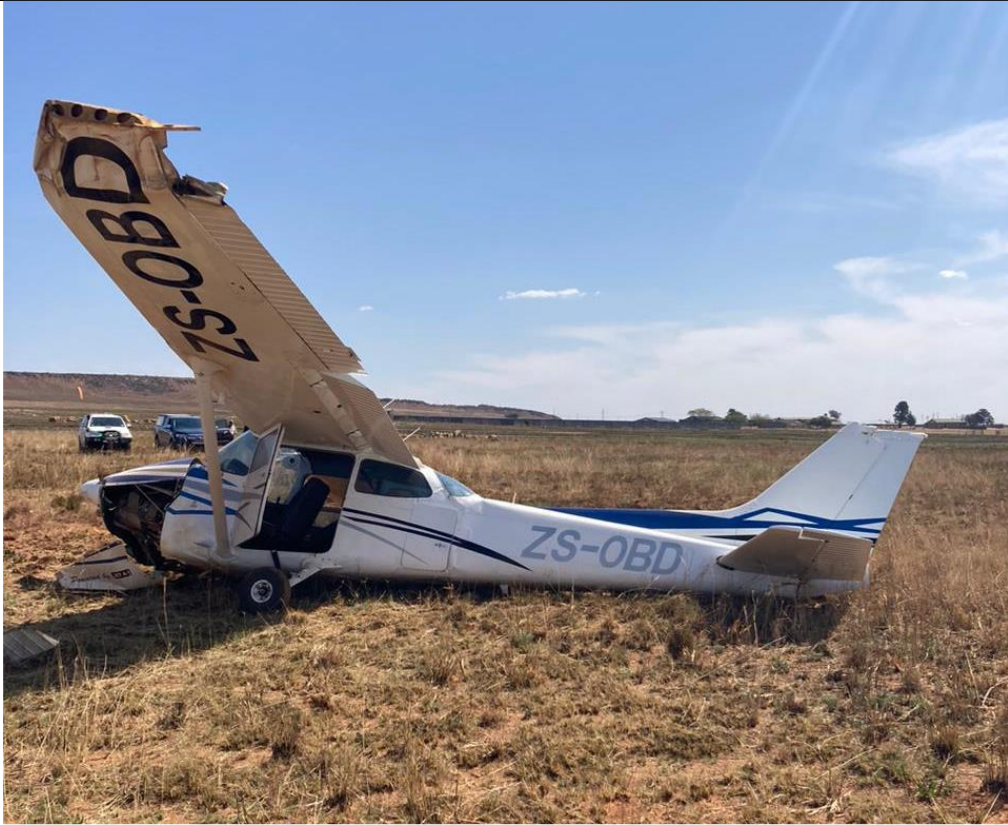
Figure 2: Final position of the aircraft. (Source:Flight instructor)

6. The aircraft was flared too high, and it bounced. The FI took control of the aircraft and initiated a go-around which was unsuccessful; the left wing dropped as the aircraft drifted to the left and, subsequently, crashed.

The training school enhanced its training protocols by developing specialised training modules on recovery techniques for inadvertent lift-offs and managing critical angles-of-attack. Furthermore, the training school planned to conduct regular practical sessions to reinforce these techniques. There was integration of advanced simulator sessions replicating emergency scenarios, such as unexpected lift-offs and stalls to allow safe practise in go-arounds and control recovery. It was also planned that the flight instructors would emphasise manual handling skills through exercises that build muscle memory to ensure that students are adept at using the control yoke under various conditions.

The flying school has standardised command protocols by establishing clear verbal commands for instructors during emergencies to ensure immediate and effective student compliance. Post-accident, the training school's FIs conducted detailed pre-flight briefings which focused on situational awareness and workload management. The FIs have also organised dedicated assessment days on which SPs complete tests and participate in simulations. The SPs are given constructive feedback by FIs after these assessments.

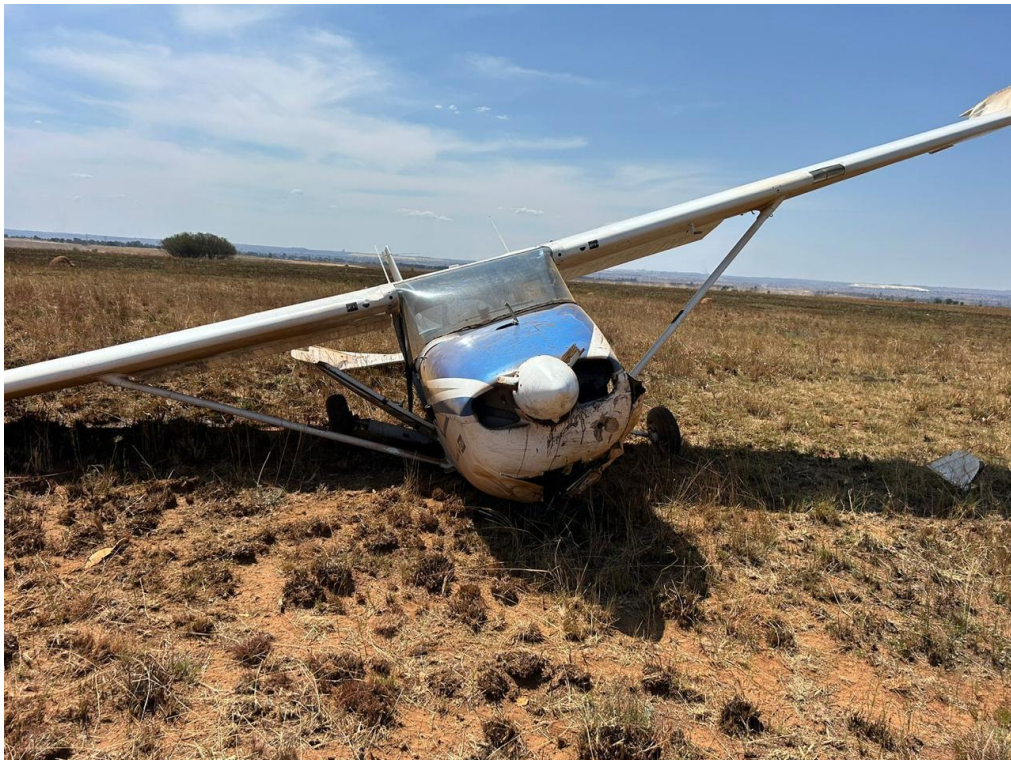
Figure 3: Front view of the aircraft. (Source: Flight instructor)

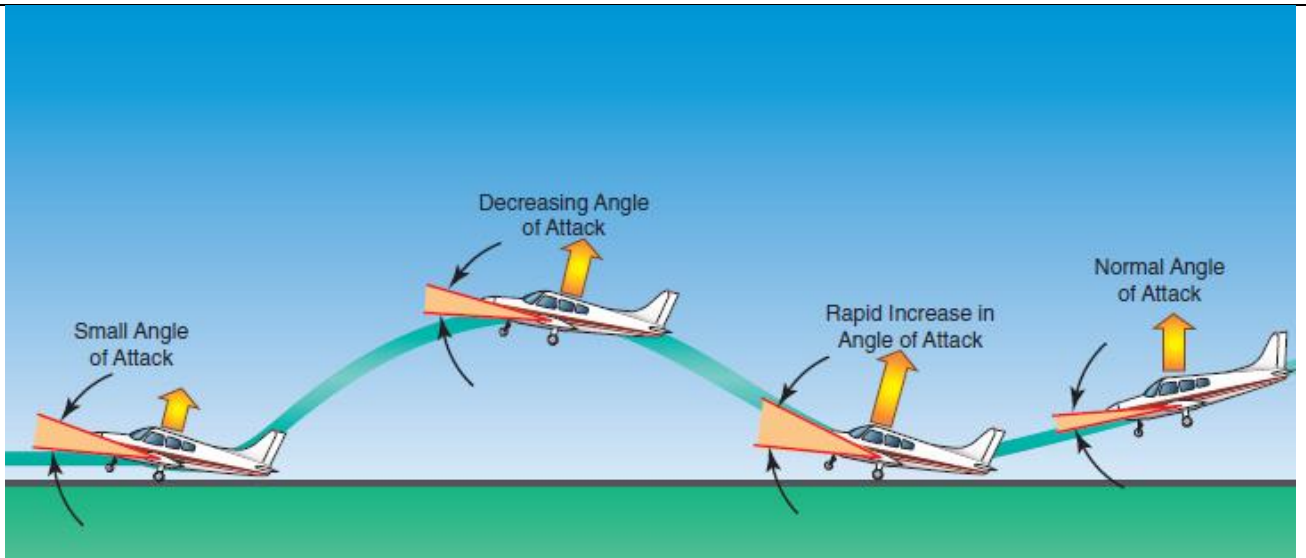
When the aeroplane contacts the ground with a sharp impact as the result of an improper attitude or an excessive rate of sink, it tends to bounce back into the air.

Illustration 1: A depiction of a bounce. (Source: FAA-airplane flying handbook)

When a bounce is severe, the safest procedure is to EXECUTE A GO-AROUND IMMEDIATELY. No attempt to salvage the landing should be made. Full power should be applied while simultaneously maintaining directional control and lowering the nose to a safe climb attitude. The go-around procedure should be continued even though the airplane may descend, and another bounce may be encountered. It would be extremely foolish to attempt a landing from a bad bounce since airspeed diminishes very rapidly in the nose-high attitude, and a stall may occur before a subsequent touchdown could be made.
