**LIMITED OCCURRENCE INVESTIGATION REPORT – FINAL**

| <b>Reference Number</b> | CA18/2/3/10509 | | | | | | |
| Registration | ZU-CMZ | | | | | | |
| Make; Model; S/N | Shadow Lite CC; Jabiru 400 (Serial Number: 0006) | | | | | | |

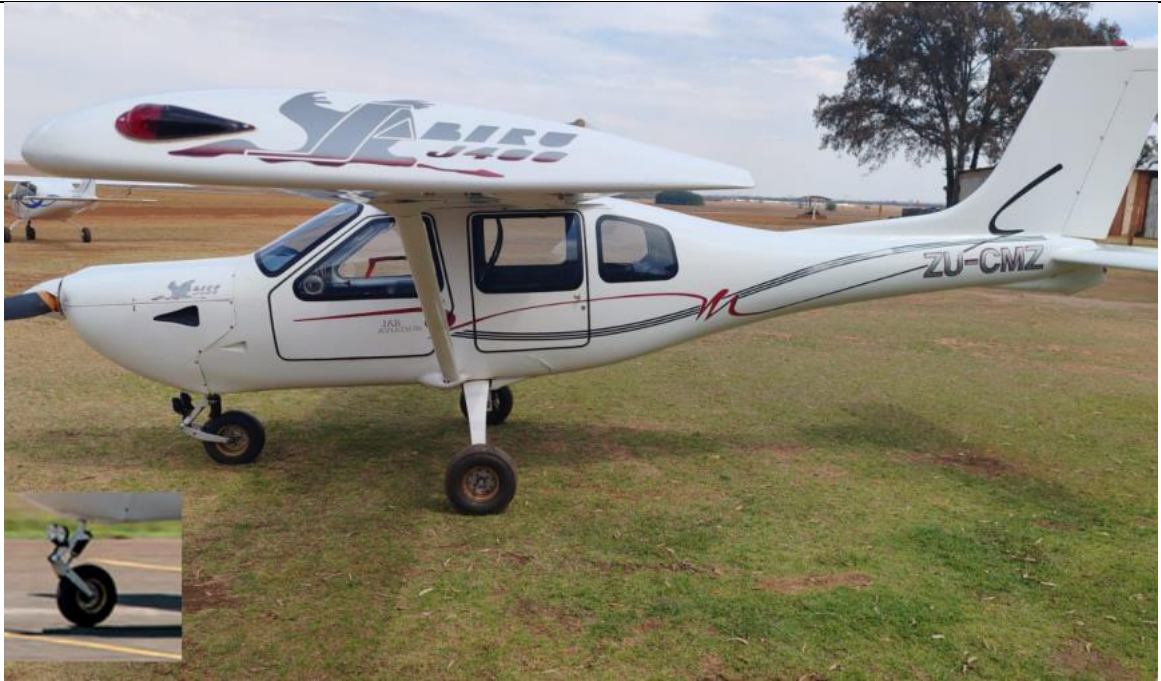
**Figure 1:** The damaged nose gear. The inset shows an undamaged nose gear. (Source: Owner)

| The pilot flared late during landing which resulted in the nose gear impacting the ground hard, followed by the propeller strikes on the ground. | |

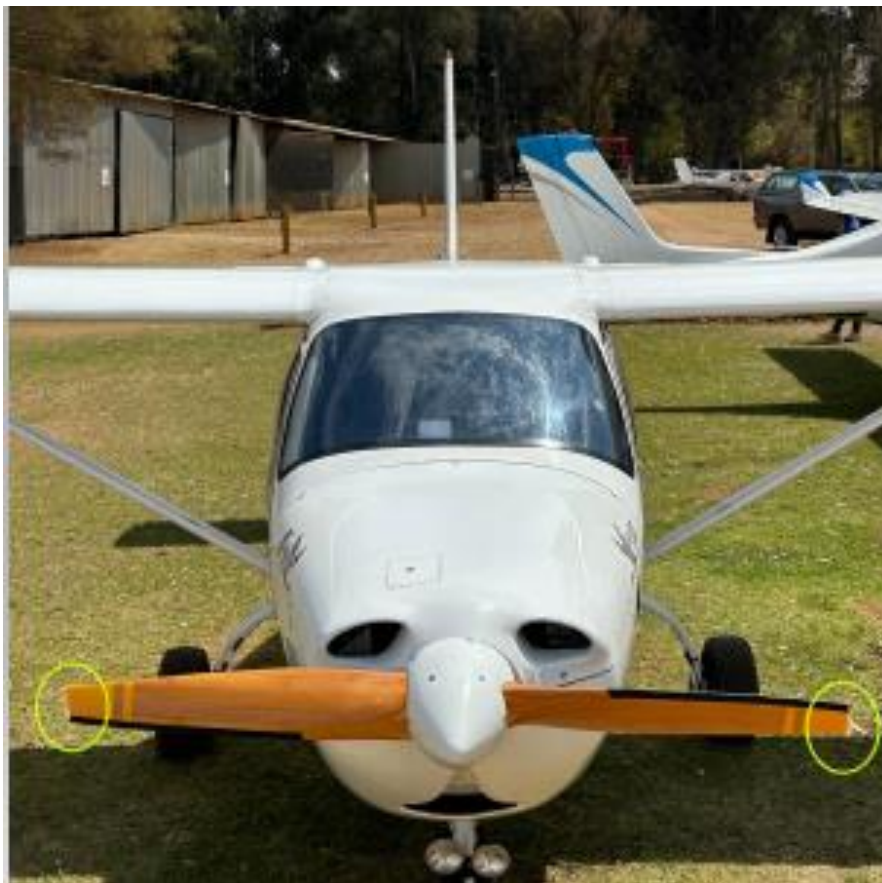
**Figure 2:** Yellow circles indicate the damaged propeller tips. (Source: Owner)
