LIMITED OCCURRENCE INVESTIGATION REPORT – FINAL

Reference Number	CA18/2/3/10510						
Classification	Accident	Date	8 October 2024		Time	0710Z	
Type of Operation	Private (Part 94)						
Location							
Place of Departure	Panorama Aerodrome, Gauteng Province		Place of Intended Landing	Thabazimbi Aerodrome (FATI), Limpopo Province			
Place of Occurrence	Runway (RWY) 07 at Thabazimbi Aerodrome (FATI), Limpopo Province						
GPS Co-ordinates	Latitude	24° 34' 39" S	Longitude	027° 24' 59" E	Elevation	3 215 ft	
Aircraft Information							
Registration	ZU-TAE						
Make; Model; S/N	Airplane Factory; Sling 2; (S/N:004)						
Damage to Aircraft	Substantial		Total Aircraft Hours	1 995			
Pilot-in-command							
Licence Type	Private Pilot Licence (PPL)		Gender	Male		Age	39
Licence Valid	Yes	Total Hours	57.9		Total Hours on Type	34.4	
Total Hours 30 Days	8.1		Total Flying on Type Past 90 Days	1.6			
People On-board	1 + 0	Injuries	0	Fatalities	0	Other (on ground)	0

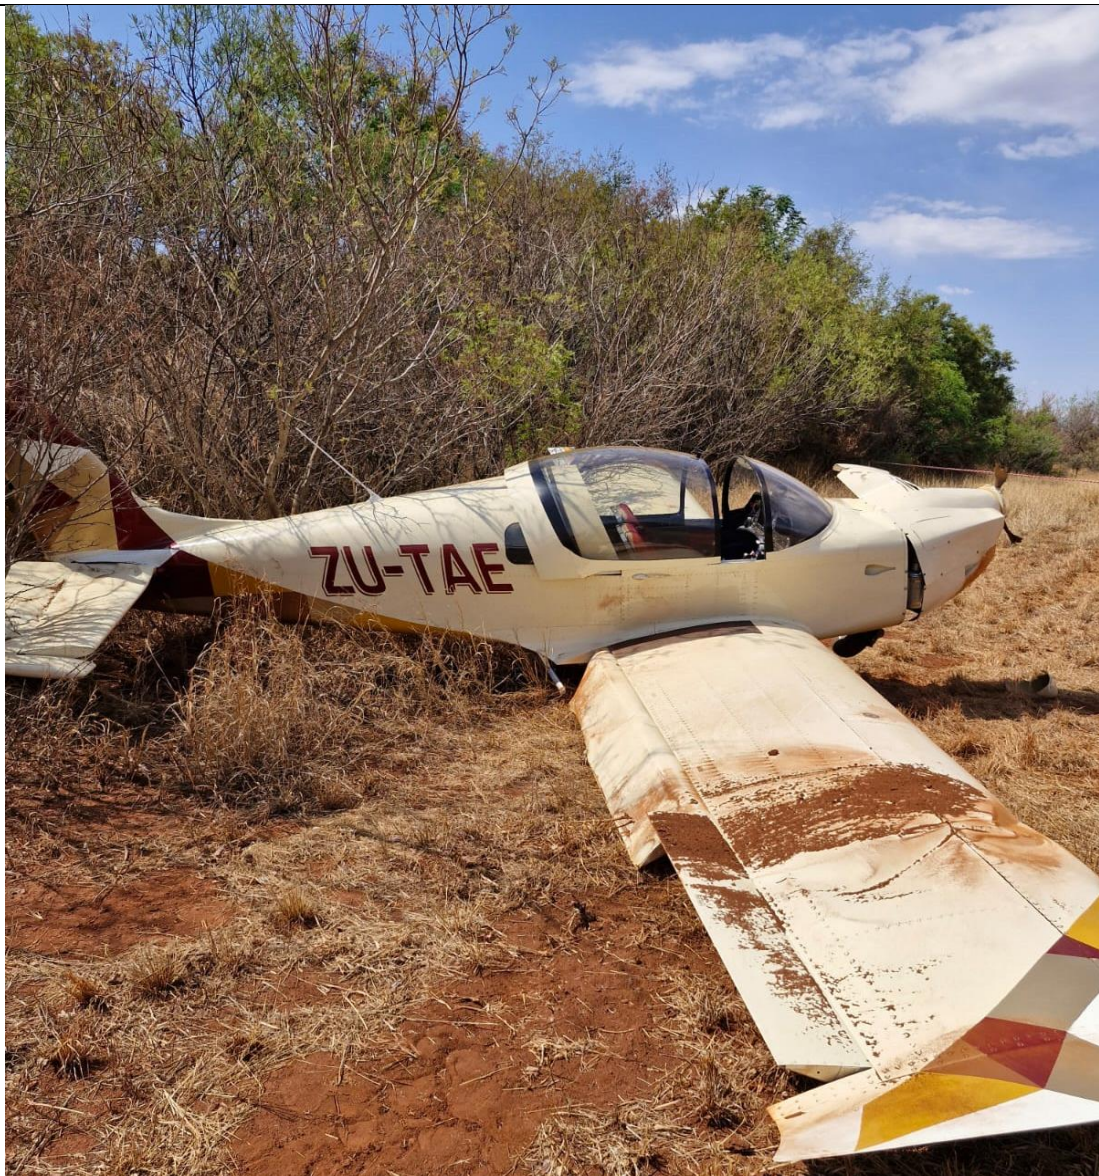
What Happened							
<p>On Tuesday, 8 October 2024, a pilot on-board a Sling 2 aircraft with registration ZU-TAE was on a private flight from Panorama Aerodrome, Gauteng province, to Thabazimbi Aerodrome (FATI) in Limpopo province. The flight was conducted under visual meteorological conditions (VMC) by day and under the provisions of Part 94 of the Civil Aviation Regulations (CAR) 2011 as amended.</p> <p>The pilot stated that he conducted the pre-flight checks, and no anomalies were noted. The aircraft took off from Panorama Aerodrome at approximately 0528Z; the flight to FATI was uneventful. Upon arrival at FATI at approximately 0650Z, the pilot requested the weather update from another pilot who was departing the aerodrome. The runway (RWY) in use was RWY 07 and the wind was blowing north-westerly with gusts. On final approach, with the flaps selected to the maximum 40 degrees, the aircraft encountered a gust of wind from the left.</p> <p>The pilot stated that he opened the throttle to full power with the intention to perform a go-around. The aircraft climbed momentarily but shortly after started to sink and impacted the ground before it veered off to the left of the runway. The aircraft skidded for approximately 60 metres (m) before it came to rest facing east. The pilot was unharmed during the accident sequence. The aircraft sustained substantial damage to the left wing, propeller blades and engine cowling.</p>

Figure 2: The aircraft as it came to rest. (Source: Pilot)

2.5 The aircraft veered off to the left of the runway probably due to turbulent wind conditions; this resulted in the left-wing tip contacting the ground and, subsequently, the pilot's loss of control of the contract.

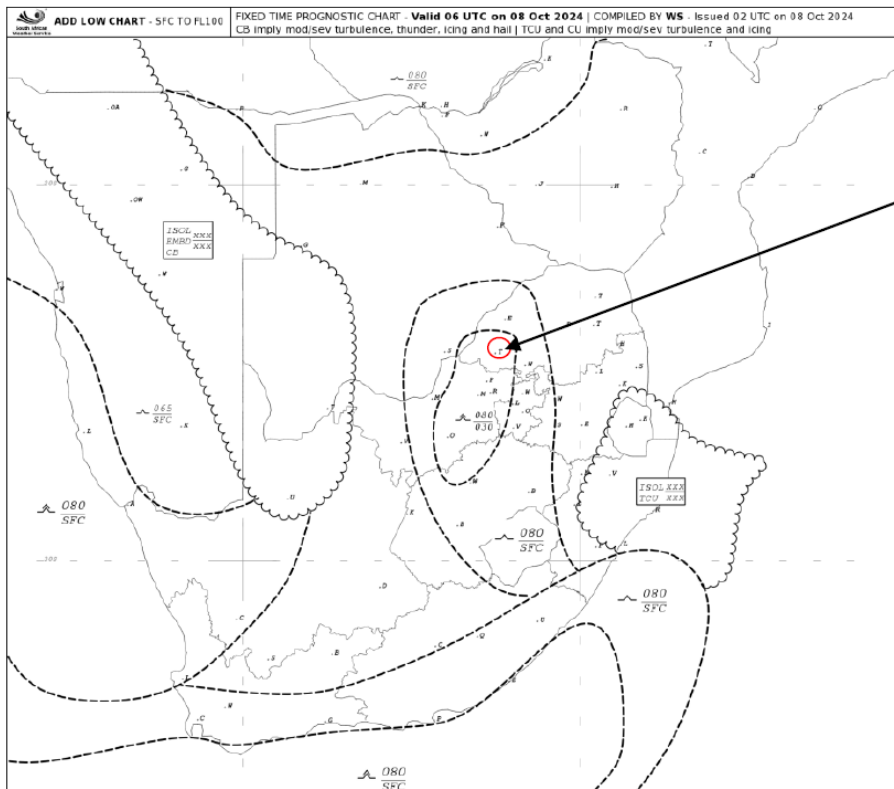
Figure 3: An extract from the accident report showing severe turbulence. (Source: SAWS)

The weather reported to the pilot before approach to land was consistent with the report obtained from the SAWS which forecasted turbulent surface wind conditions during the flight; therefore, the weather is a contributory factor to this accident.

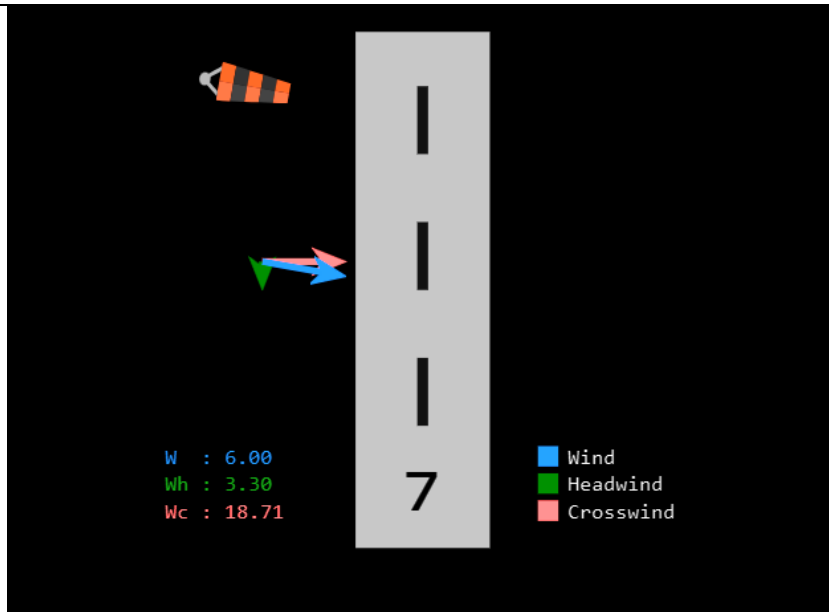
The aircraft's maximum demonstrated crosswind component is 15 knots (kts). The crosswind component at the time of the accident was calculated to be approximately 18 kts, which was above the 15 kts limit.

Figure 4: An illustration of the approximate wind conditions with an 18.71 crosswind from the left during landing. (Source: <https://e6bx.com/wind-components/>)

Probable Cause(s)
Loss of directional control during landing due to excessive crosswind conditions, which subsequently led to the aircraft veering off to the left of the runway.
Contributing Factor(s)
Turbulent wind conditions.
Safety Action(s)
None.
Safety Message and/or Safety Recommendation/s
None.
About this Report
<i>The decision to conduct a limited investigation is based on factors including whether the cause is known and the evidence supporting the cause is clear, the level of safety benefit likely to be obtained from an investigation and that will determine the scope of an investigation. For this occurrence, a limited investigation has been conducted, and the Accident and Incident Investigations Division (AIID) has relied on the information submitted by the affected person/s and organisation/s to compile this limited report. The report has been compiled using information supplied in the initial notification, as well as from follow-up desk top enquiries to bring awareness of potential safety issues to the industry in respect of this occurrence, as well as possible safety action/s that the industry might want to consider in preventing a recurrence of a similar occurrence.</i>
