## LIMITED OCCURRENCE INVESTIGATION REPORT

| <b>Reference Number</b> | CA18/2/3/10511 | | | | | | |
| <b>Registration</b> | ZU-JBA | | | | | | |
| <b>Make; Model; S/N</b> | Jabiru; J400 (Serial Number: 51) | | | | | | |

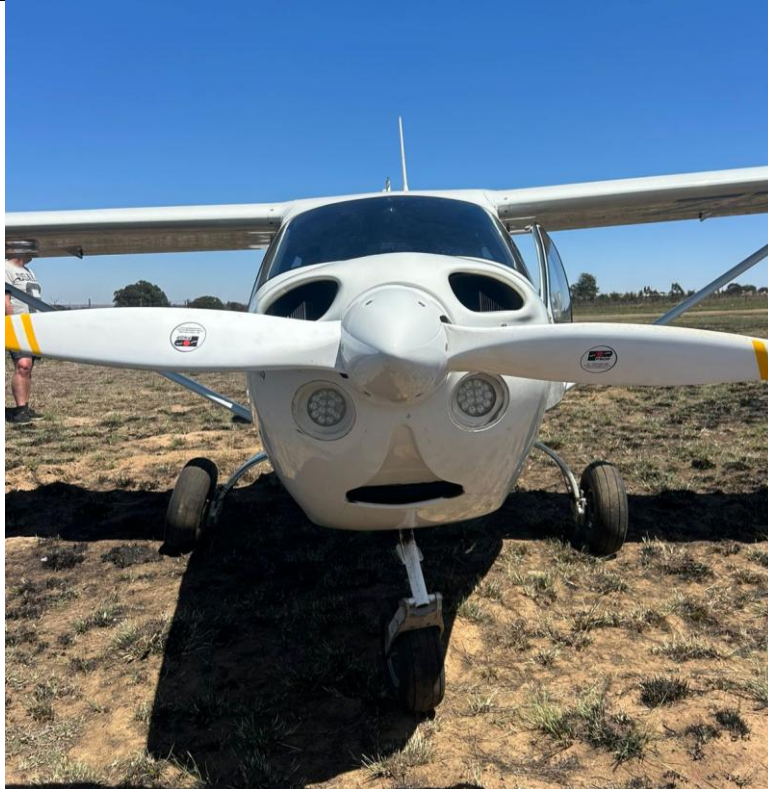
**Figure 2:** The aircraft post-accident. (Source: Operator)

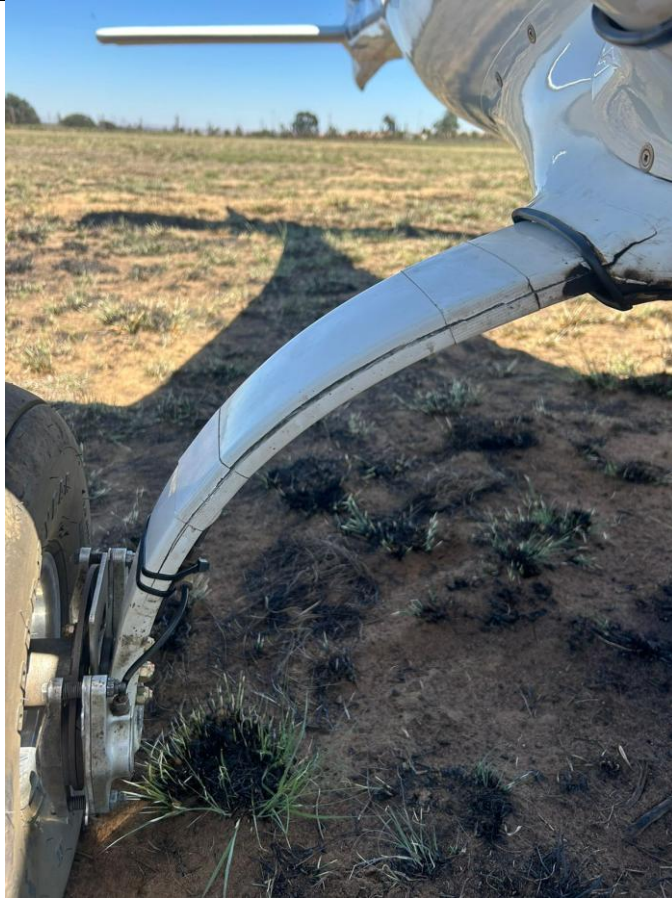
**Figure 3:** The delaminated strut. (Source: Pilot)

| 10. The aircraft landed hard during a touch-and-go exercise which resulted in the delamination of the right landing gear strut. |
| The aircraft's right landing gear strut delaminated due to a hard landing. |
