**LIMITED OCCURRENCE INVESTIGATION REPORT – FINAL**

<b>Reference Number</b>	CA18/2/3/10512						
<b>Classification</b>	Accident	<b>Date</b>	10 October 2024		<b>Time</b>	0940Z	
<b>Type of Operation</b>	Private (Part 94)						
<b>Location</b>							
Place of Departure	Kimberley Aerodrome (FAKM), Northern Cape Province		Place of Intended Landing	De Aar Aerodrome (FADA) Northern Cape Province			
Place of Occurrence	Near the threshold of Runway 02 at FAKM, Northern Cape Province						
GPS Co-ordinates	Latitude	28°49'10.42"S	Longitude	24°45'48.38"E	Elevation	3 917 ft	
<b>Aircraft Information</b>							
Registration	ZU-CWK						
Make; Model; S/N	Yakovlev Aircraft Factories; Yak 52 (Serial Number: 882807)						
Damage to Aircraft	Substantial		Total Aircraft Hours	926.7			
<b>Pilot-in-command</b>							
Licence Type	Commercial Pilot Licence (CPL) Aeroplane		Gender	Male	Age	58	
Licence Valid	Yes	Total Hours	6224	Total Hours on Type	6.4		
Total Hours 30 Days	10.4		Total Flying on Type Past 90 Days	6.4

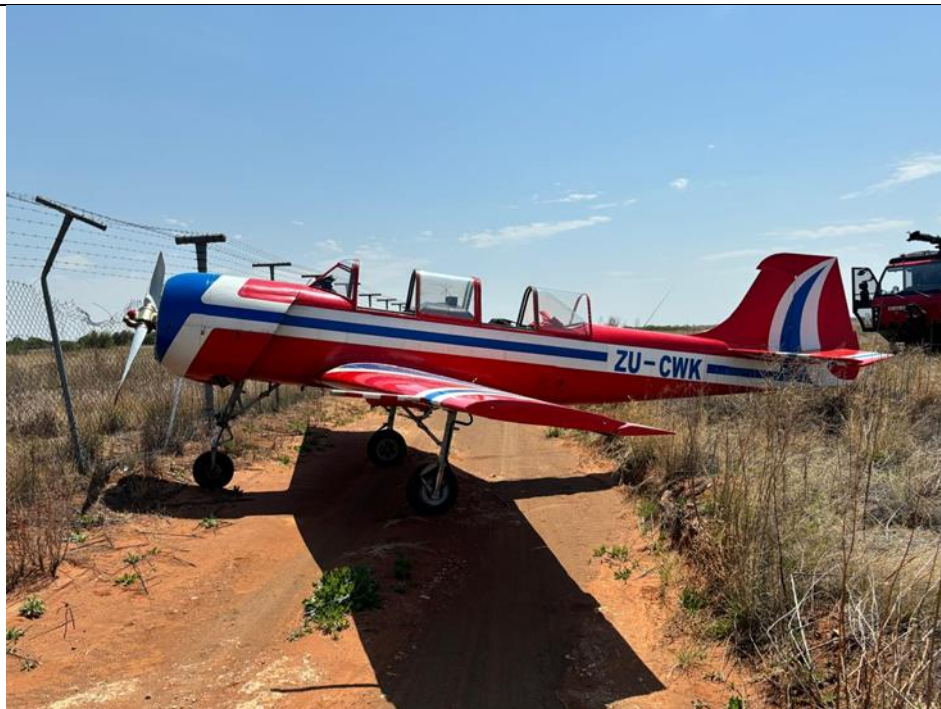
<b>People On-board</b>	1+1	<b>Injuries</b>	0	<b>Fatalities</b>	0	<b>Other (on ground)</b>	0
<b>What Happened</b>							
<p>On Thursday, 10 October 2024, a pilot and a passenger on-board a Yak 52 aircraft with registration ZU-CWK took off on a private flight from Kimberley Aerodrome (FAKM) in the Northern Cape province to De Aar Aerodrome (FADA) in the same province. The flight was conducted under visual meteorological conditions (VMC) by day and under the provisions of Part 94 of the Civil Aviation Regulations (CAR) 2011 as amended.</p> <p>At approximately 0940Z, the pilot requested taxi clearance from the air traffic control (ATC) officer and was instructed to backtrack on Runway (RWY) 02 and to wait for departure clearance. The pilot reported that during taxi at the intersection of RWY 02 and RWY 28, the brakes felt ineffective because of the strong tailwind. The pilot further stated that he kept braking to maintain normal taxi speed. As he was nearing RWY 02 threshold, he noticed that the aircraft's speed was too high and decided to switch off the engine to slow down the aircraft as he intended to complete a 180° left turn along the runway's turning area (which is on the right side) to line up on Runway 02 threshold. The pilot applied the brakes, but they seemed ineffective, and the aircraft could not stop or complete the left turn. He then attempted to steer the aircraft using the rudder pedals, but they were also not effective. As a result, the aircraft exited the turning area, careered westerly and impacted a perimeter fence before it stopped. The pilot reported the occurrence to the ATC tower and requested the assistance of the emergency services. The propeller and the lower part of the vertical stabiliser were damaged. The pilot and the passenger were not injured.</p>

**Figure 1:** The aircraft came to a stop after impacting the perimeter fence. (Source: Owner)

2.3	The aircraft's Certificate of Registration (C of R) was issued to the present owner on 9 March 2021.
2.4	The pilot backtracked the aircraft for more than 2 kilometres (km) at a high speed as there was tailwind on RWY 02 which is 3km long. This resulted in loss of brake efficiency due to overheating. When the pilot realised that the aircraft could not stop, he switched off the engine during a left turn and the aircraft veered off the runway and impacted a perimeter fence.
<b>Probable Cause(s)</b>	
The tailwind propelled the aircraft to taxi at a high-speed and the brakes overheated and became ineffective. The aircraft veered off the runway during a left turn and impacted a perimeter fence.	
<b>Contributing Factor(s)</b>	
<ul style="list-style-type: none"> <li>Inability to maintain the recommended taxi speed.</li> </ul>	
<b>Safety Action(s)</b>	
None.	
<b>Safety Message and/or Safety Recommendation/s</b>

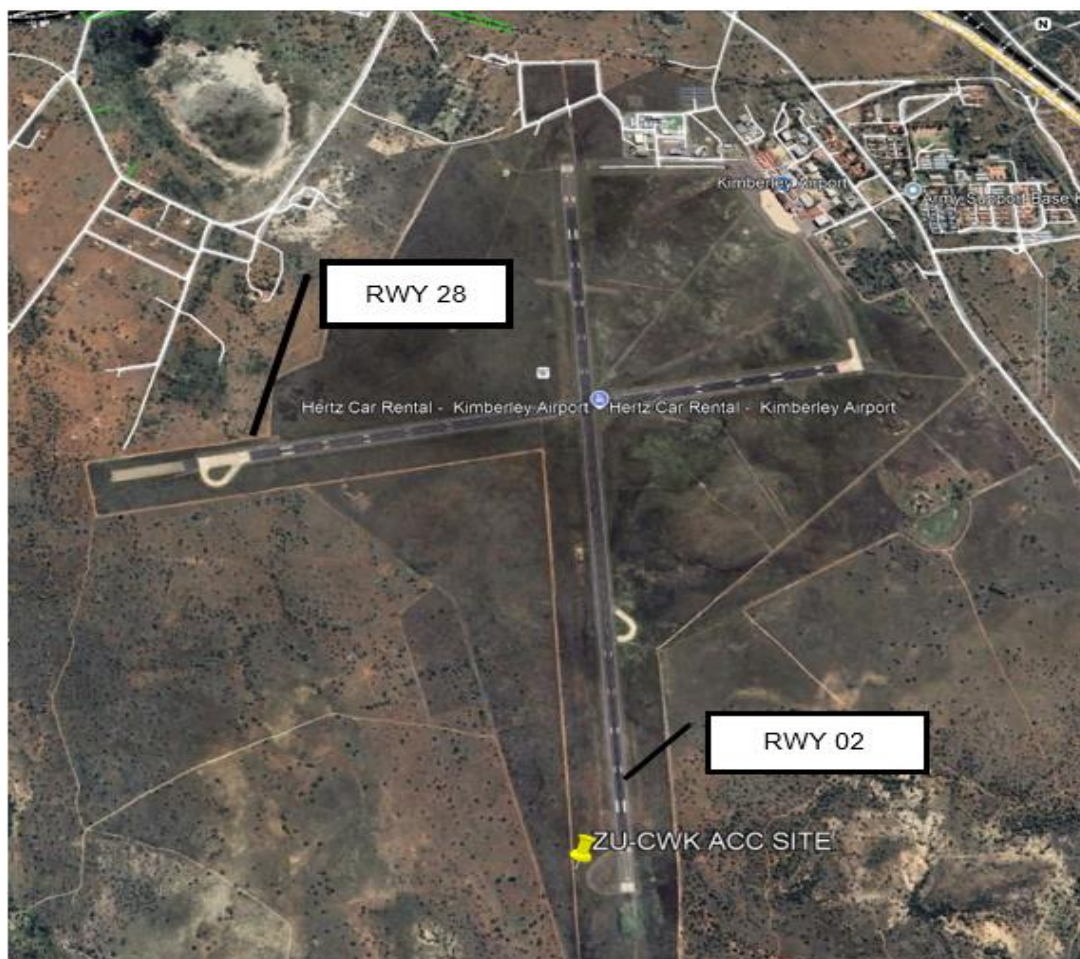
**Figure 2:** Aerial view of the aerodrome and the accident site.
