LIMITED OCCURRENCE INVESTIGATION REPORT – FINAL

Reference Number	CA18/2/3/10513						
Classification	Accident	Date	25 September 2024	Time	1630Z		
Type of Operation	Private (Part 94)						
Location							
Place of Departure	Elandsvlei Farm Private Airstrip in Piketberg, Western Cape Province			Place of Intended Landing	Elandsvlei Farm Private Airstrip in Piketberg, Western Cape Province		
Place of Occurrence	During landing on Runway 02 at Elandsvlei Farm private airstrip in Piketberg, Western Cape Province						
GPS Co-ordinates	Latitude	32°47'.58" S	Longitude	018°51'.49" E	Elevation	514 feet	
Aircraft Information							
Registration	ZU-IGP						
Make; Model; S/N	Babst C. F; Carl Babst Raven Z090 (Serial Number: 200901)						
Damage to Aircraft	Substantial			Total Aircraft Hours	571.2		
Pilot-in-command							
Licence Type	National Pilot Licence (NPL)		Gender	Male		Age	53
Licence Valid	Yes	Total Hours	898.6		Total Hours on Type	604.9	
Total Hours 30 Days	9.9		Total Hours on Type Past 90 Days		9.9

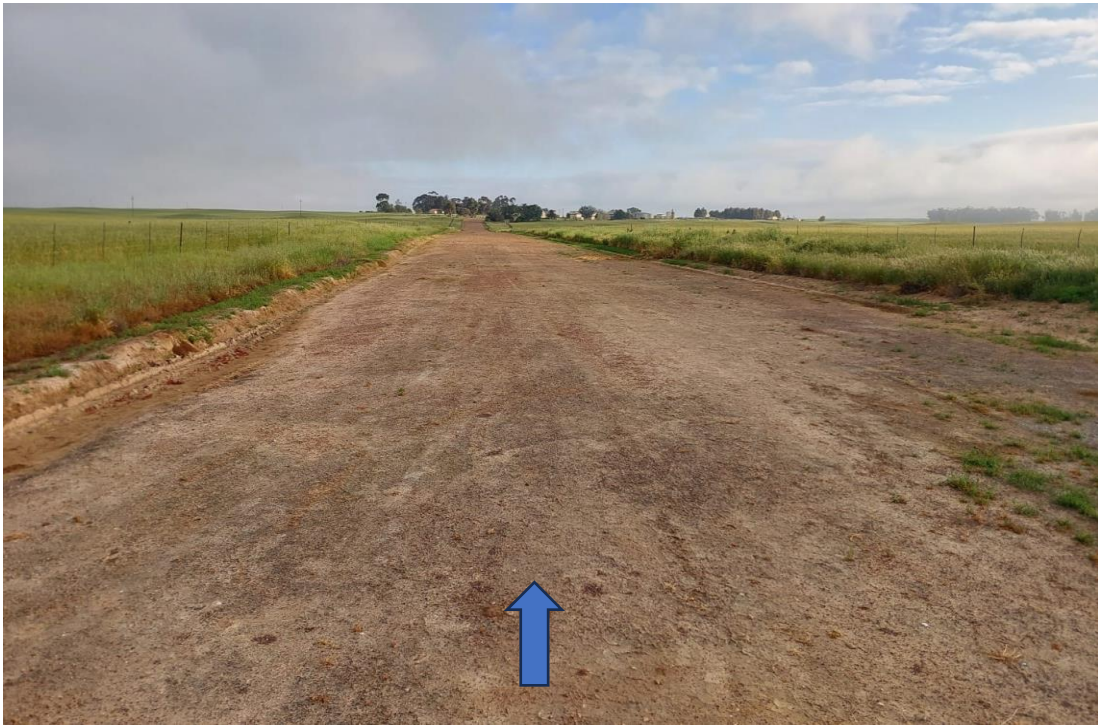
Figure 2: The runway and the direction of landing. (Source: Pilot)

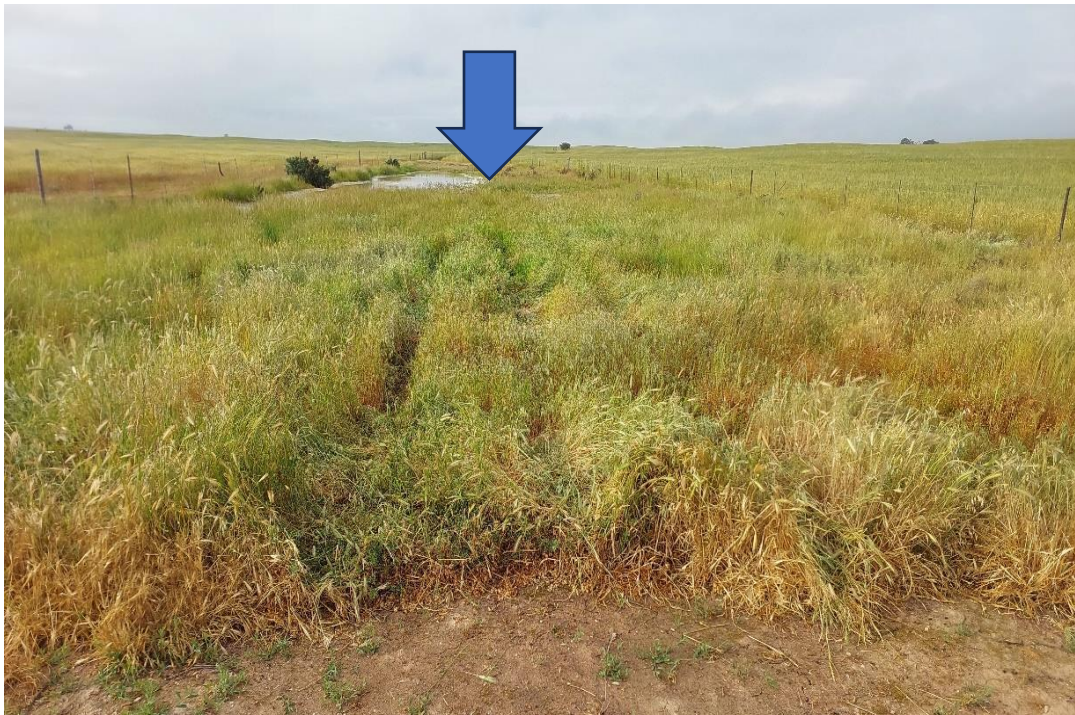
After approximately 35 minutes of flight time, the aircraft returned to the airstrip. Whilst overhead the airstrip, the pilot checked the windsock and the wind direction favoured landing on Runway 02. The pilot commenced with the approach for landing on Runway 02. Before the aircraft could reach the threshold at approximately 60 mph and 30 ft above ground level (AGL), the pilot flared the aircraft. The aircraft then lost height and landed hard on the grass area approximately 20 metres (m) short of the runway threshold and rolled until it stopped on the gravel runway. The aircraft sustained substantial damage. Both the main gear landing gear boxes that are built into the centre section part of the wing with the ribs attached to them pushed upwards and the main landing gear oleos bent during the accident sequence. The pilot and the passenger were unharmed.

Figure 3: The direction of landing and the impression marks left by the aircraft's main wheels and the tail, short of the threshold of the gravel runway. (Source: Pilot)

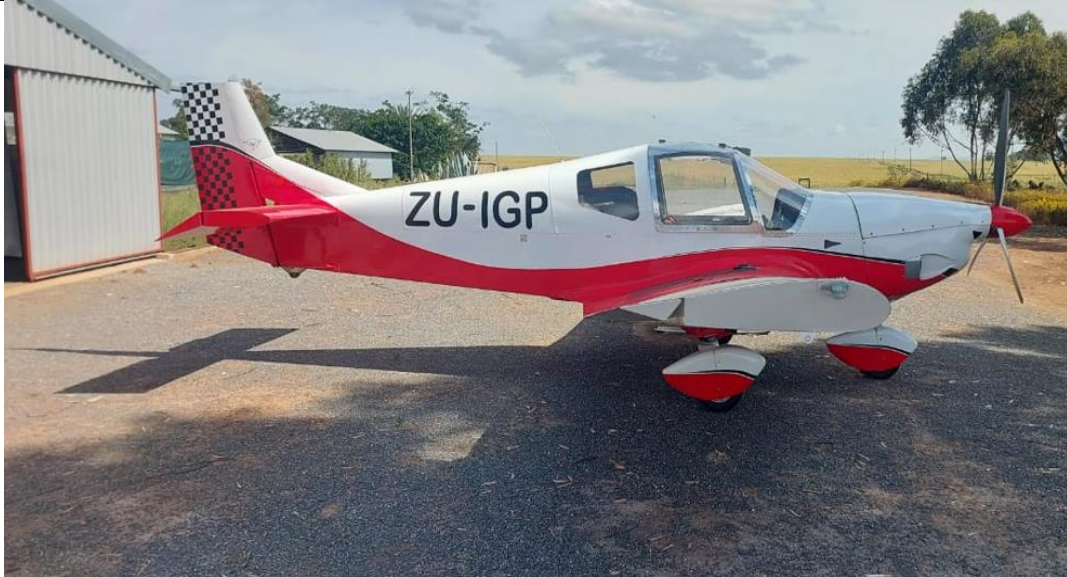
Figure 4: The aircraft after it was recovered from the accident site. (Source: Pilot)

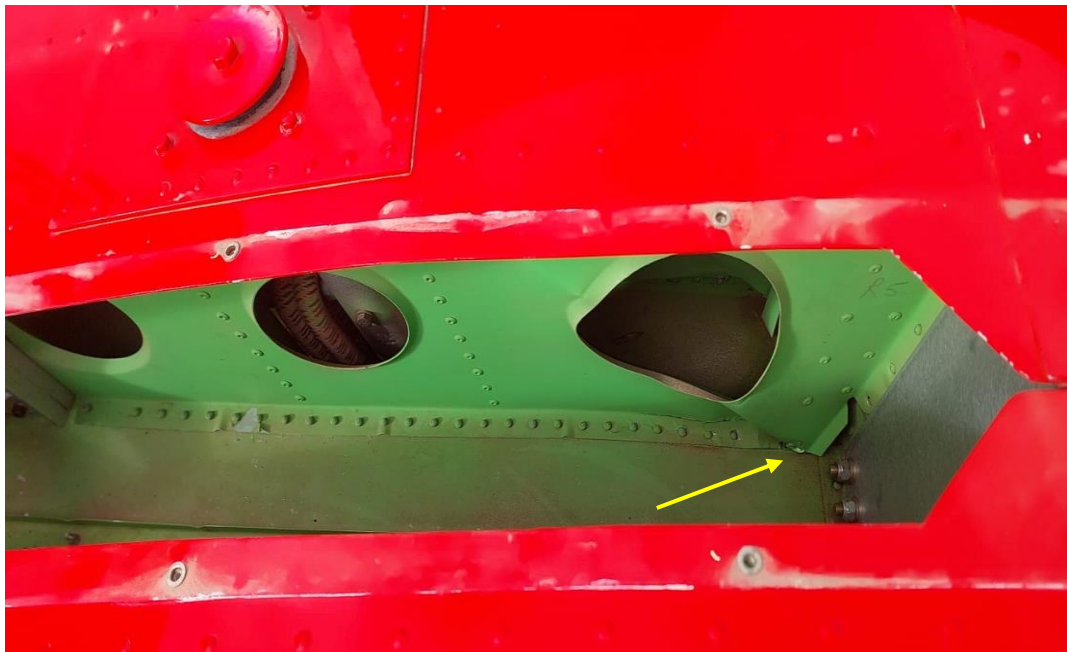
Figure 5: Damage sustained to the left side of the main gear landing gear box. (Source: Pilot)

2.5	The aircraft's maximum take-off mass is 540 kilograms (kg). The aircraft weighed 530.3kg when it landed, which meant that it was operated within its allowable weight limit at the time of the accident.
Probable Cause(s)	
The air speed was decreased to below 65 mph during the flare, consequently, the aircraft lost lift and landed hard on the grass area approximately 20m short of the threshold of Runway 02.	
Contributing Factor(s)	
None.	
Safety Action(s)	
None.	
Safety Message and/or Safety Recommendation/s	
In the interest of safety and to avoid injury and damage to property, pilots should be vigilant during the critical phases of flight such as take-offs and landings; this accident could have been avoided if the pilot executed a go-around after noticing that the aircraft was low in height and speed.	
About this Report	
<p><i>The decision to conduct a limited investigation is based on factors including whether the cause is known and the evidence supporting the cause is clear, the level of safety benefit likely to be obtained from an investigation, and that will determine the scope of an investigation. For this occurrence, a limited investigation has been conducted, and the Accident and Incident Investigations Division (AIID) has relied on the information submitted by the affected person/s and organisation/s to compile this limited report. The report has been compiled using information supplied in the initial notification, as well as from follow-up desktop inquiries to bring awareness of potential safety issues to the industry in respect of this occurrence, as well as possible safety action/s that the industry might want to consider in preventing a recurrence of a similar occurrence.</i></p> <p><i>All times given in this report are Co-ordinated Universal Time (UTC) and will be denoted by (Z). South African Standard Time is UTC plus 2 hours.</i></p>
