LIMITED OCCURRENCE INVESTIGATION REPORT – FINAL

Reference Number	CA18/2/3/10514						
Classification	Accident	Date	10 October 2024	Time	1517Z		
Type of Operation	Private (Part 91)						
Location							
Place of Departure	Bethlehem Aerodrome (FABM), Free State Province			Place of Intended Landing	New Tempe Aerodrome (FATP), Free State Province		
Place of Occurrence	Left of the N5 Road between Senekal and Winburg, Free State Province						
GPS Co-ordinates	Latitude	28°24'19.40" S	Longitude	027°25'59.80" E	Elevation	4 795 feet	
Aircraft Information							
Registration	ZS-MCY						
Make; Model; S/N	Beech Aircraft Corporation; 58 (Serial Number: TH764)						
Damage to Aircraft	Substantial			Total Aircraft Hours	6 234.9		
Pilot-in-command							
Licence Type	Private Pilot Licence (PPL)		Gender	Male		Age	56
Licence Valid	Yes	Total Hours	604.3		Total Hours on Type	93.5	
Total Hours Past 30 Days	6.8		Total Hours on Type Past 90 Days			16.6	
People On-board	1 + 0	Injuries	0	Fatalities	0	Other (on ground)	0

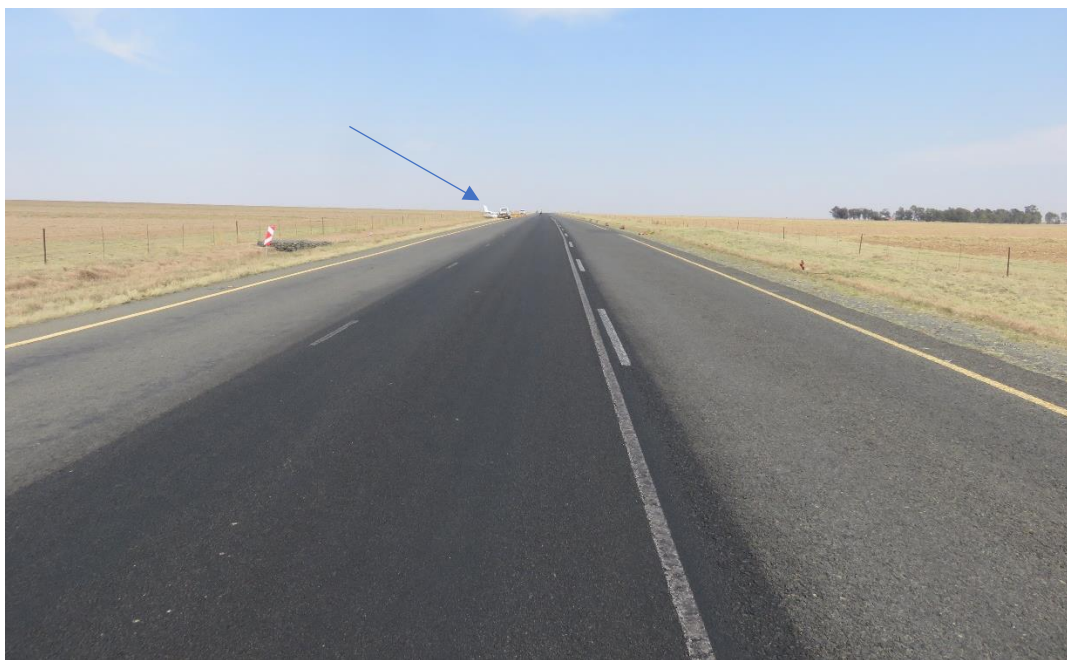
Figure 1: The N5 road, with the aircraft at a distance.

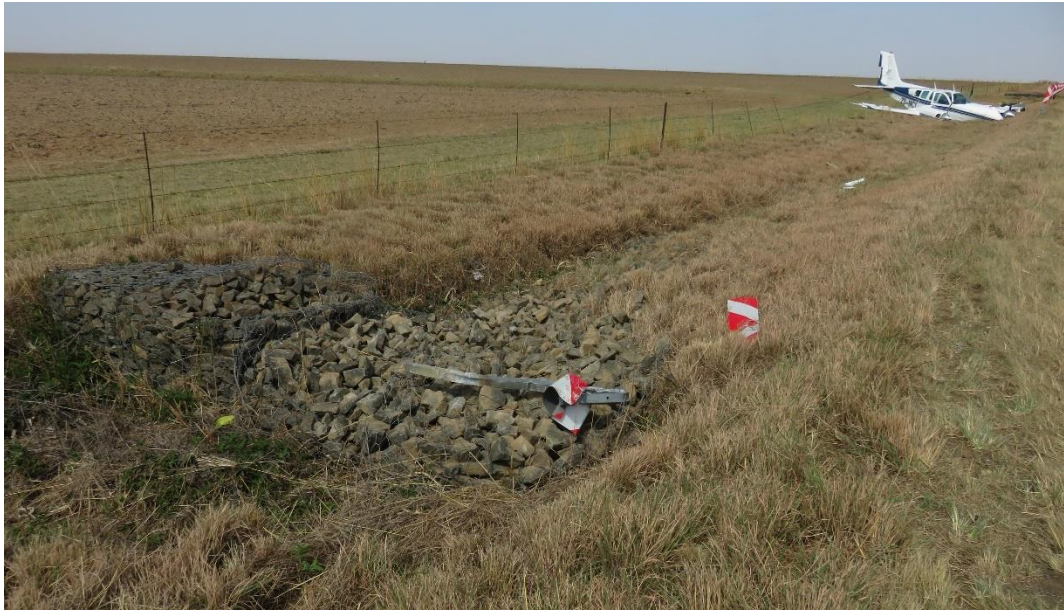
Figure 2: The stormwater barrier and two of the hazard marker boards that the aircraft impacted.

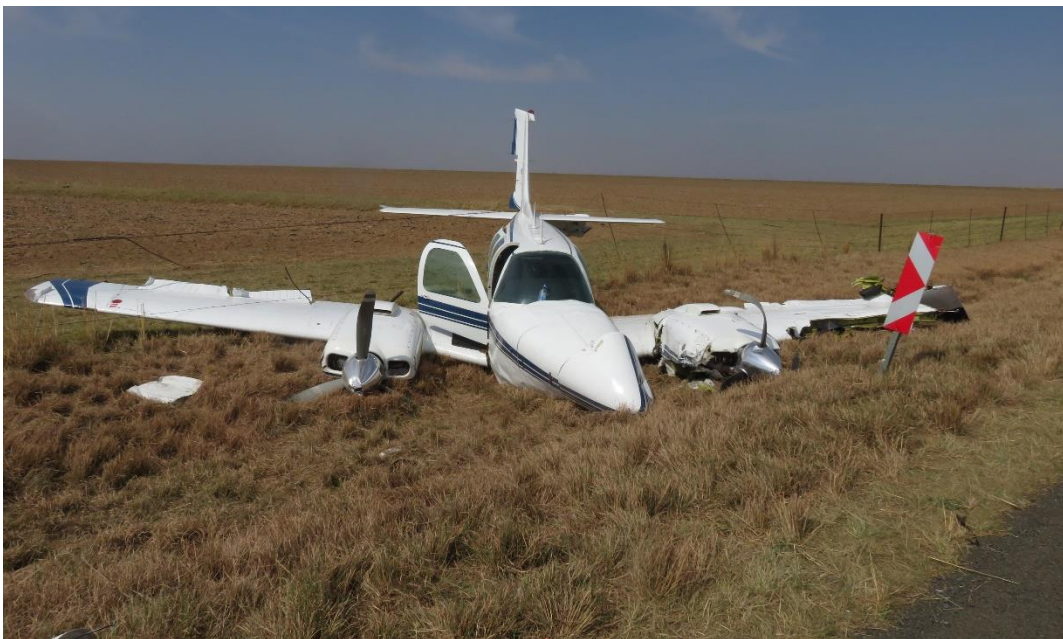
Figure 3: The aircraft as it came to rest next to the road.

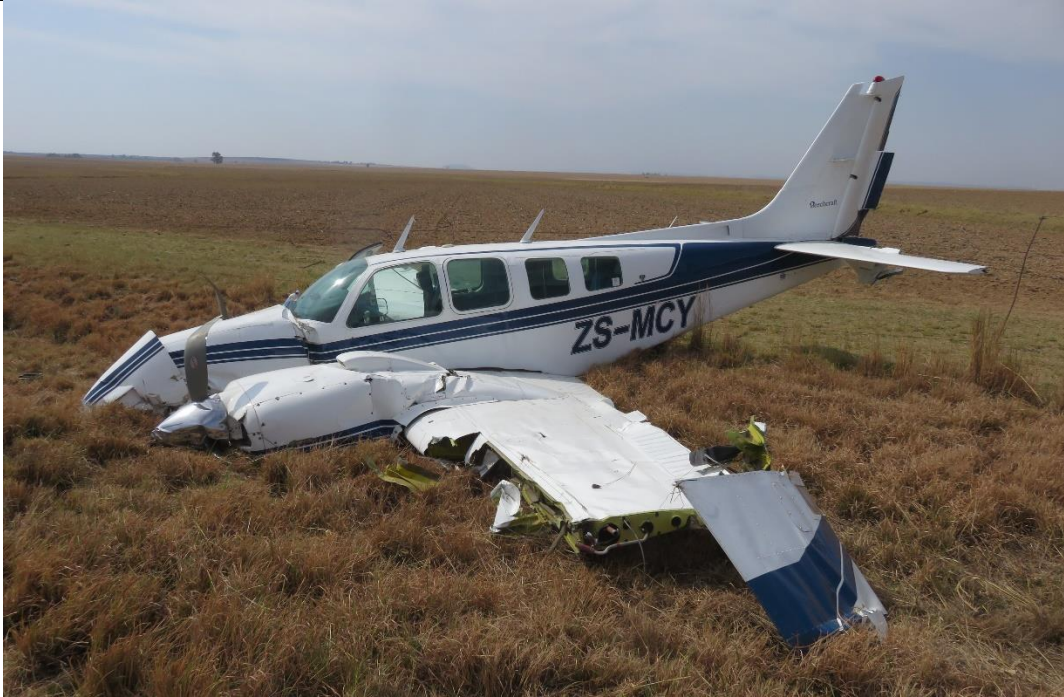
Figure 4: Substantial damage to the left wing.

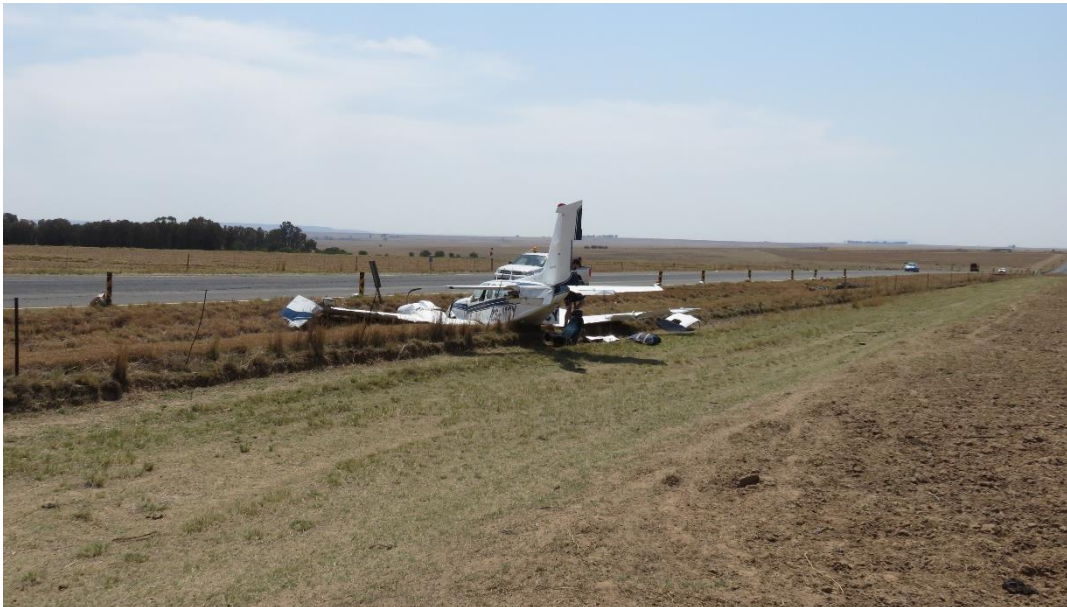
Figure 5: An aft view of the aircraft next to the N5.

4.	<u>Road used for Landing</u>
4.1	The road was in good condition and consisted of three lanes which provided ample space to land. There was no traffic on the road in the immediate area at the time of landing. The part of the road on which the aircraft landed was upslope (see Figure 5).
Probable Cause	
Following a dual engine stoppage in-flight due to fuel exhaustion, the pilot landed the aircraft on a National Road (N5) and lost directional control which resulted in the left wing striking several road hazard markers next to the road as well as a stormwater barrier. The aircraft came to rest in a trench next to the road.	
Contributing Factors

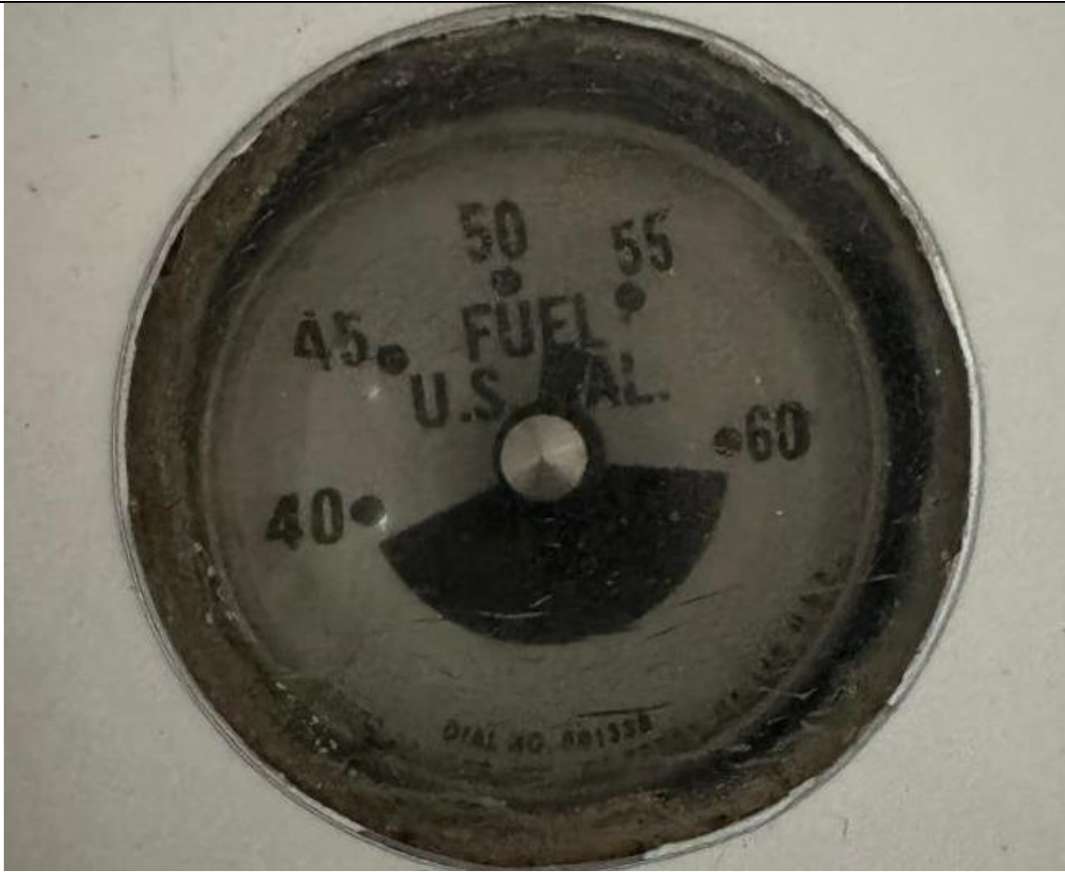
Figure 6: External fuel level sight gauge with the needle in the seven o'clock position. These gauges only provide readings if the fuel quantity is between 40 and 60 US gallons.
The picture had been enlarged as this is a small gauge.

A visual fuel level sight gauge in each wing leading edge, outboard of the engine nacelle, can be used for partial filling or off-loading of fuel. This gauge is to be used only when it reads within the calibrated areas, which are between 40 to 60 US gallons (see Figure 6).

- 2.10 The external fuel level sight gauges are small, and a person needs to look closely to obtain an accurate reading. These gauges only display a reading if the fuel quantity in the tanks is between 40 and 60 US gallons.

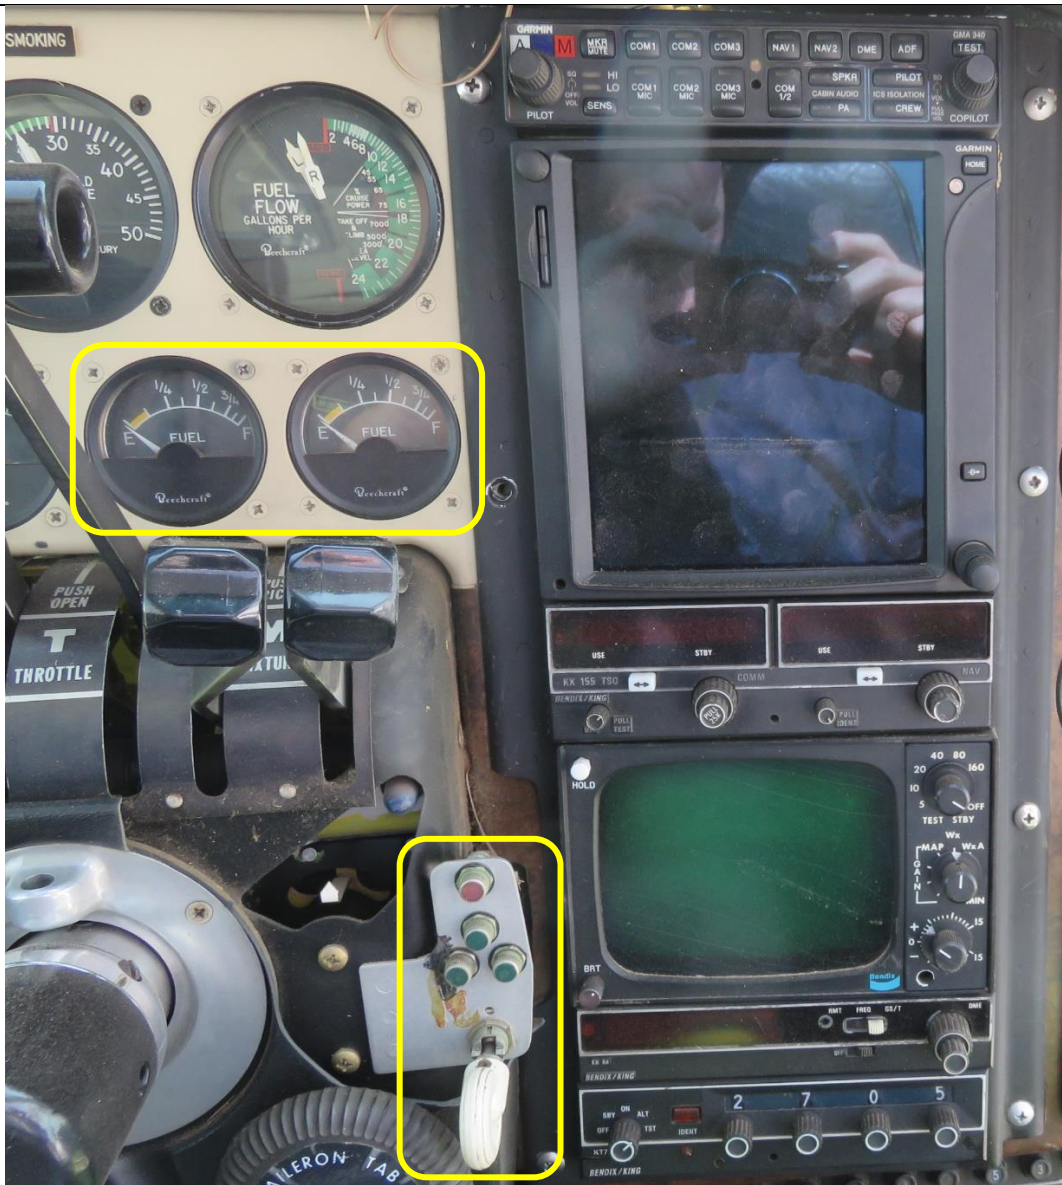
Figure 7: The fuel gauges in the cockpit with the landing gear lever in the DOWN position.

- 1.3 The pilot stated that the fuel gauges on the instrument panel were inaccurate and that he relied on the external fuel level sight gauges.
- 1.4 The pilot did not make entries in the aircraft flight folio for any of the flights since he departed from FATP. This was in contravention of Part 91.03.5 of the CAR 2011 as amended.

- 2.6 The propeller fitted to the left engine was feathered, and the one fitted to the right engine was not.
- 2.7 The landing gear lever in the cockpit was found in the DOWN position.

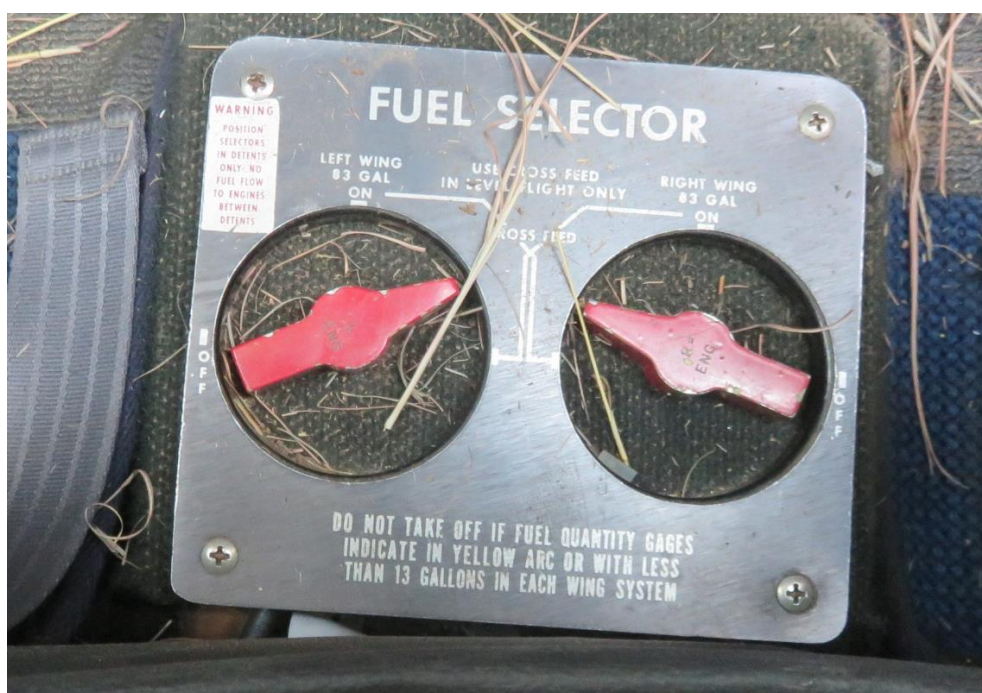
Figure 8: The fuel selector as it was found on site.

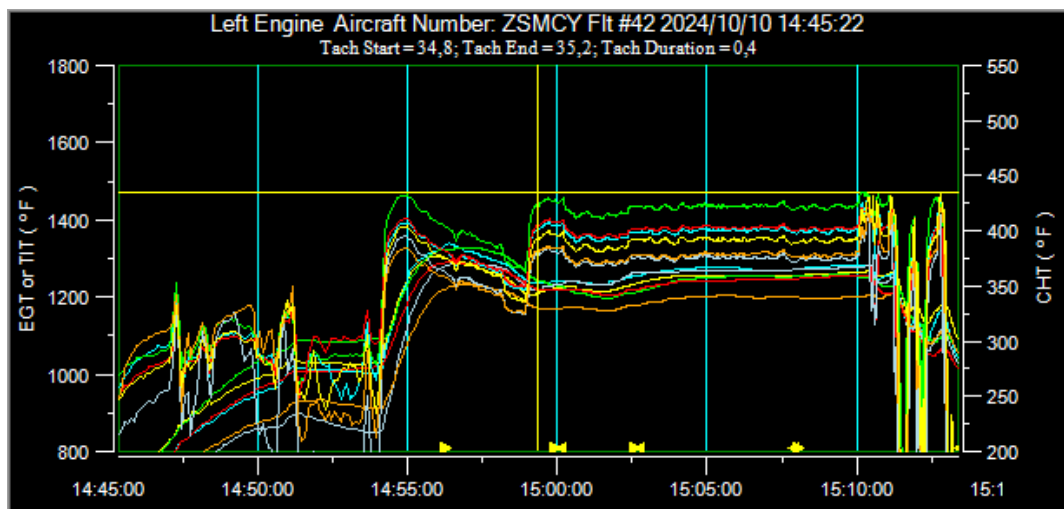
Based on data that was downloaded from the unit (Graphs 1 and 2), the two engines shut down at the same time.

Graph 1: The JPI EDM 790 data for the left engine, accident flight.

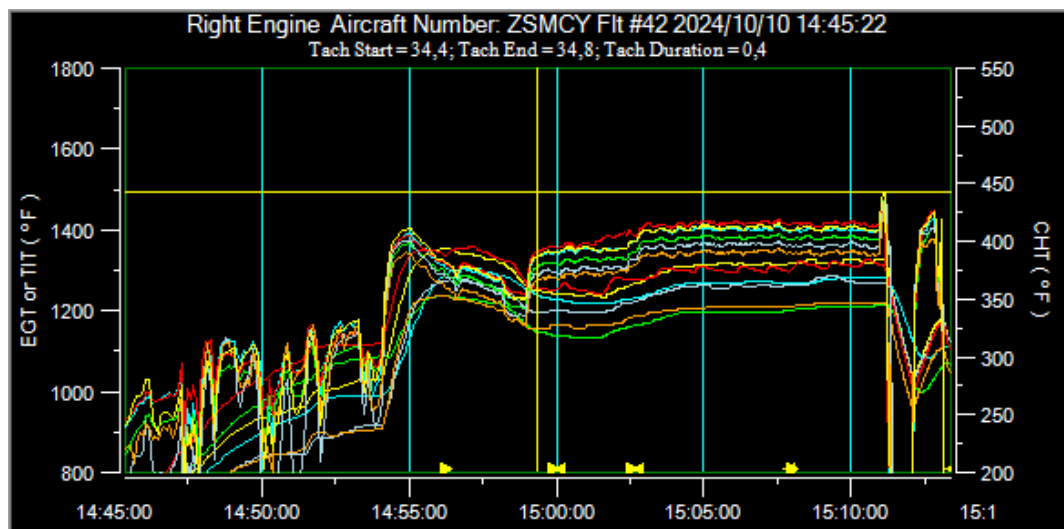
Graph 2: The JPI EDM 790 data for the right engine, accident flight.

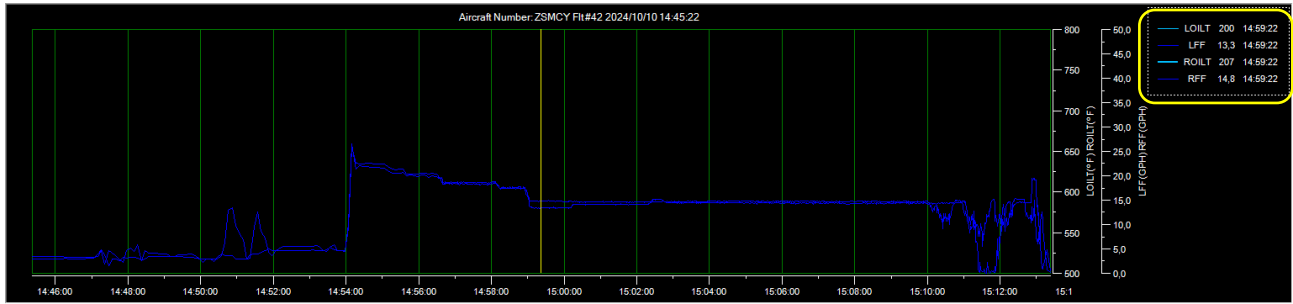
Graph 3: In this graph the average fuel flow for the left and right engine is displayed in gallons per hour. The time from start-up to take-off was approximately 8 minutes.
