**LIMITED OCCURRENCE INVESTIGATION REPORT – FINAL**

| <b>Reference Number</b> | | CA18/2/3/10515 | | | | | |
| <b>Registration</b> | ZU-KFJ | | | | | | |
| <b>Make; Model; S/N</b> | Airplane Factory; Sling 4 High Wing (Serial Number: 016G) | | | | | | |

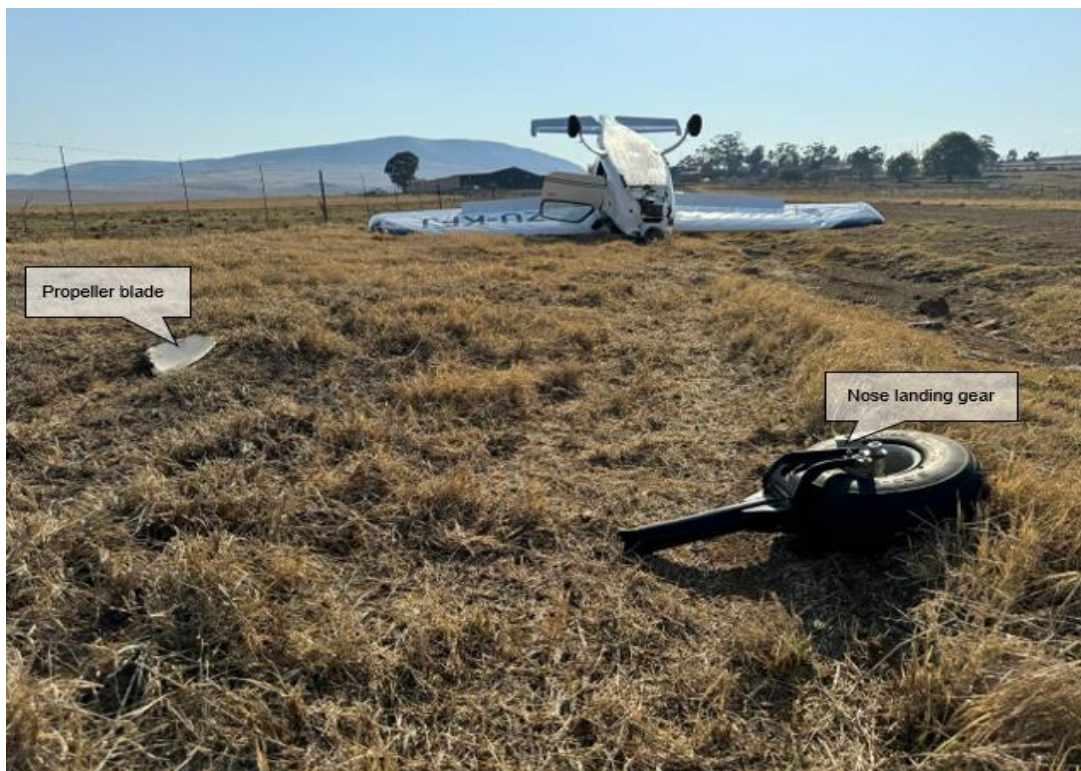
**Figure 2:** The aircraft's resting position after the accident. (Source: Manufacturer)

The aircraft encountered a whirlwind during landing which caused the pilot to lose control of the aircraft. The aircraft landed hard, bounced and veered off to the left of the runway. This caused the nose gear failure and the aircraft subsequently nosed over before it rested in an inverted position.

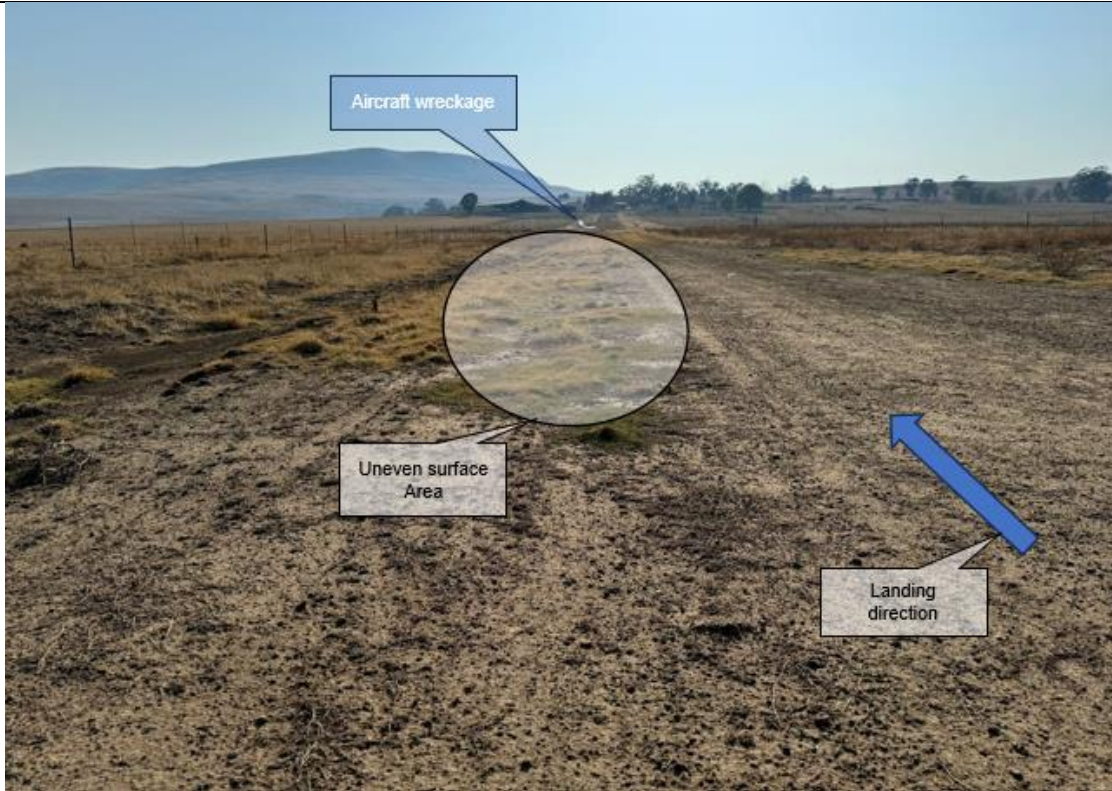
**Figure 3:** The runway surface condition.

Figures 3 and 4 illustrate the condition of the runway surface area on which the aircraft landed.

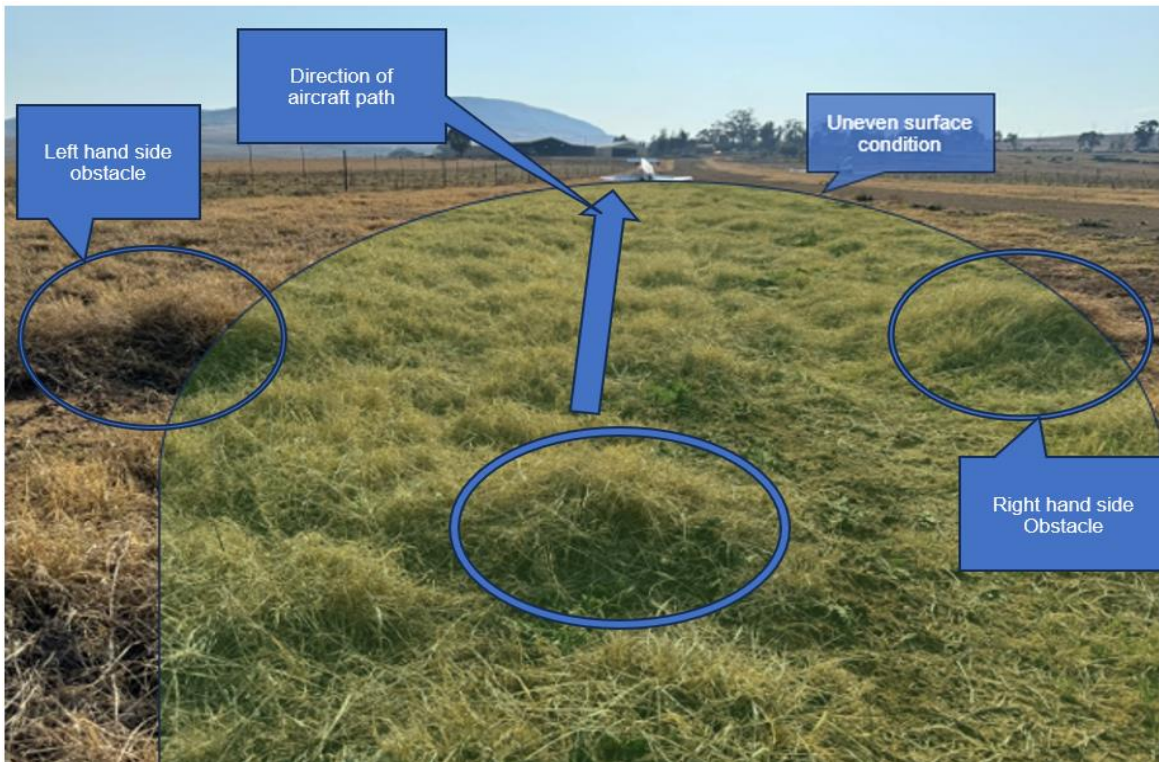
**Figure 4:** The uneven surface on which the aircraft rolled after it had landed.

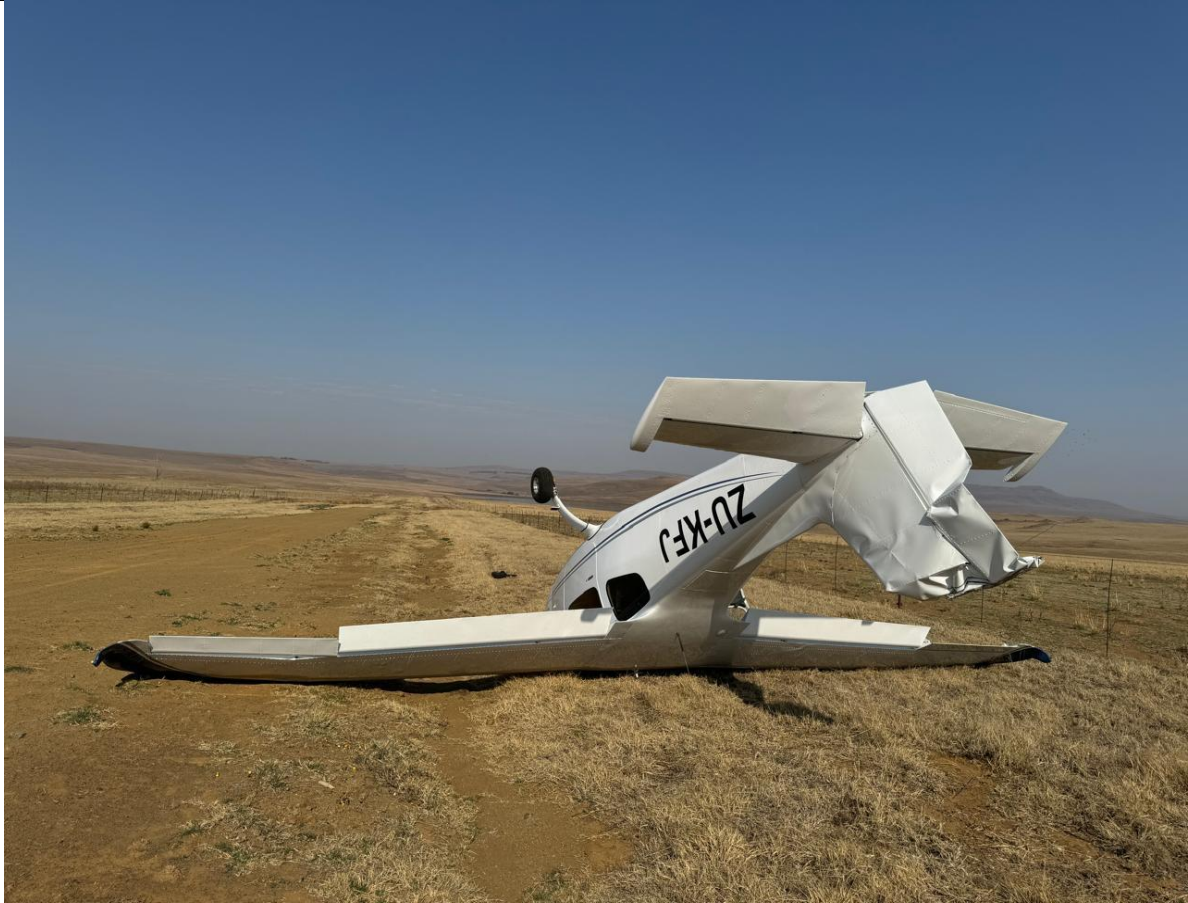
**Figure 5:** Damage to the tail fin due to impact with the ground.
