LIMITED OCCURRENCE INVESTIGATION REPORT – FINAL

Reference Number	CA18/2/3/10517						
Classification	Accident		Date	16 October 2024		Time	1450Z
Type of Operation	Training (Part 141)						
Location							
Place of Departure	Wonderboom Aerodrome (FAWB), Gauteng Province		Place of Intended Landing	Wonderboom Aerodrome (FAWB), Gauteng Province			
Place of Occurrence	Runway 06 at Wonderboom Aerodrome (FAWB)						
GPS Co-ordinates	Latitude	25° 39' 19.00" S	Longitude	028° 13' 17.00" E	Elevation	4 095 ft	
Aircraft Information							
Registration	ZS-SUJ						
Make; Model; S/N	Cessna Aircraft Company; C172M Skyhawk (S/N: 17261667)						
Damage to Aircraft	Substantial		Total Aircraft Hours	8 504.18			
Pilot-in-command							
Licence Type	Student Pilot Licence (SPL)		Gender	Male		Age	19
Licence Valid	Yes	Total Hours	44.2		Total Hours on Type	44.2	
Total Hours 30 Days	7.2		Total Flying on Type Past 90 Days	21.6			
People On-board	1 + 0	Injuries	0	Fatalities	0	Other (on ground)	0

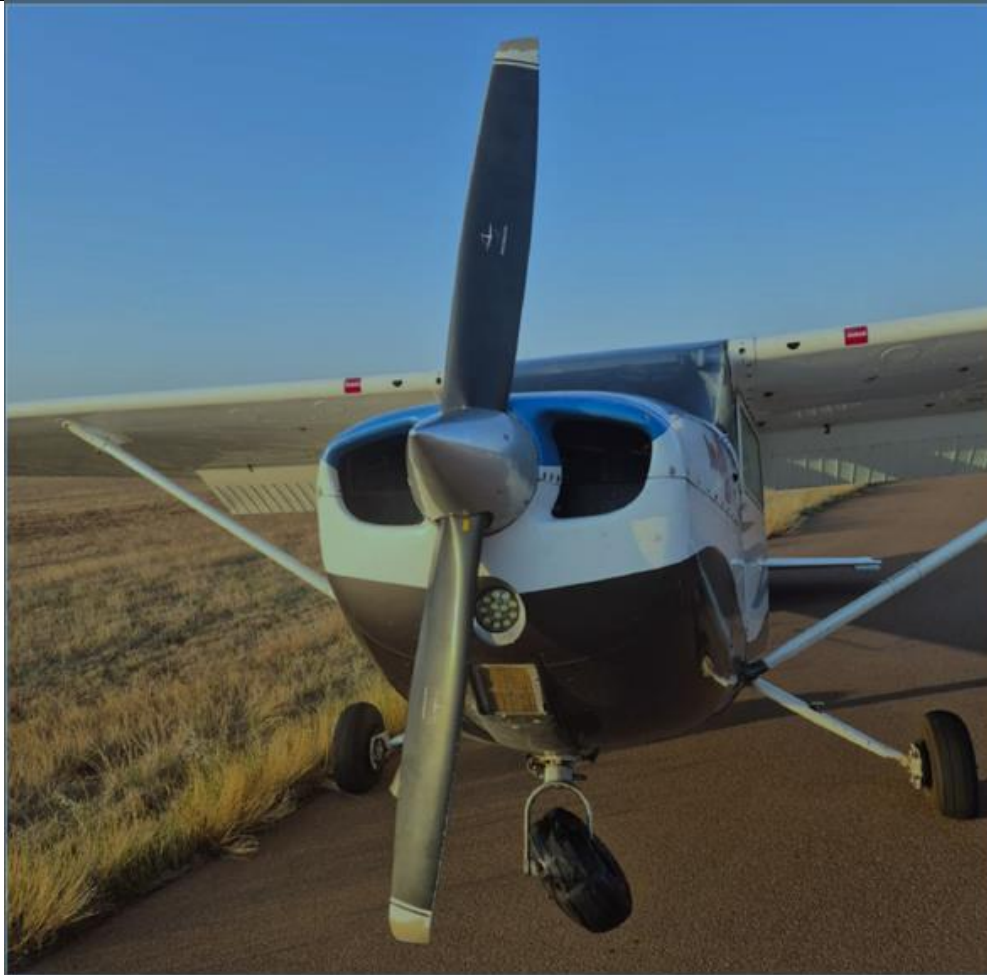
Figure 2: Damage sustained to the nose gear and the propeller blades. (Source: FAWB-ARFF)

2.7 With the aircraft's flaps configuration set at 30 degrees, it is likely that the pilot reduced power and the aircraft flared which significantly reduced the forward speed; the aircraft dropped height and touched down hard on the runway. It then bounced which caused damage to the nose gear.

It is likely that the aircraft approached at a high speed and height which prompted the pilot to reduce engine power and the aircraft flared. As a result, the aircraft's height dropped, followed by a hard touch down and several bounces with damage to the nose gear.

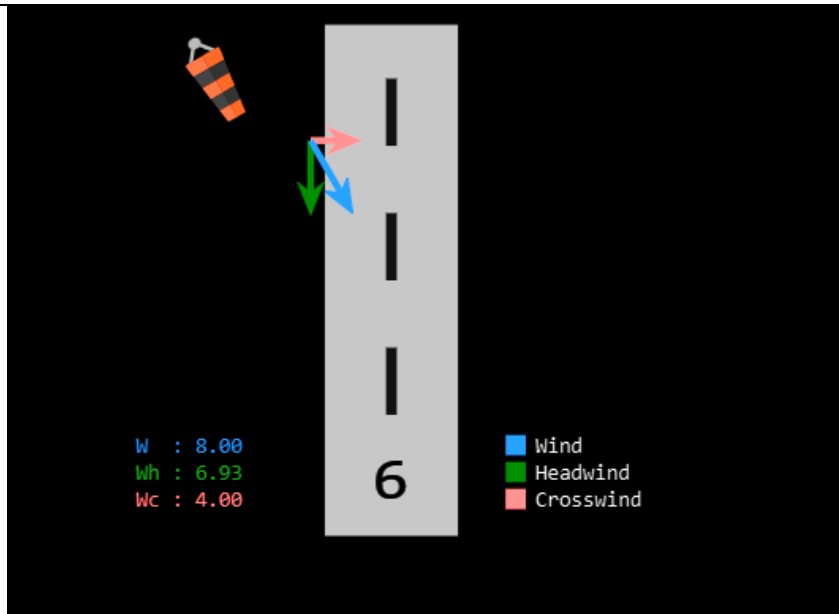
Figure 3: The average wind component calculations at the time of the accident. (Source:e6bx.com)

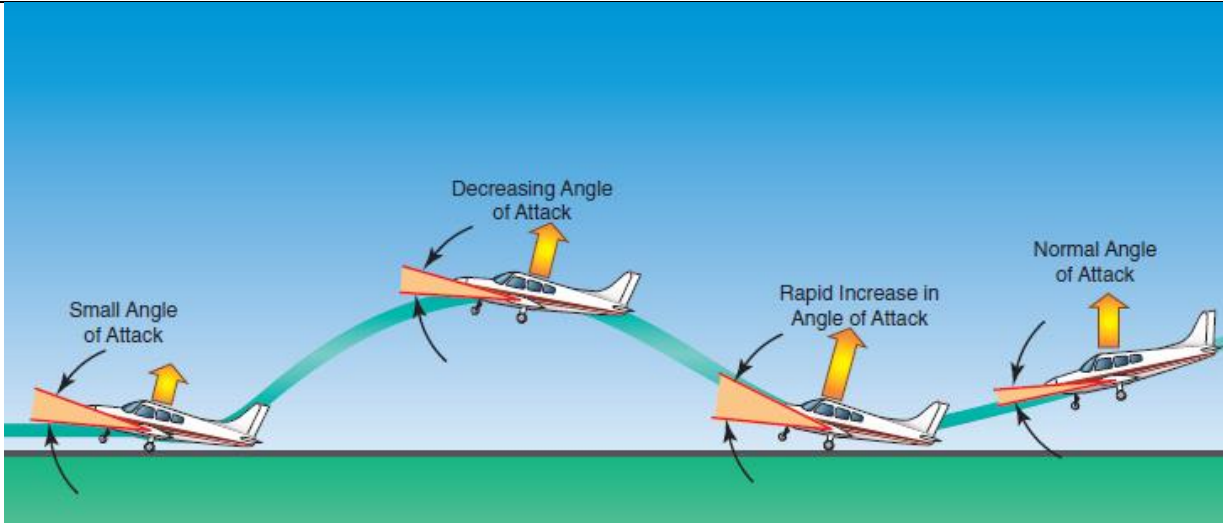
When the aeroplane contacts the ground with a sharp impact as the result of an improper attitude or an excessive rate of sink, it tends to bounce back into the air.

Illustration 1: A depiction of the bounce. (Source: Source: FAA-airplane flying handbook chapter 8)

When a bounce is severe, the safest procedure is to EXECUTE A GO-AROUND IMMEDIATELY. No attempt to salvage the landing should be made. Full power should be applied while simultaneously maintaining directional control and lowering the nose to a safe climb attitude. The go-around procedure should be continued even though the airplane may descend, and another bounce may be encountered. It would be extremely foolish to attempt a landing from a bad bounce since airspeed diminishes very rapidly in the nose-high attitude, and a stall may occur before a subsequent touchdown could be made.
