AIRCRAFT ACCIDENT REPORT AND EXECUTIVE SUMMARY

Reference:		CA18/2/3/10518	
Aircraft Registration	ZU-RGR	Date of Accident	15 October 2024		Time of Accident	0730Z
Type of Aircraft	Magni Gyro M-24		Type of Operation		Private (Part 94)	
Pilot-in-command Licence Type	National Pilot Licence		Age	52	Licence Valid	Yes
Pilot-in-command Flying Experience	Total Flying Hours		938.0		Hours on Type	Unknown
Last Point of Departure	Nelspruit Airport (FANS), Mpumalanga Province					
Next Point of Intended Landing	Musina Aerodrome (FAMH), Limpopo Province					
Damage to Aircraft	Destroyed					
Location of the accident site with reference to easily defined geographical points (GPS readings if possible)						
Hanglip Mountain in Louis Trichardt at Global Positioning System (GPS) co-ordinates determined to be 22°59' 38.6" South 29°54' 19.9" East, at an elevation of 4 770 feet (ft)						
Meteorological Information	Surface wind: 060°/6kt; temperature: 11°C; dew point: 0°C; Cloud base: overcast

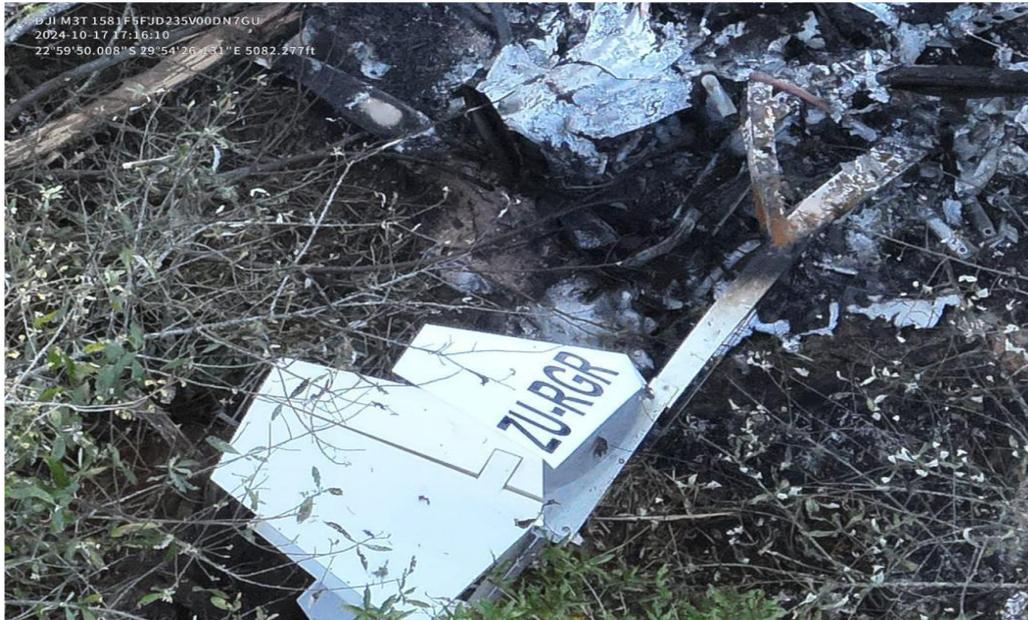
1.3.1 The aircraft was destroyed by impact forces and the post-impact fuel-fed fire.

Figure 2: The wreckage with the tail number still visible. (Source: ARCC)

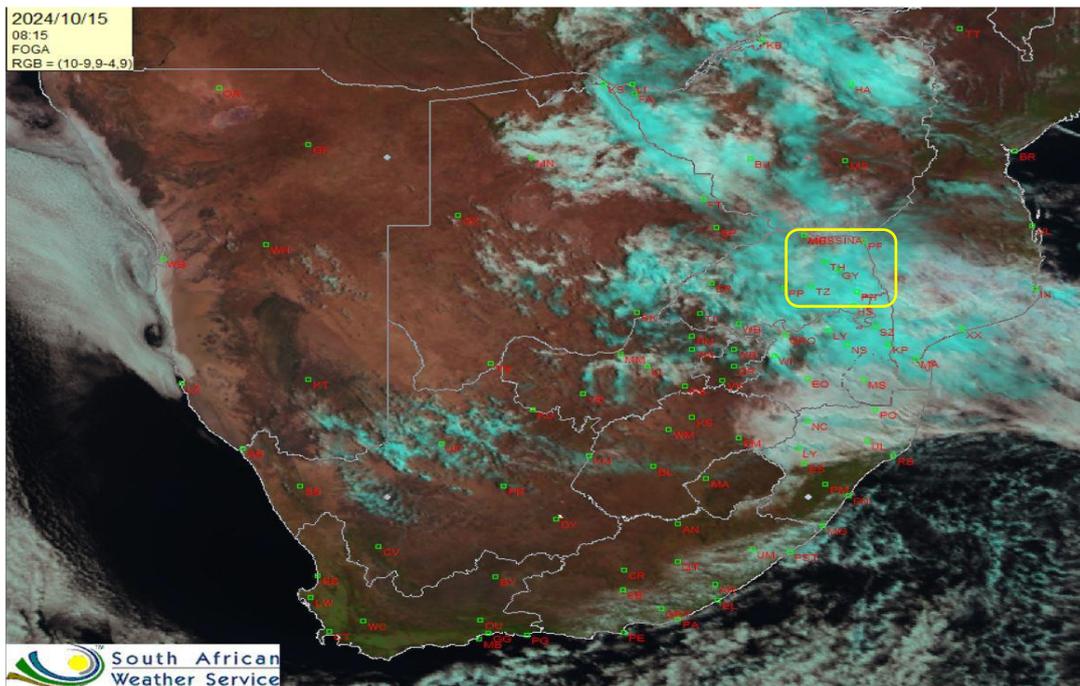
1.7.2 The satellite indicated low clouds below 10 000 feet (ft); however, the METAR recorded at FAPP indicated that the lowest clouds were 2 000ft above ground level (AGL).

Figure 4: The satellite image at 08:15 (local time) on 15 October 2024.

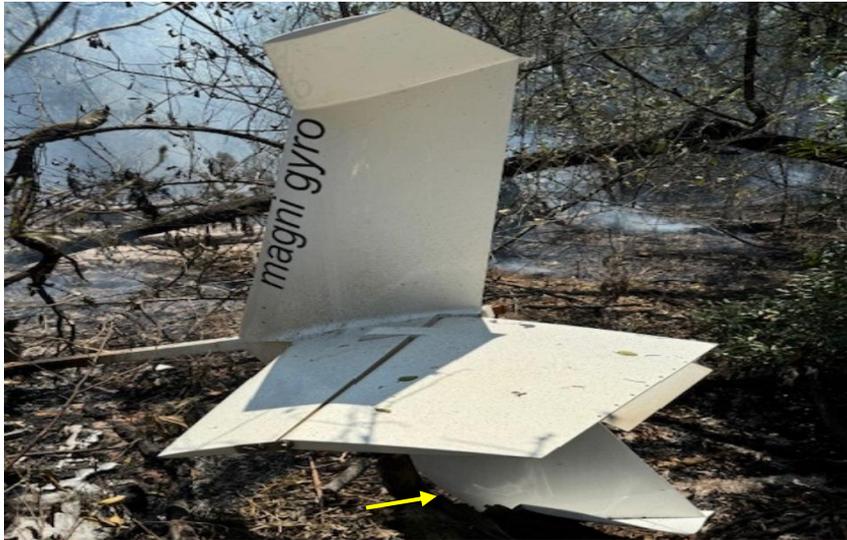
1.12.1 The aircraft crashed near the top of Hanglip Mountain at an elevation of approximately 4 770ft. The elevation (to the top of the mountain) is 5 640ft. The aircraft initially impacted the trees at a high speed on the east side of the mountain at a heading of approximately 331°. It was evident that a significant amount of energy at impact was absorbed by the canopy before the aircraft reached the ground. The aircraft was destroyed by the post-impact fuel-fed fire. Despite the extensive damage to the aircraft structure due to impact and the fire, it was established that the aircraft was intact at the time of the accident. There was no evidence of pre-impact damage to either the propeller or main rotor blades. The rudder had remained attached to the keel. The right horizontal stabiliser was undamaged, however, the left fin and the left horizontal stabiliser sustained substantial damage.

Figure 5: The tail section and the damaged left fin/horizontal stabiliser.

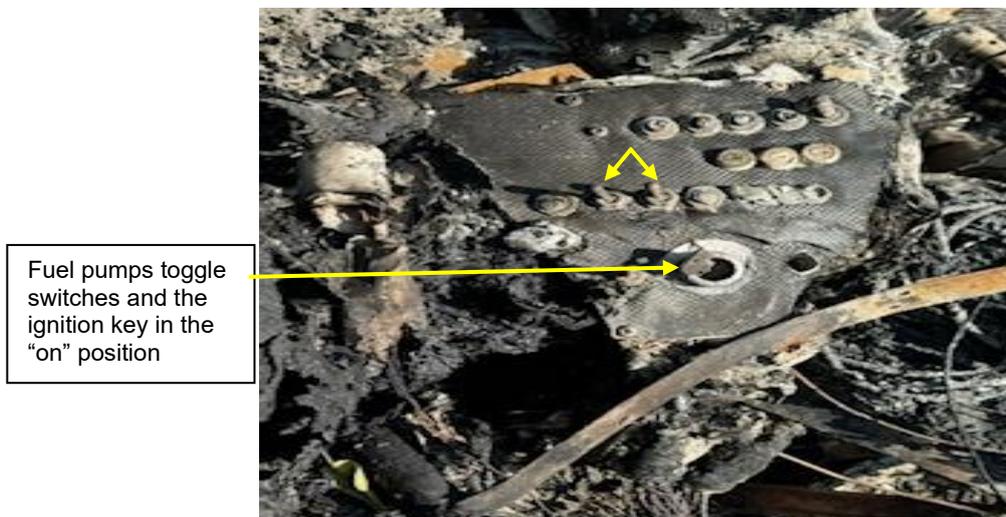
1.12.3 The fuel pump toggle switches and the ignition key were found in the “on” position; however, some switches were damaged. Most of the instruments were destroyed by the fire blaze. The beams that supported the pilot’s side of the seat had bent rearwards. The buckles on each of the four-point harnesses were found still connected and in “locked” position, and all the seat harness attachment fittings were still attached to the aircraft’s structure. The nosewheel fork was found broken, which was consistent with the impact force. The main landing gear beams and wheel assemblies were still attached; however, the tyres were burnt. The door frames and the windshield were destroyed by the post-impact fire.

Fuel pumps toggle switches and the ignition key in the “on” position

Figure 6: The fuel pumps toggle switches and the ignition key after the accident.

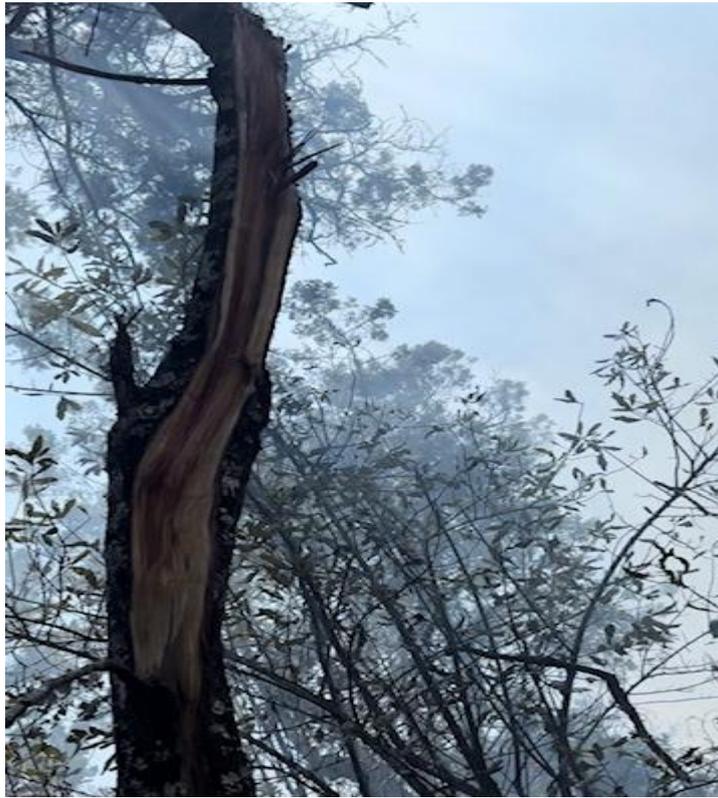
1.12.4 Before impact with the ground, one of the aircraft’s main rotor blades severed one of the tree branches at an estimated height of 3 metres (m). The tree was damaged by the turning rotor, an indication that the engine was producing substantial power at the time of the accident.

Figure 7: The area where a tree branch separated after it was hit by the rotating main rotor blade.

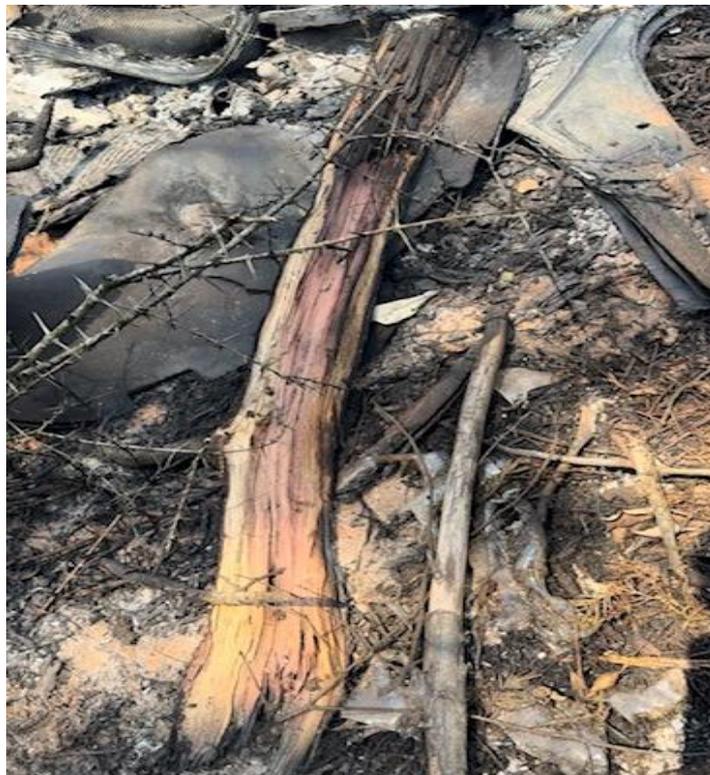
Figure 8: The severed tree branch.

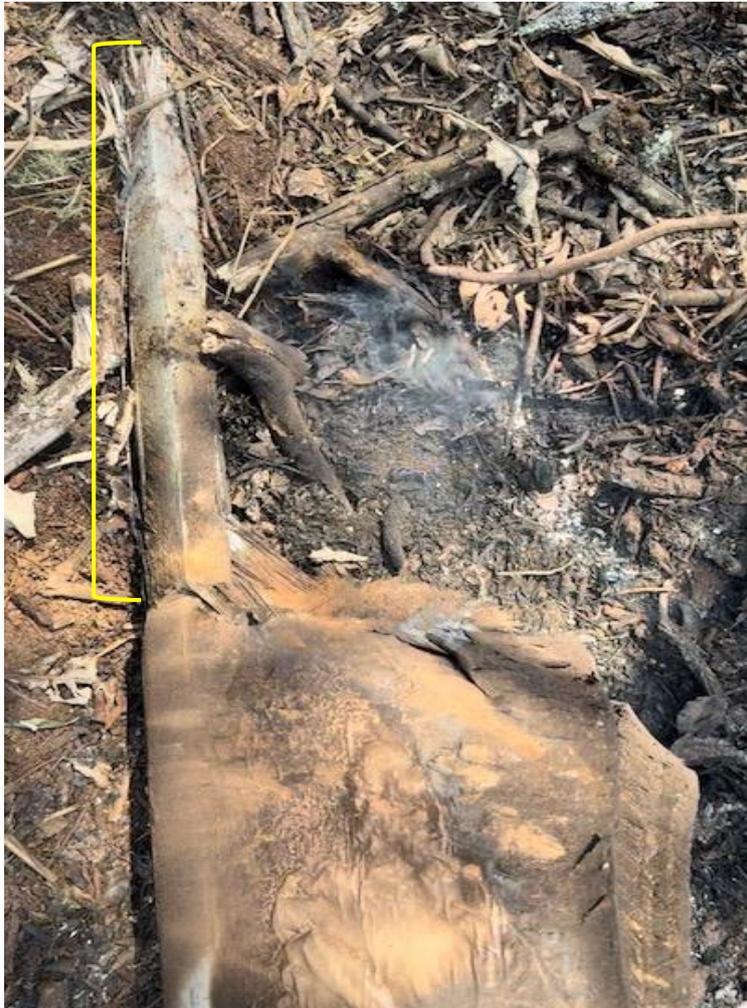
1.12.5 The main rotor blade tip that hit the tree was severed. The rotor head was in place; however, one of the rods was found slightly bent.

Figure 9: The severed tip of the main rotor blade that hit the tree branch.

at the time of impact. However, the amount of power could not be determined. The main rotor blade (Figure 9) indicated that it struck and severed the tree branch at high revolutions per minute (RPM). Examination of the engine also revealed no pre-impact anomalies that could have precluded normal operation.

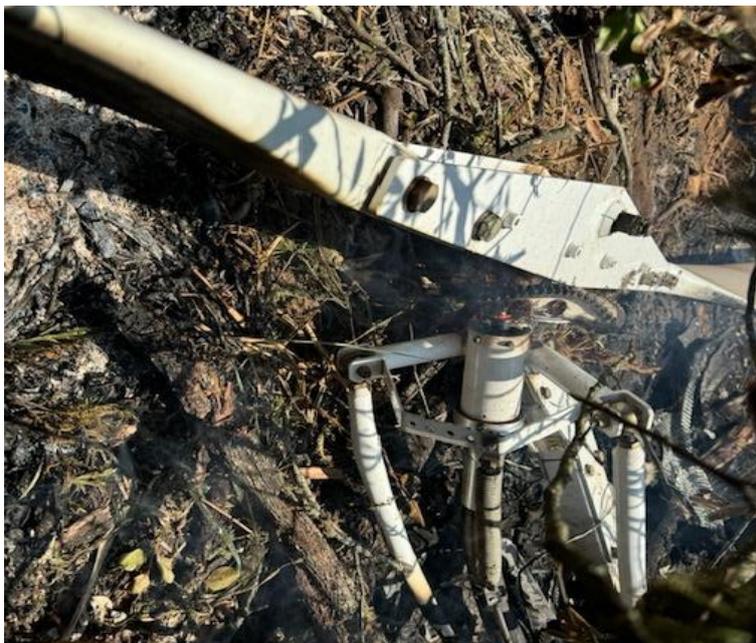
Figure 10: The main rotor head and the bent rod.
