LIMITED OCCURRENCE INVESTIGATION REPORT – FINAL

Reference Number	CA18/2/3/10519						
Classification	Accident	Date	17 October 2024	Time	1040Z		
Type of Operation	Private (Part 94)						
Location							
Place of Departure	Virginia Airport (FAVG), KwaZulu-Natal Province		Place of Intended Landing	Virginia Airport (FAVG), KwaZulu Natal-Province			
Place of Occurrence	Beachwood Golf Course, 0.7 nautical miles from the Virginia Airport (FAVG)						
GPS Co-ordinates	Latitude	29°47'3.45" S	Longitude	031°3'4.23" E	Elevation	20 ft	
Aircraft Information							
Registration	ZU-IDV						
Make; Model; S/N	Sling Aircraft; Sling 2 (Serial Number: 178)						
Damage to Aircraft	Substantial		Total Aircraft Hours	1 723.1			
Pilot-in-command							
Licence Type	Commercial Pilot Licence (CPL)		Gender	Male		Age	24
Licence Valid	Yes	Total Hours	401.2		Total Hours on Type	352.2	
Total Hours 30 Days	15.4		Total Flying on Type Past 90 Days	6.4			
People On-board	2+0	Injuries	0	Fatalities	0	Other (on ground)	0

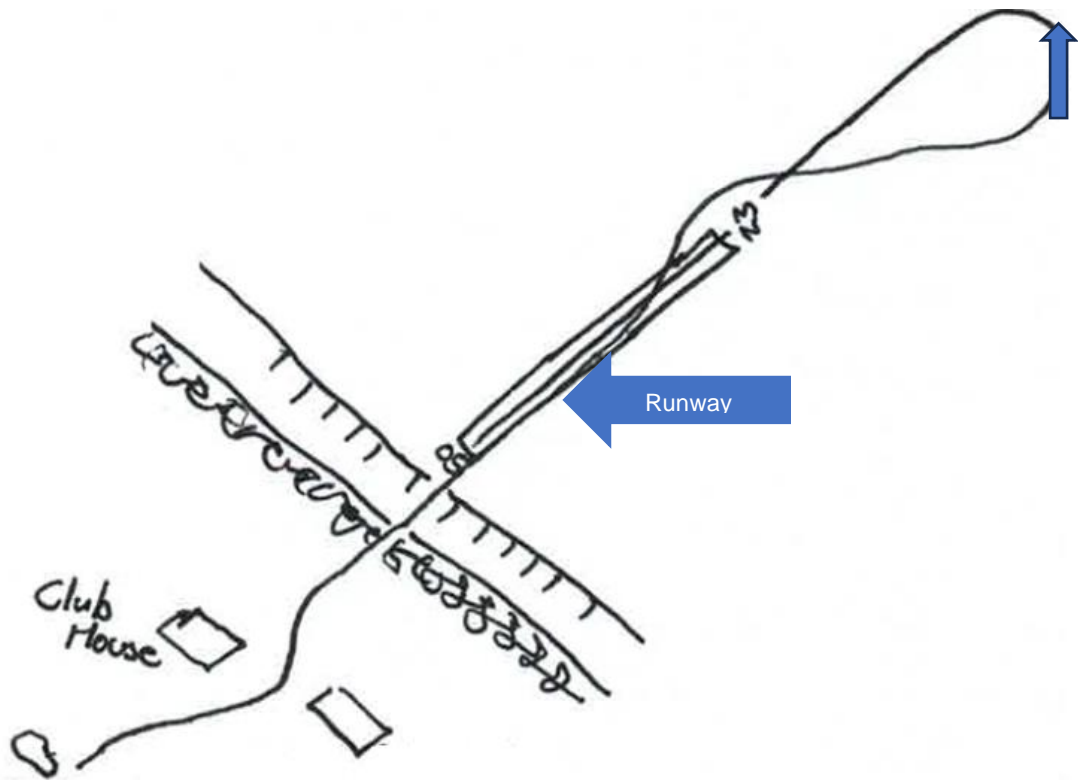
to try and increase the aircraft's descent, but the aircraft was not properly configured for final approach and was too high to land on RWY 23. When the aircraft approached the end of the runway, he added power with the hope that the engine would respond so that the aircraft could clear the fence; there was a short burst of power, and the aircraft cleared the fence. The pilot decided to land on Beachwood Golf Course, about 0.7 nautical miles from the airport.

Figure 1: A depiction of the sequence of events. The blue arrow shows the direction of the flight.
(Source: Pilot)

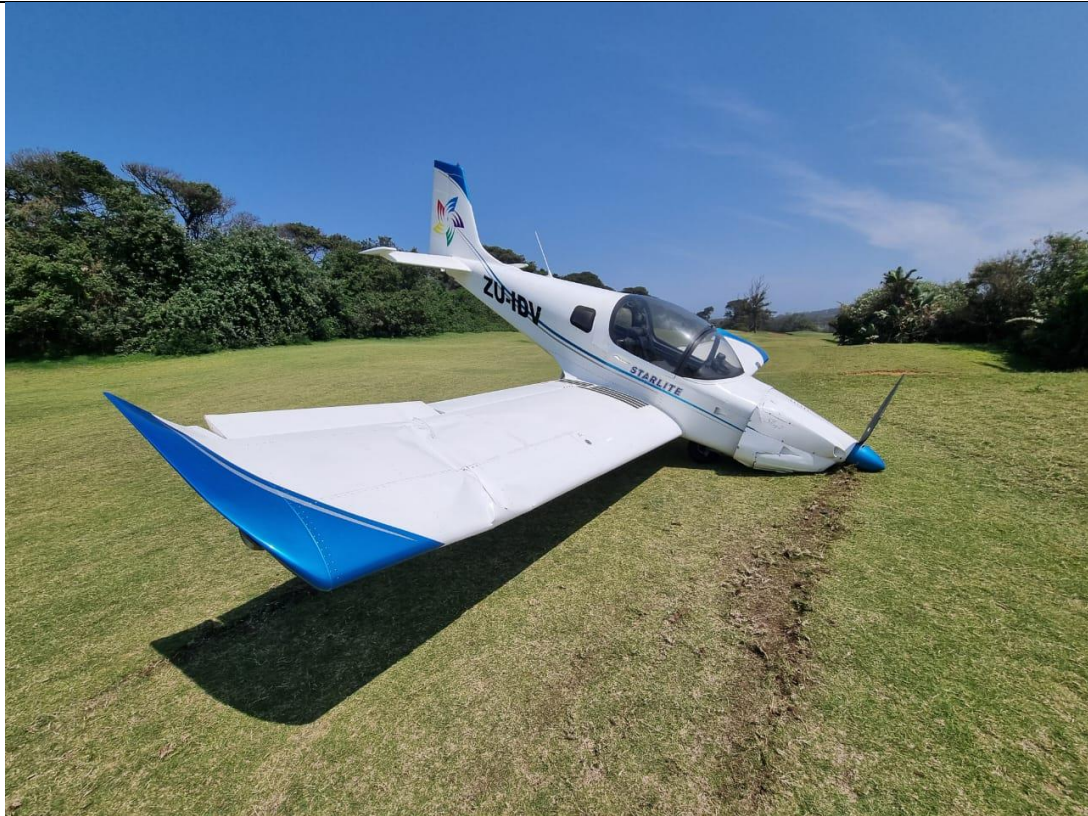
During the landing roll, the nose landing gear broke which caused the propeller to impact the ground; this also damaged the right-side wing. The pilot and the AME were unharmed during the accident sequence. The aircraft sustained substantial damage to the nose landing gear, engine cowlings, propeller and the right wing.

Figure 2: The aircraft after it had landed at the golf course. (Source: Pilot)

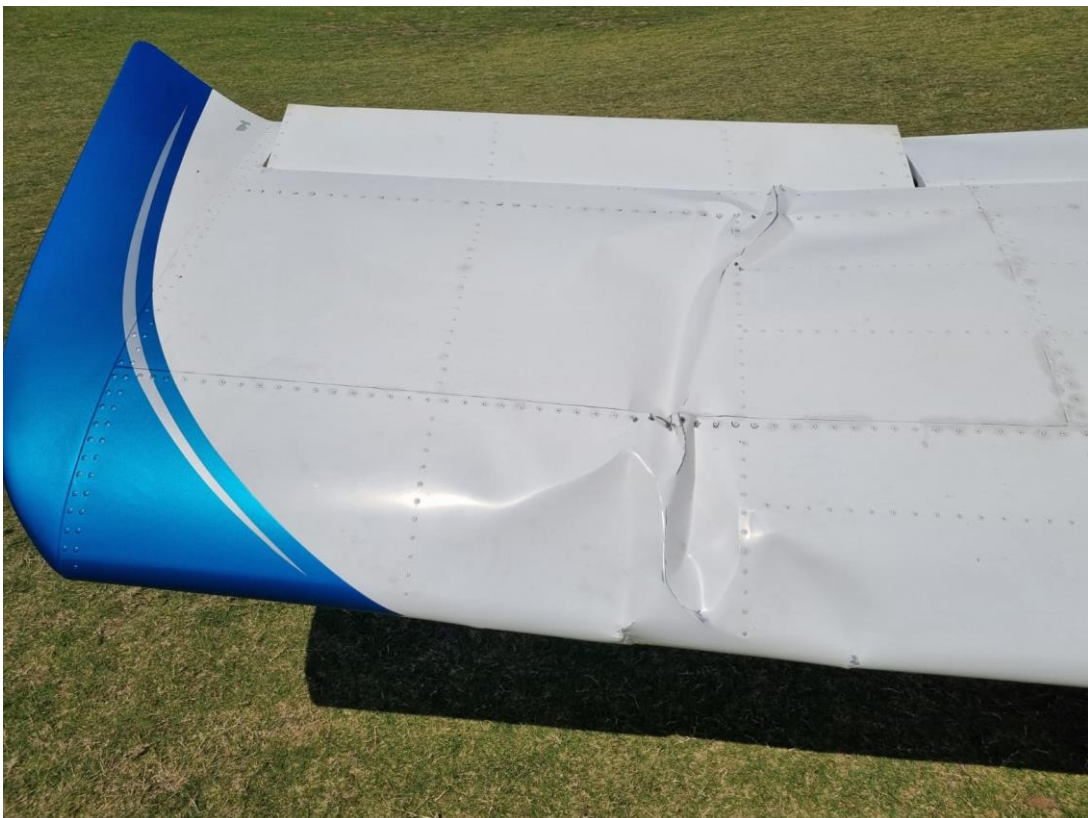
Figure 3: The damaged right wing. (Source: Pilot)
