LIMITED OCCURRENCE INVESTIGATION REPORT – FINAL

Reference Number	CA18/2/3/10520						
Classification	Accident	Date	19 October 2024			Time	1300Z
Type of Operation	Private (Part 91)						
Location							
Place of Departure	Kwaggasvlakte Farm in Thabazimbi, Limpopo Province		Place of Intended Landing	Kwaggasvlakte Farm in Thabazimbi, Limpopo Province			
Place of Occurrence	Bushy terrain, approximately 10 nautical miles north of Kwaggasvlakte Farm, Thabazimbi						
GPS Co-ordinates	Latitude	24°25'.54" S	Longitude	27°33'.00" E	Elevation	3 248 feet	
Aircraft Information							
Registration	ZS-PXS						
Make; Model; S/N	Robinson; R44 Raven II (Serial Number: 11882)						
Damage to Aircraft	Substantial			Total Aircraft Hours	4 264		
Pilot-in-command							
Licence Type	Commercial Pilot Licence		Gender	Male		Age	36
Licence Valid	Yes	Total Hours	9 800		Total Hours on Type	300	
Total Hours 30 Days	8.9		Total Hours on Type Past 90 Days	8.9			
People On-board	1 + 0	Injuries	0	Fatalities	0	Other (on ground)	0

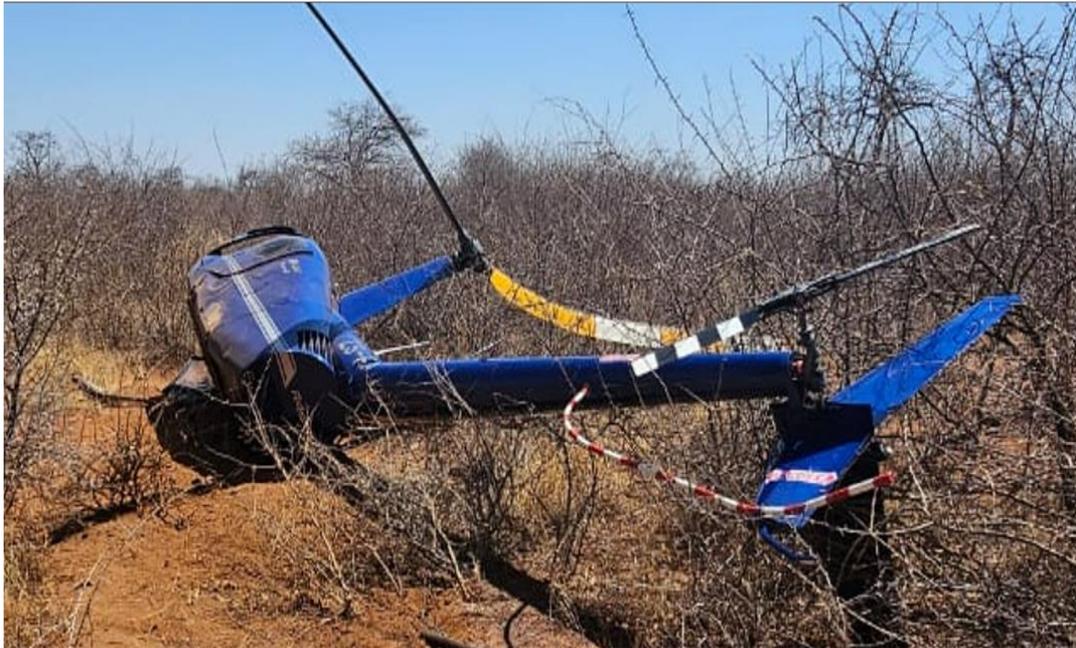
What Happened							
<p>On Saturday, 19 October 2024, a pilot on-board a Robinson R44 Raven II helicopter with registration ZS-PXS was conducting a private flight from Kwaggasvlakte Farm in Thabazimbi to Limpopo River, both in Limpopo province, with the intention of return to the take-off farm. Visual meteorological conditions (VMC) by day prevailed at the time of the flight which was conducted under the provisions of Part 91 of the Civil Aviation Regulations (CAR) 2011 as amended.</p> <p>The pilot stated that before the flight, he conducted a pre-flight inspection of the helicopter and nothing abnormal was found. The helicopter had a total of 106 litres (l) of Avgas 100LL in the tanks. Around 1100Z, the helicopter lifted off from the helipad and headed in a north-easterly direction. The engine power was set at 103% (percent) revolutions per minute (RPM) and the manifold air pressure (MAP) indicated 20 inches of mercury. The flight to Limpopo River was uneventful; he did not land and, after approximately 2 hours of flight time whilst on his return to the farm, flying at 600 feet (ft) above ground level (AGL), the helicopter suddenly lost engine power. The pilot engaged the helicopter to enter autorotation to execute a forced landing; however, the helicopter impacted the ground hard with the skid landing gear. The helicopter tilted to the right and rested on its right side on a bushy terrain. The helicopter sustained substantial damage. The pilot was not injured, he vacated the helicopter unassisted.</p>

Figure 1: The helicopter at the accident site. (Source: Pilot).

2.6	The reason for the reported loss of engine power could not be determined.	
Probable Cause(s)		
An undetermined engine power loss which resulted in an unsuccessful forced landing on a bushy terrain.		
Contributing Factor(s)		
It is possible that the pilot allowed the main rotor RPM to decay below the acceptable limits (97%) whilst flying back to Kwaggasvlakte Farm in Thabazimbi.		
Safety Action(s)		
None.
