LIMITED OCCURRENCE INVESTIGATION REPORT – FINAL

Reference Number	CA18/2/3/10521						
Classification	Accident		Date	30 October 2024		Time	1500Z
Type of Operation	Private (Part 91)						
Location							
Place of Departure	Cape Winelands Airport (FAWN), Western Cape Province			Place of Intended Landing	Cape Town International Airport (FACT), Western Cape Province		
Place of Occurrence	Symphony Nature Reserve at GPS: 33°57'19.48" S 18°37'13.96" E elevation 169ft						
GPS Co-ordinates	Latitude	33°57'19" S	Longitude	018°37'13" E	Elevation	169ft	
Aircraft Information							
Registration	ZS-DVY						
Make; Model; S/N	Cessna Aircraft Company; C172E (Serial Number: 172-51654)						
Damage to Aircraft	Substantial			Total Aircraft Hours	5 045.67		
Pilot-in-command							
Licence Type	Commercial Pilot Licence (CPL)		Gender	Female		Age	20
Licence Valid	Yes	Total Hours	410		Total Hours on Type	35.9	
Total Hours 30 Days	69.5		Total Flying on Type Past 90 Days			35.9

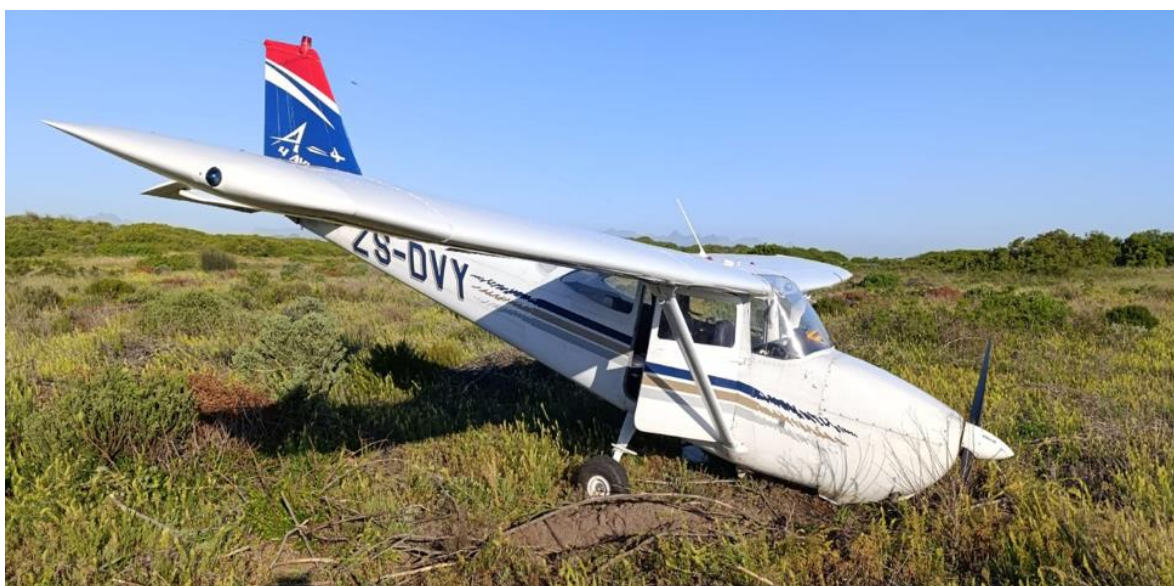
The pilot declared a Mayday to the FACT ATC and, thereafter, initiated a glide. The ATC prioritised the aircraft and directed the pilot to report final approach number one. The pilot advised the ATC that the aircraft would not make it to FACT, adding that she would land on an open field. The pilot conducted the fault-finding procedure whilst steering the aircraft to the identified open field; she also made attempts to restart the engine but without success. Upon reaching the identified field, she extended the flaps to full and touched down on the grass-covered and uneven surface. As a result, the landing gear collapsed during the landing roll and the propeller struck the ground. After the aircraft had come to a stop, the pilot turned off the master switch and exited the aircraft. The aircraft sustained damage to the nose gear strut and the propeller. The pilot was not injured.

Figure 2: The aircraft after the accident. (Source: Operator)

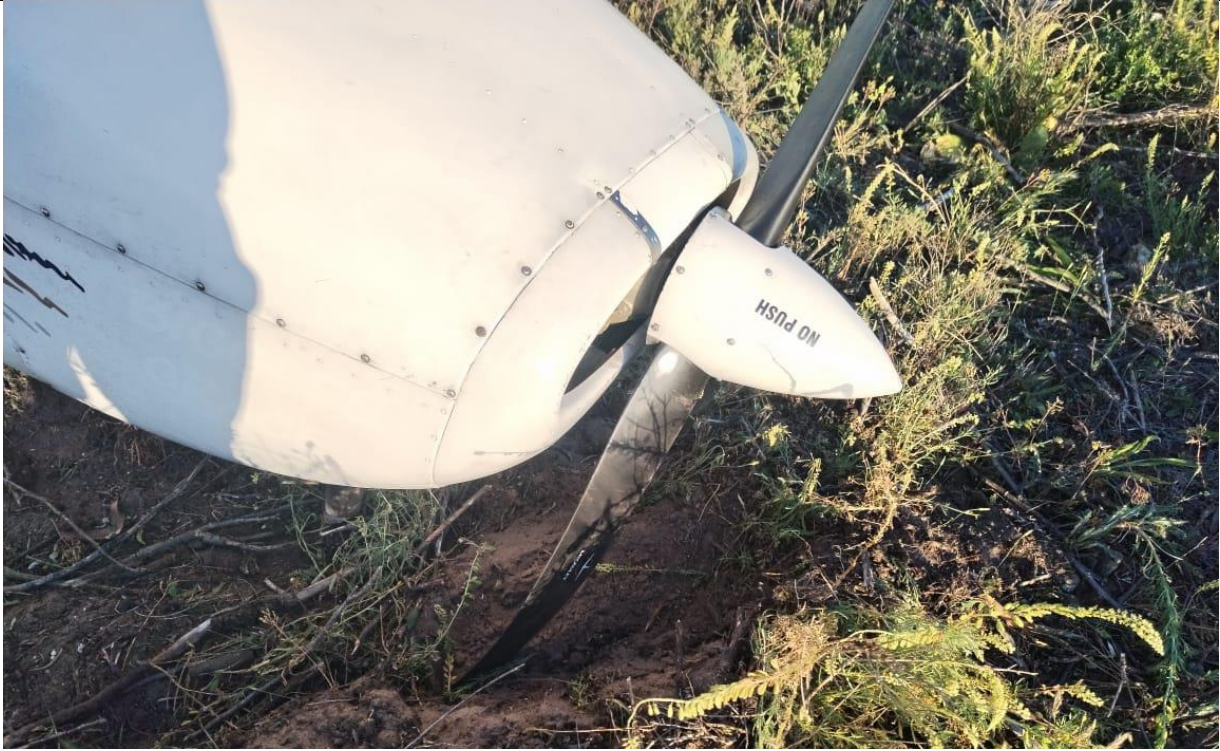
Figure 3: The bent propeller blade. (Source: Operator)

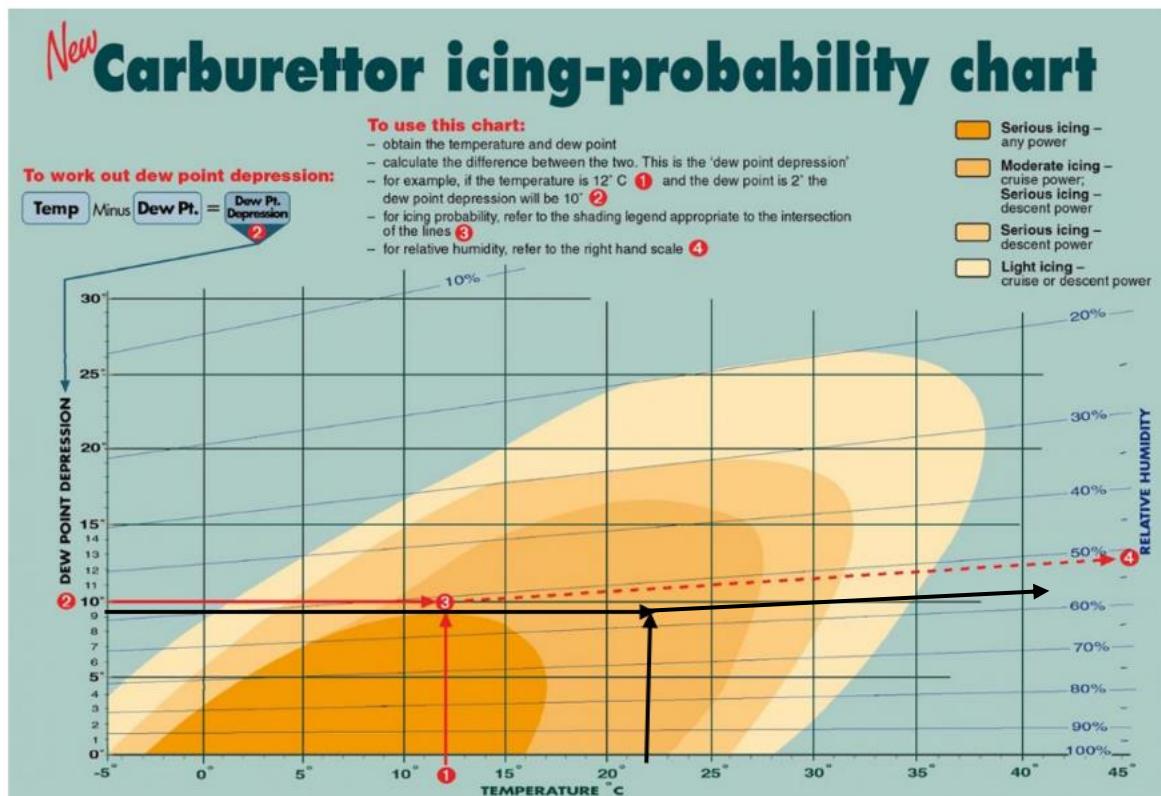
Figure 4: Carburettor icing probability calculations.

The temperature at the time of the accident was 22°C and the dewpoint was 13°C; therefore, the dew point depression was 9°C. The relative humidity was approximately 57%. The carburettor icing probability chart shows a possibility of moderate icing at cruise power or serious icing at descent power based on the temperature and dew point reported at the time of the accident. The aircraft was orbiting when the engine lost power and stopped.

<p>7. The carburettor icing probability chart indicated a possibility of moderate icing at cruise power or serious icing at descent power settings based on the temperature and dew point reported at the time of the flight.</p> <p>8. It is probable that the engine lost power and stopped because of carburettor icing whilst orbiting in the vicinity of FACT.</p>
Probable Cause(s)
Engine power loss and stoppage whilst orbiting in the vicinity of FACT airspace which led to the pilot executing an unsuccessful forced landing.
Contributing Factor(s)
None.
Safety Action(s)
None.
Safety Message and/or Safety Recommendation/s
None.
About this Report
<p><i>The decision to conduct a limited investigation is based on factors including whether the cause is known and the evidence supporting the cause is clear, the level of safety benefit likely to be obtained from an investigation and that will determine the scope of an investigation. For this occurrence, a limited investigation has been conducted, and the Accident and Incident Investigations Division (AIID) has relied on the information submitted by the affected person/s and organisation/s to compile this limited report. The report has been compiled using information supplied in the initial notification, as well as from follow-up desk top enquiries to bring awareness of potential safety issues to the industry in respect of this occurrence, as well as possible safety action/s that the industry might want to consider in preventing a recurrence of a similar occurrence.</i></p> <p><i>All times given in this report are Co-ordinated Universal Time (UTC) and will be denoted by (Z). South African Standard Time is UTC plus 2 hours.</i></p>
