AIRCRAFT ACCIDENT REPORT AND EXECUTIVE SUMMARY

Reference:		CA18/2/3/10522	
Aircraft Registration	ZU-IBE	Date of Accident	1 November 2024		Time of Accident	1747Z	
Type of Aircraft	Jabiru J170			Type of Operation	Training (Part 141)		
Pilot-in-command Licence Type	Commercial Pilot Licence		Age	49	Licence Valid	Yes	
Pilot-in-Command Flying Experience	Total Flying Hours		437.9		Hours on Type	119.4	
Last Point of Departure	Rhino Park Aerodrome, Gauteng Province						
Next Point of Intended Landing	Wonderboom Aerodrome (FAWB), Gauteng Province						
Damage to Aircraft	Destroyed						
Location of the accident site with reference to easily defined geographical points (GPS readings if possible)							
Carlsruhe Private Game Reserve (GPS position: 25°40'50.70" South 028°29'21.05" East), elevation: 4 734 feet							
Meteorological Information	Surface wind: 030°/5kts, temperature: 26°C, dew point: 6°C						
Number of People on Board	2 + 0	Number of People Injured	0	Number of People Killed	2	Other (On Ground)	0

SACAA (AIID)	FAILURE INVESTIGATION REPORT: CYLINDER, JABIRU J170 ENGINE, AIRCRAFT No ZU-IBE	FA-0012-04-25	
		DATE 2025-04-25	ISSUE 1

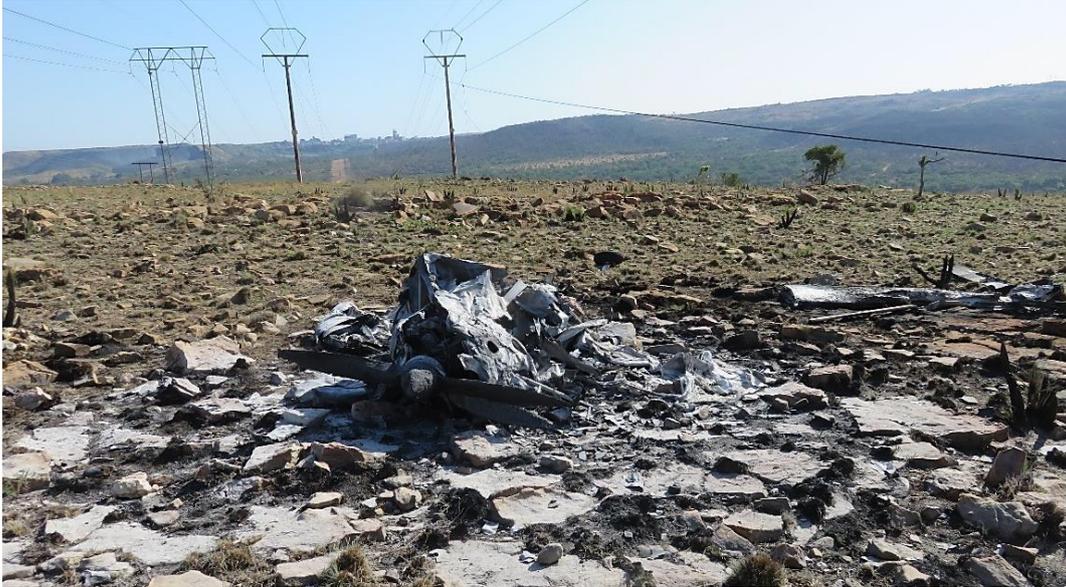
1.3.1 The aircraft was destroyed by post-impact fuel-fed fire that erupted.

Figure 2: The wreckage after the post-impact fire.

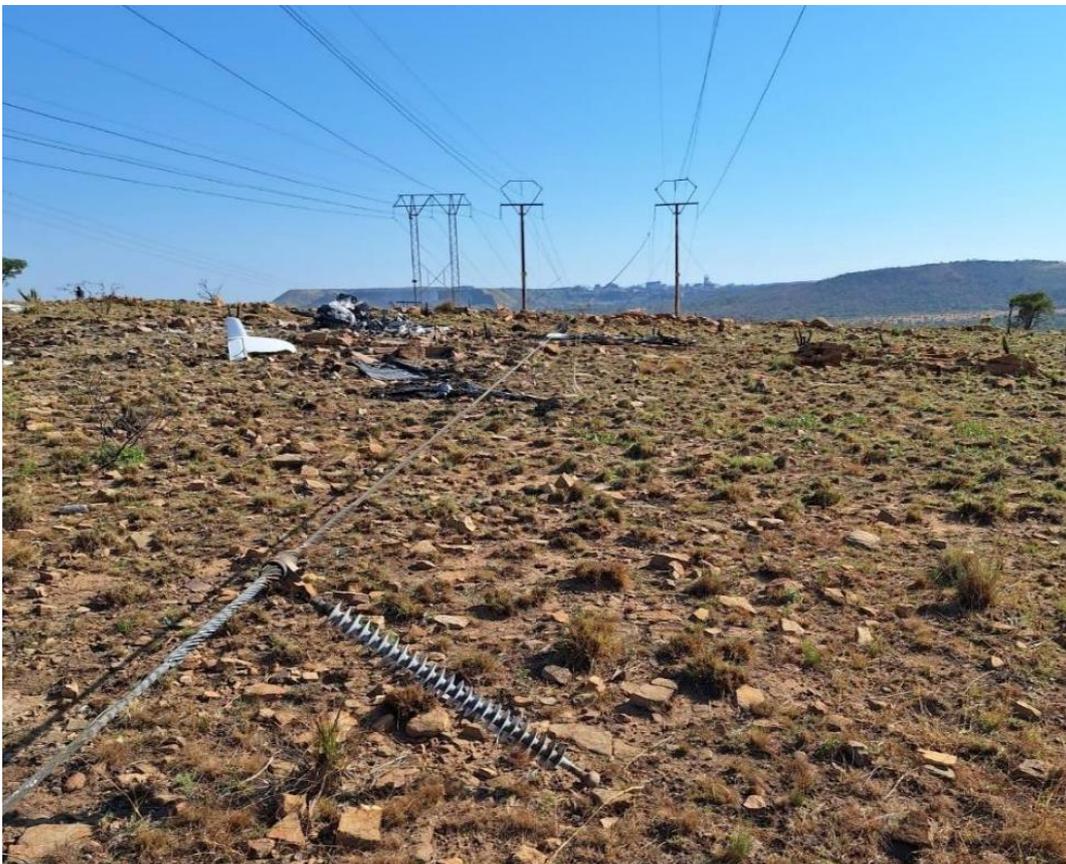
1.4.1 Several Eskom powerline pylons and conductors were damaged after impact with the aircraft. Some parts of Cullinan experienced power failure after the accident.

Figure 3: One of the high-tension cables that snapped from the pylon during the accident.

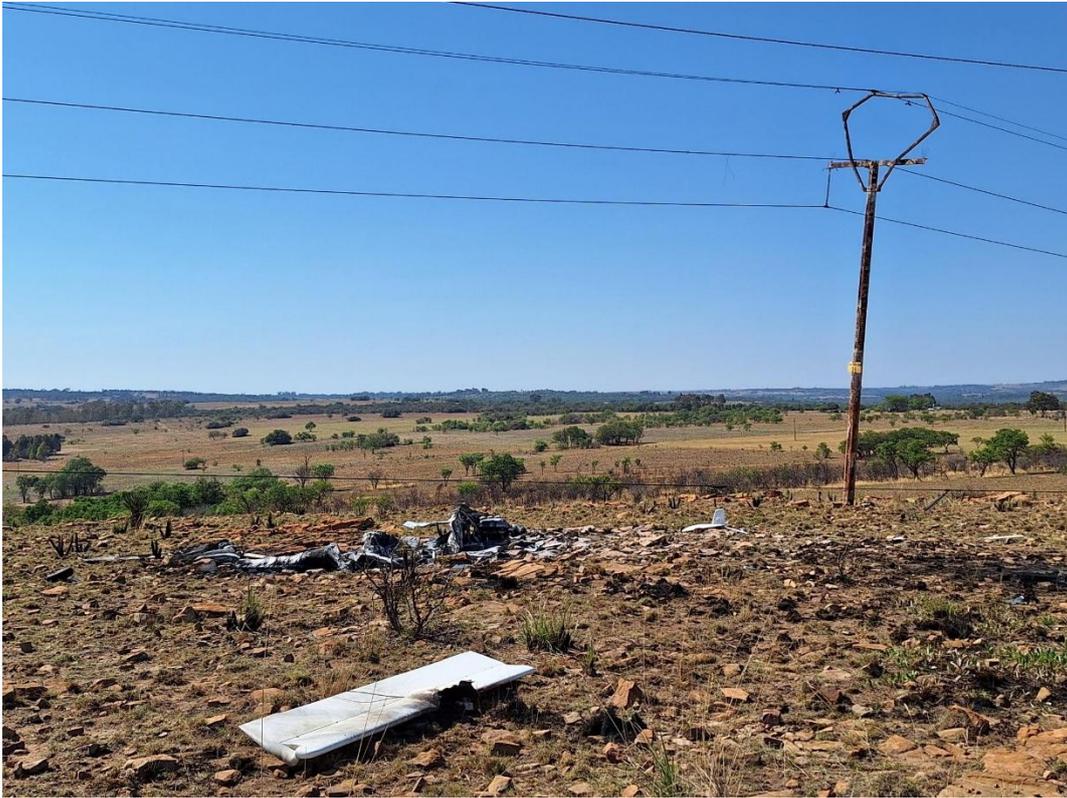
- 1.12.1 The aircraft impacted high-tension powerlines whilst flying in a north north-westerly direction. The wreckage distribution covered an approximate 30m radius, and the fuselage was consumed by post-impact fire that erupted. The aircraft parts that were not totally destroyed were scorched.

Figure 5: The accident site.

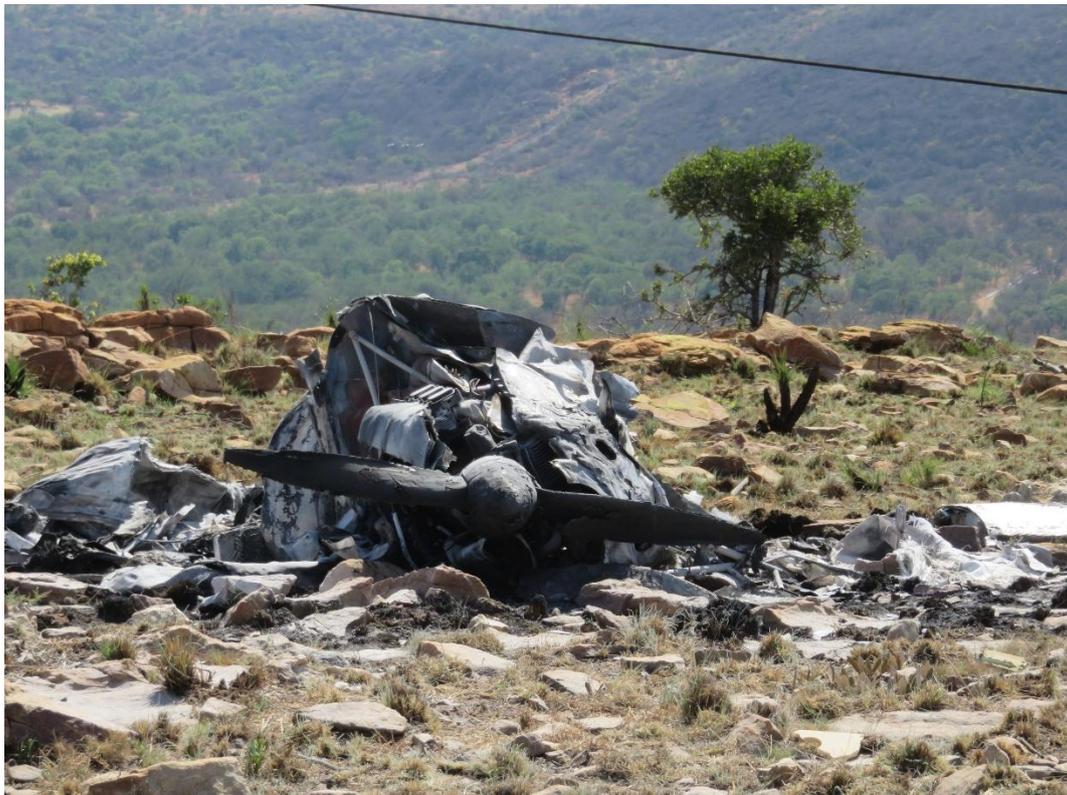
Figure 6: The aircraft fuselage.

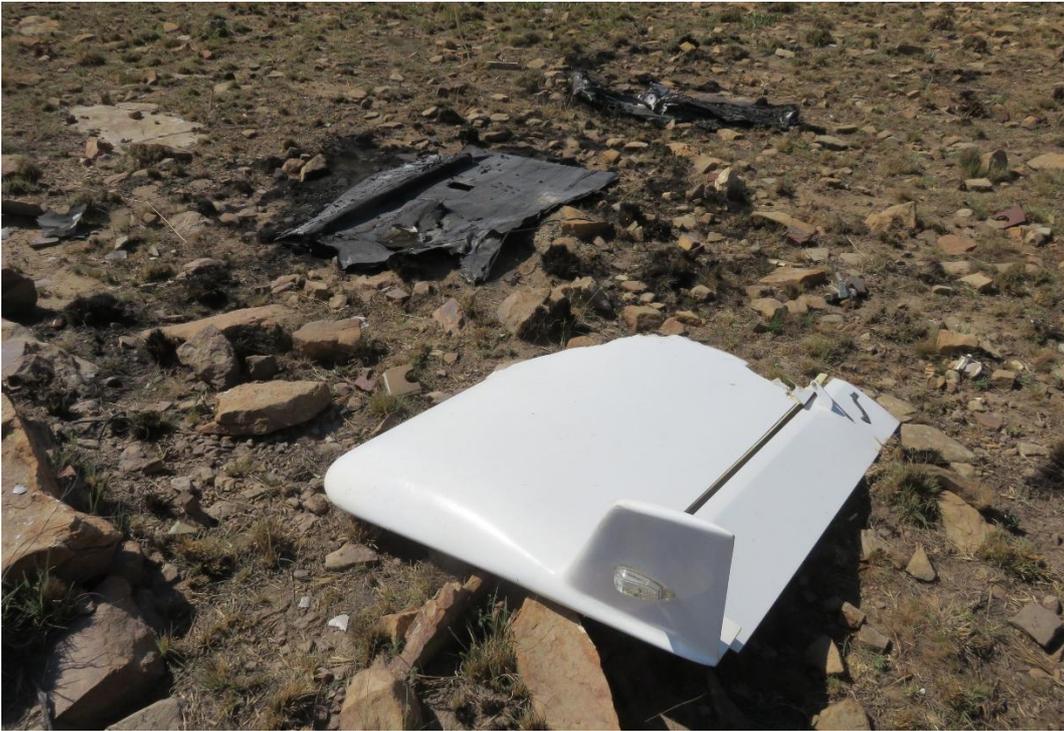
Figure 7: A section of the left outer wing.

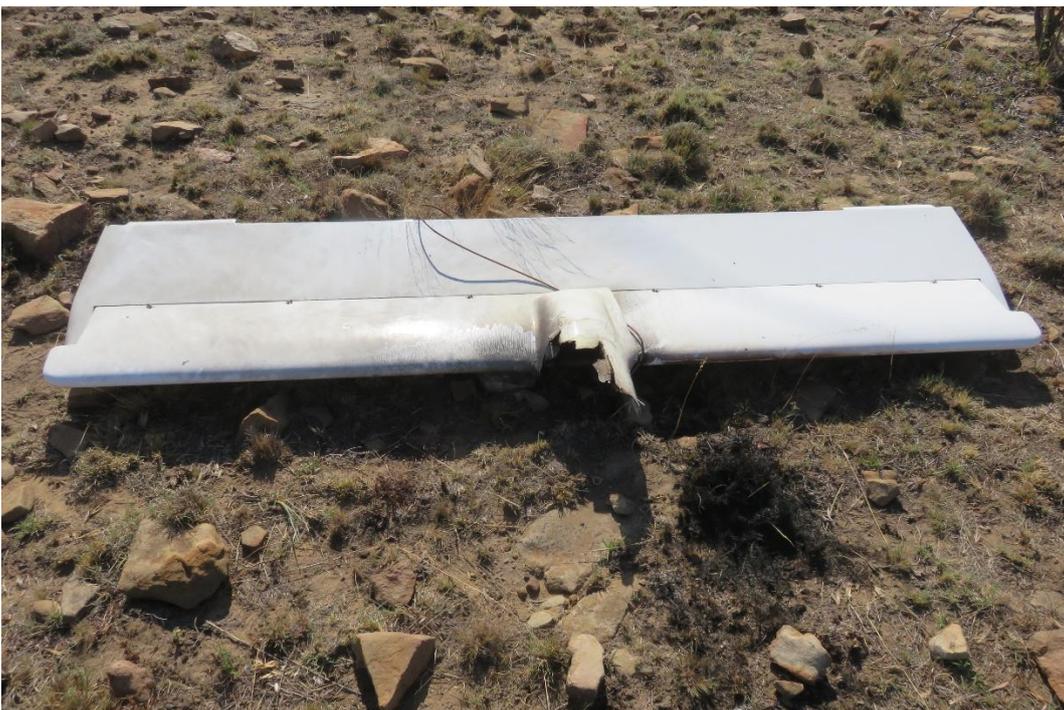
Figure 8: The horizontal plane with the vertical fin ripped off.

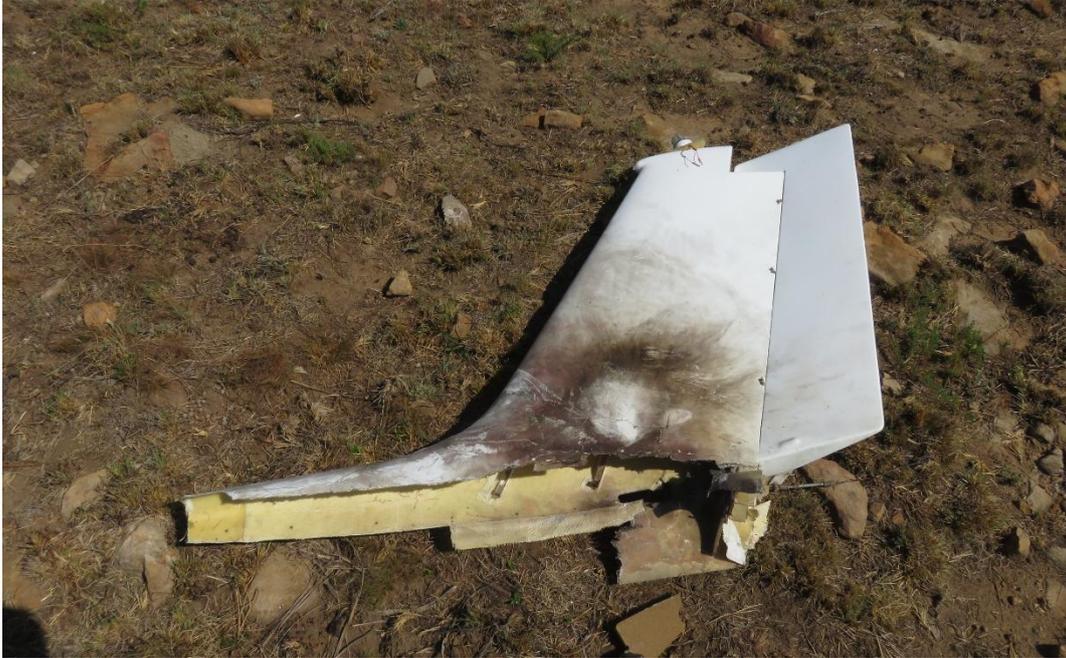
Figure 9: The vertical fin with the rudder still attached.

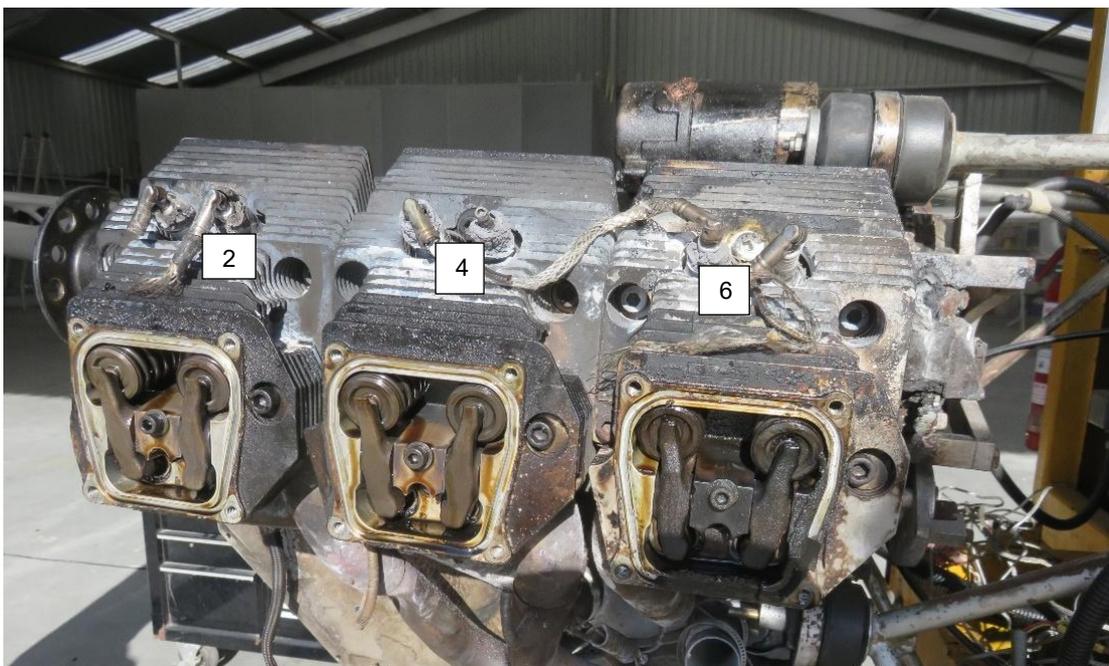
1.16.2 The engine was severely scorched due to the post-impact fire. During an external inspection, it was found that all three cylinders on the left side of the engine crankcase (Cylinders No. 2, 4, and 6) were loose. These engine cylinder assemblies consisted of two major parts, the cylinder barrel and the cylinder head. During a visual examination of the engine, it was also noted that the No.6 cylinder had a crack approximately 180° around its circumference and close to the crankcase on the barrel area (see Figure 11). The engine still contained a substantial amount of oil (see pistons in Figures 11 and 12); the sump still contained a small amount of oil. Apart from the observation mentioned above, no other mechanical defects were noted during the teardown procedure. All six-cylinder barrels were measured, and they met the specifications of the engine manual. The magnetos and all associated ignition wiring were destroyed in the post-impact fire. There was neither evidence of any modifications having been made to the engine, nor were there any unauthorised parts used.

Figure 10: A view of the left side of the engine with the numbers 2-, 4- and 6-cylinder tappet covers removed.

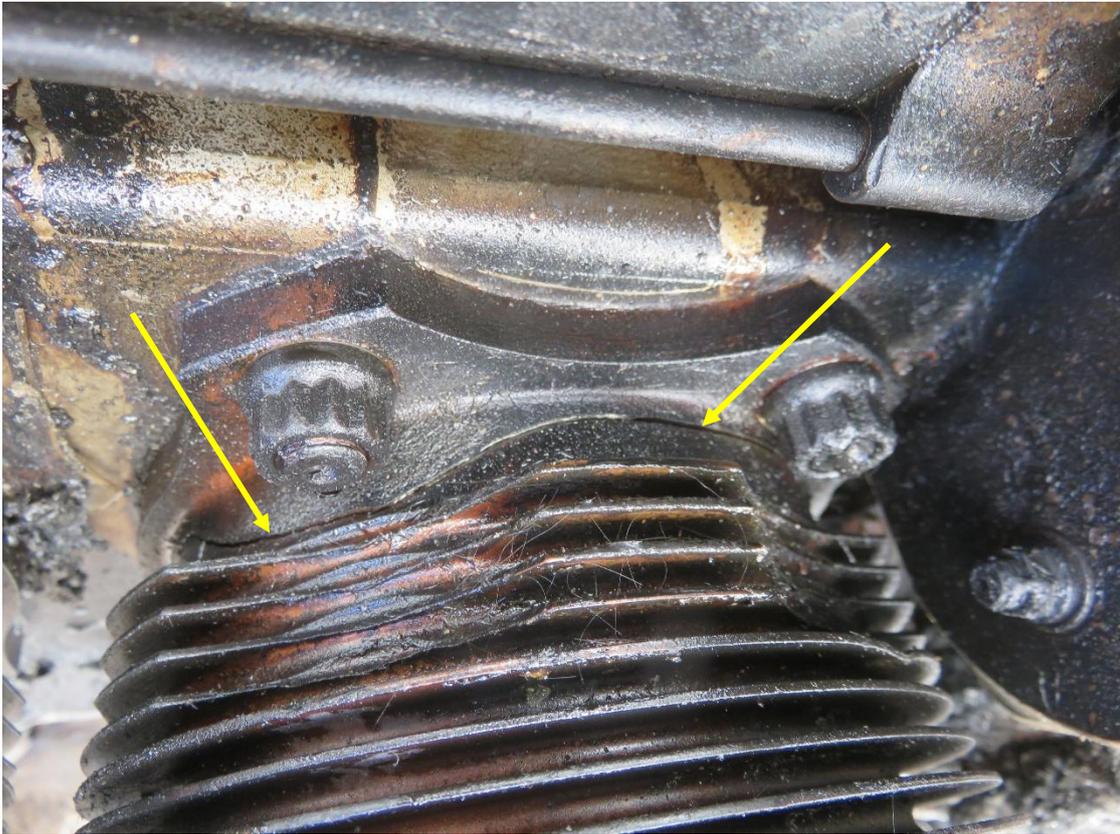
Figure 11: The cracked No.6 cylinder viewed from the top.

3.2.15 A fatigue crack had developed on the No.6 cylinder, and the two compression rings on the No.4 piston were found to have failed. No other mechanical defects were found on the engine.

3.3.1 The cause of the accident was total loss of propulsion power due to a fatigue crack on the No.6-cylinder barrel. The aircraft subsequently impacted the high-tension powerlines during a forced landing on a moonless night.

4.2.1 It is recommended that the Director of Civil Aviation issue a mandatory advisory notice (MAN) which calls for immediate inspection for any possible cracks on the cylinder barrels (as found in this accident) on all Jabiru 3300A engines. These cracks might not be limited to the 3300A series engines, but also on 2200A series engines.

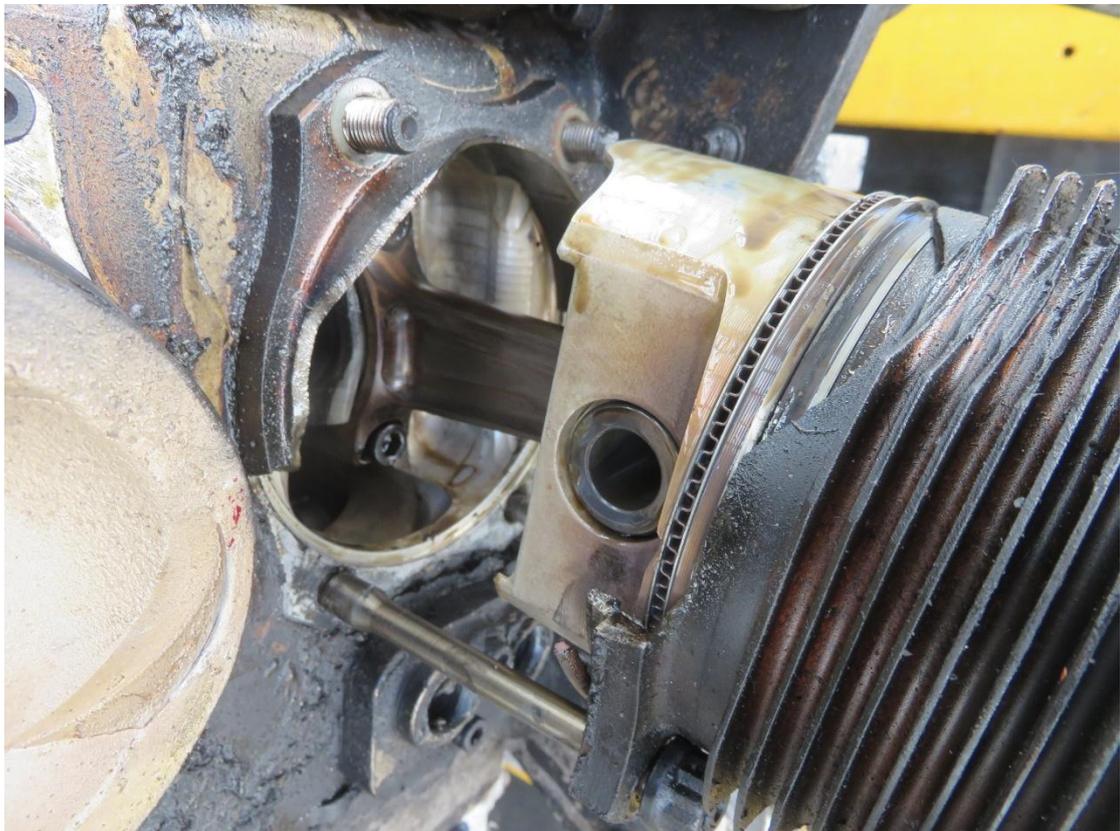
Figure 12: During the removal of the No.6 cylinder, a section separated on the cracked surface.

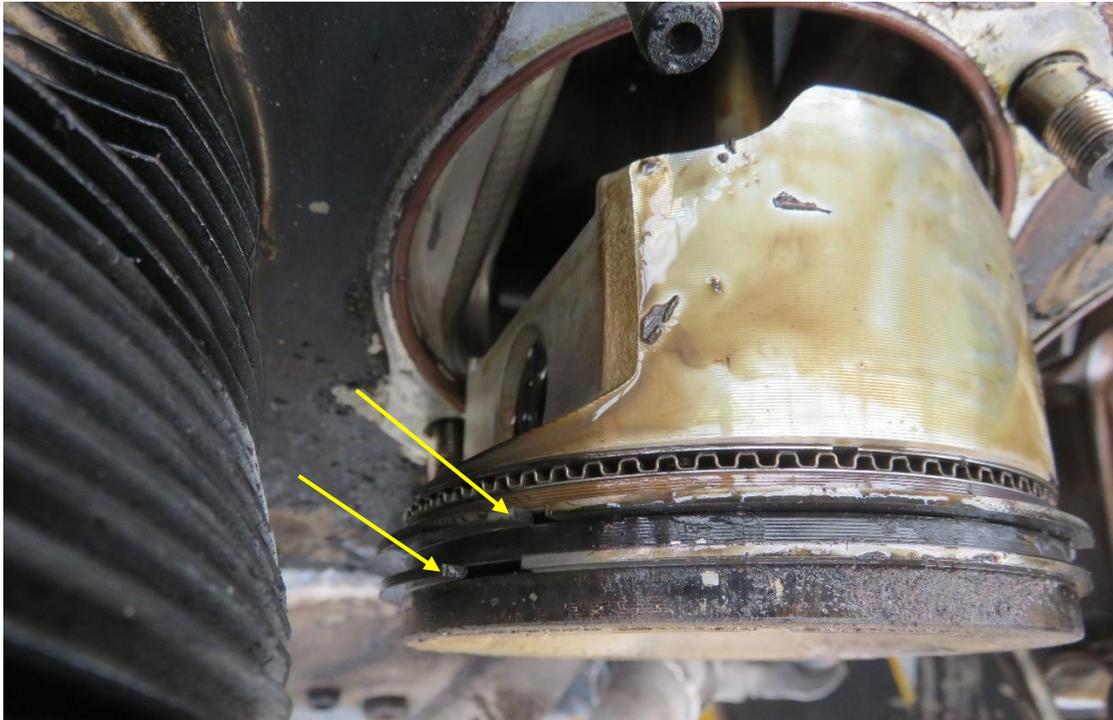
Figure 13: Both the compression rings on the No.4 piston were broken.

In aircraft, piston rings play a vital role in the proper functioning of an engine, sealing the combustion chamber and ensuring that power is efficiently transferred from the fuel-air mixture that is ignited to the crankshaft. However, despite their importance, piston rings can fail due to a variety of factors, leading to decreased engine performance. Piston ring failure could be attributed to a lack of lubrication, overheating, wear and tear, poor installation, dirt and debris, and improper maintenance. In this accident, it could not be determined when the two compression rings on piston No.4 failed. There was no documented evidence in the flight folio of any defects before the flight; moreover, the crew did not communicate via WhatsApp that they had encountered a decrease in engine power at any stage of the flight.

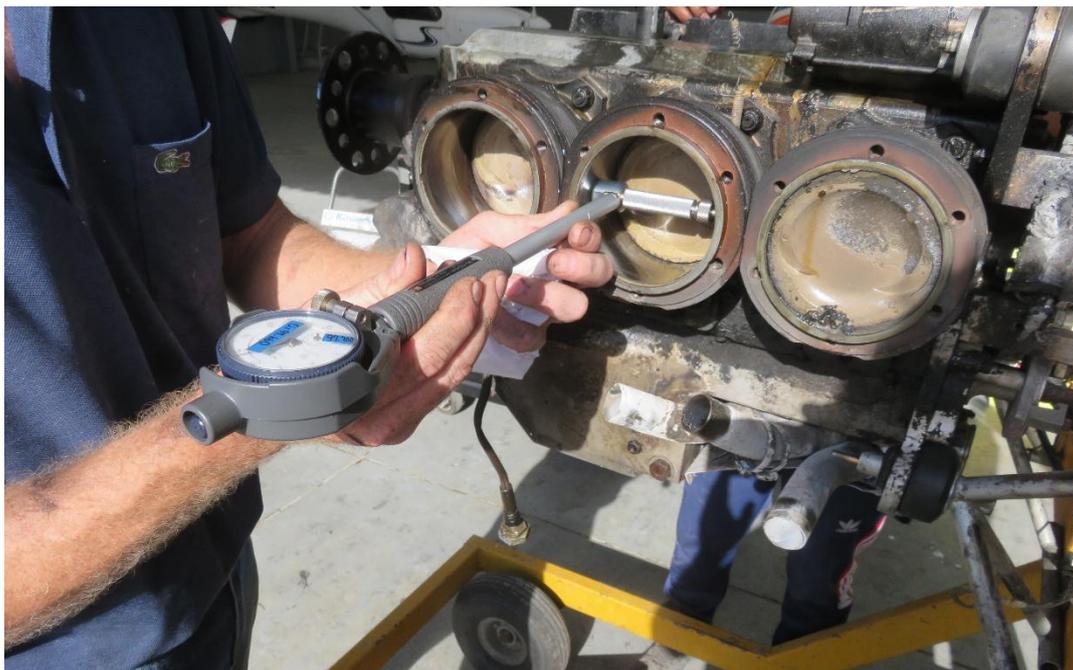
Figure 14: All six-cylinder barrels were measured and were found to be within limits.

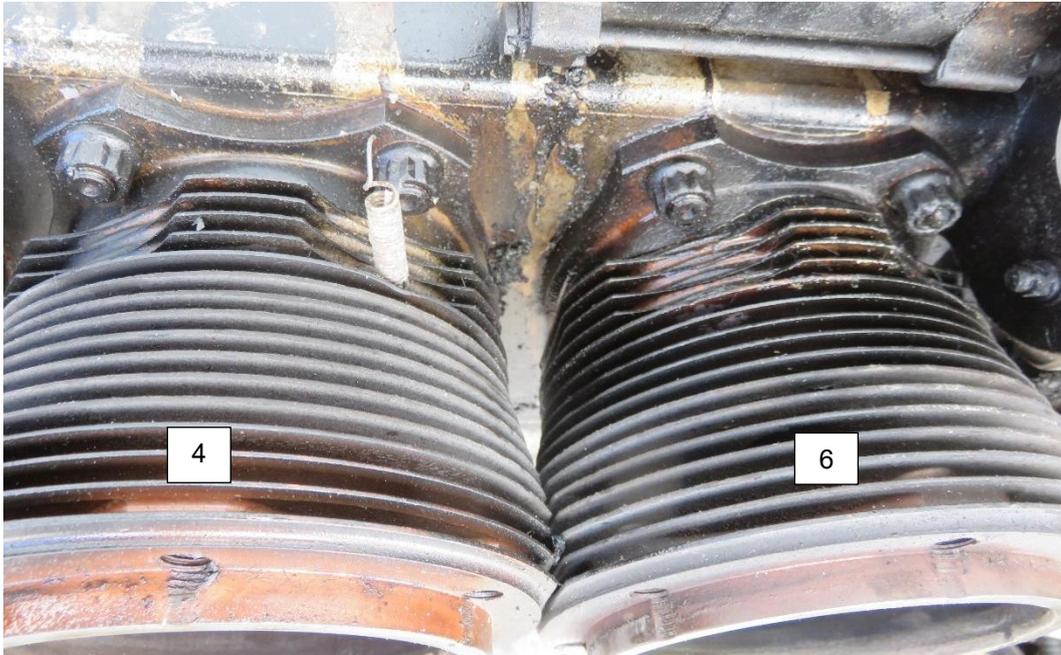
Figure 15: The No.4 and No.6 cylinders. A substantial discolouration is visible on the No.6 cylinder in the area of the crack and cooling fins.

Pilots do not open the engine cowlings during their pre-flight inspections and would not have been able to notice any discolouration on or in the area of the No.6 cylinder where the crack had initiated. Engine cowlings are removed during scheduled maintenance inspections or if an engine defect is being attended to, post a scheduled maintenance inspection. It could, therefore, be possible that the crack on cylinder No.6 had developed over time, but because the cowling was not removed since the last maintenance inspection, the crack, which had initiated due to fatigue, propagated over an undetermined period to the point where the engine failed, evidenced during the engine teardown inspection. The fatigue crack on the cylinder probably progressed slowly over time. It could, however, have propagated during this flight to an extent that it initiated the engine abnormality, referred to by the pilot in his WhatsApp message to the flight instructor on the ground. The information supplied by the crew could, therefore, be regarded as vague to make a detailed analysis of the reported abnormality, which had elevated from a hazard to a risk and the subsequent failure.

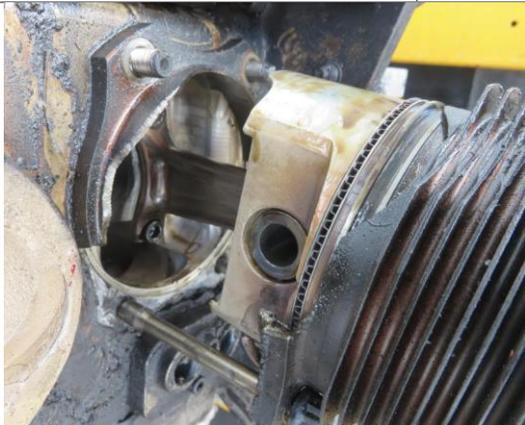
The aircraft was fitted with a 3300A engine. Cylinders are machined in one piece from solid bar 4140 chrome molybdenum alloy steel, with the pistons running directly in the steel bores. During the OEM teardown, it was noted that the No. 6 cylinder fractured and separated from the crankcase (Photo 3).

Photo 3: Fractured No. 6 Cylinder, as found²

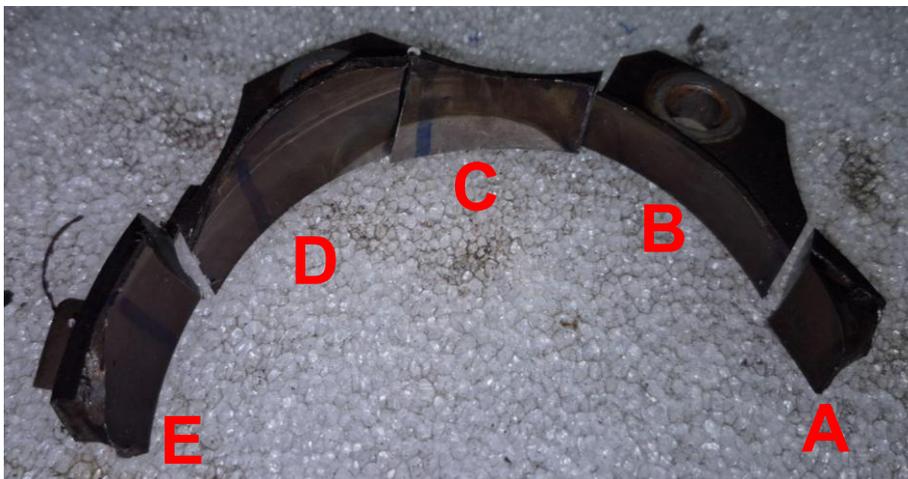
Photo 5: Sectioned fracture surface (digital)

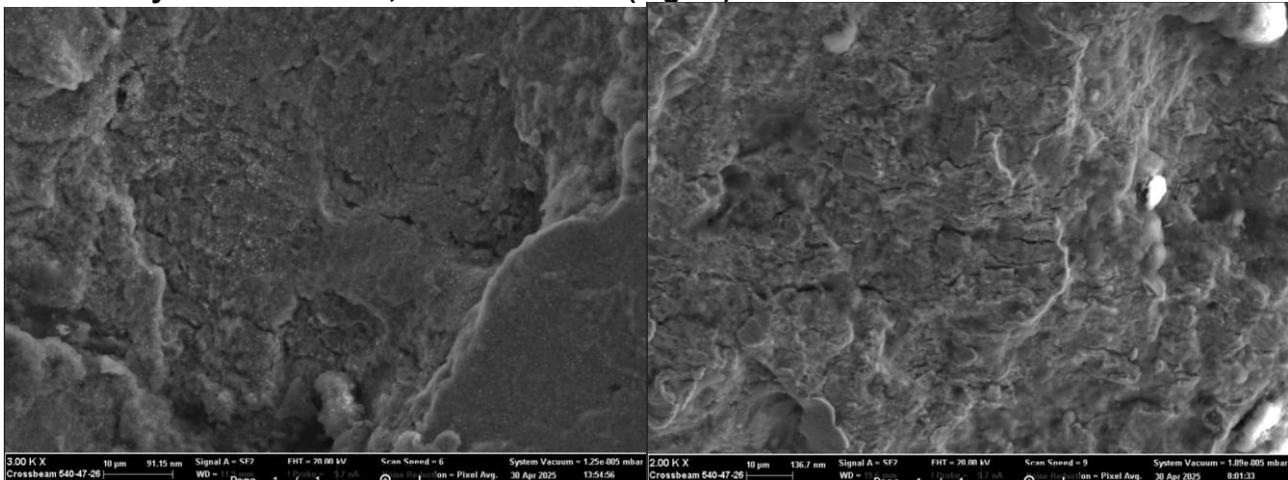
- (a) *The high-magnification inspection confirmed **fatigue** as the primary fracture mode during the initial stages of the failure.*

Fractograph 1: Fatigue striations, area A (2000-3000X, 20kV, SE, FEGSEM)

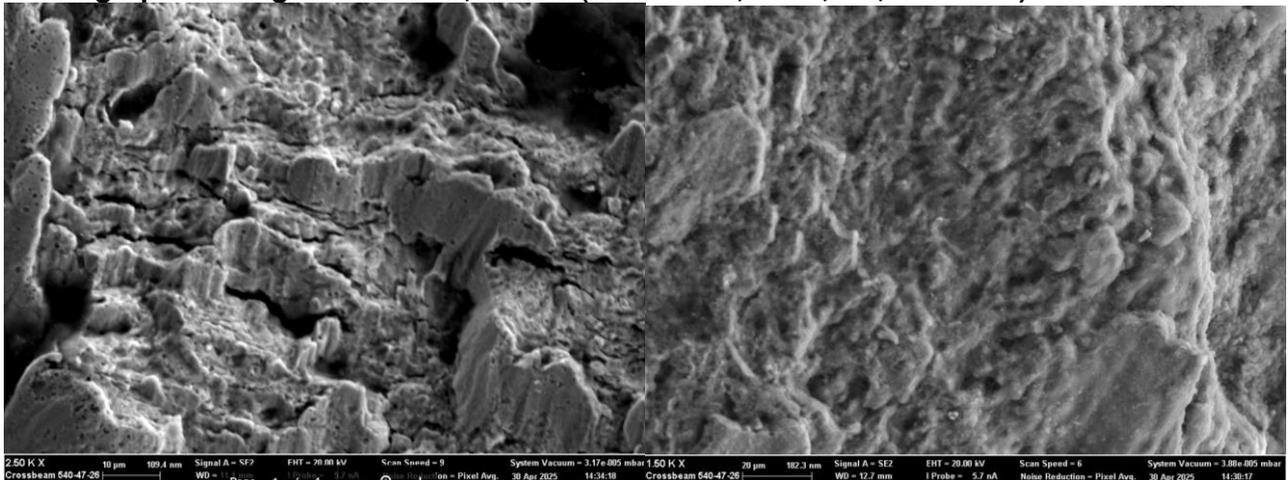
Fractograph 2: Fatigue striations, area D (1500-2500X, 20kV, SE, FEGSEM)

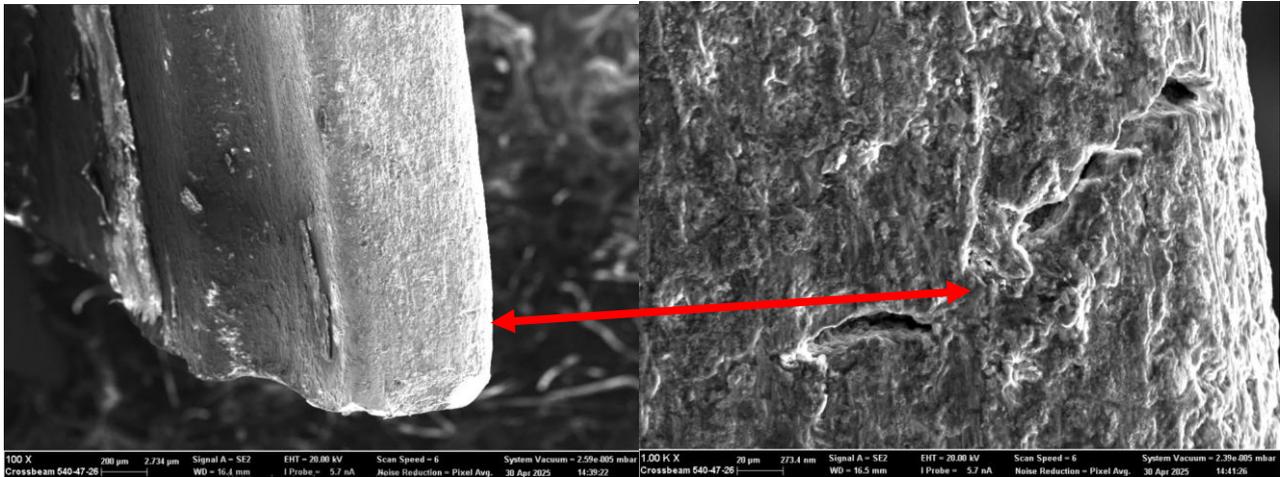
- (b) *Secondary fracture initiations close to the fatigue fracture initiation zones, suggesting exceedingly high tensile loads during operation. No clear surface stress raisers (nick marks, corrosion pitting, etc.) were noted.*

Fractograph 3: Secondary fracture initiations (100-1000X, 20kV, SE, FEGSEM)

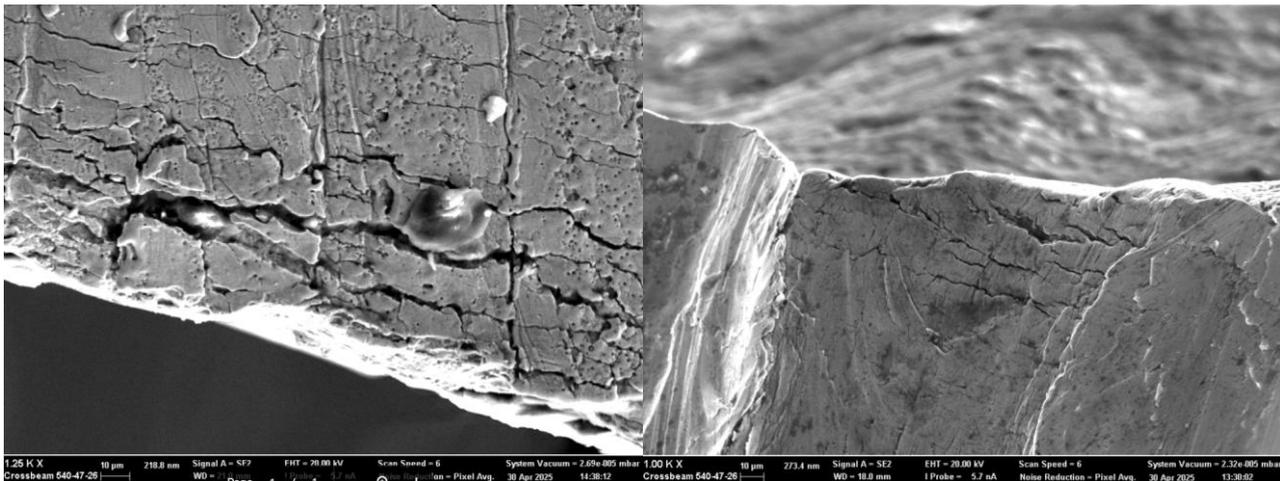
Fractograph 4: Secondary fracture initiations (1000-1250X, 20kV, SE, FEGSEM)

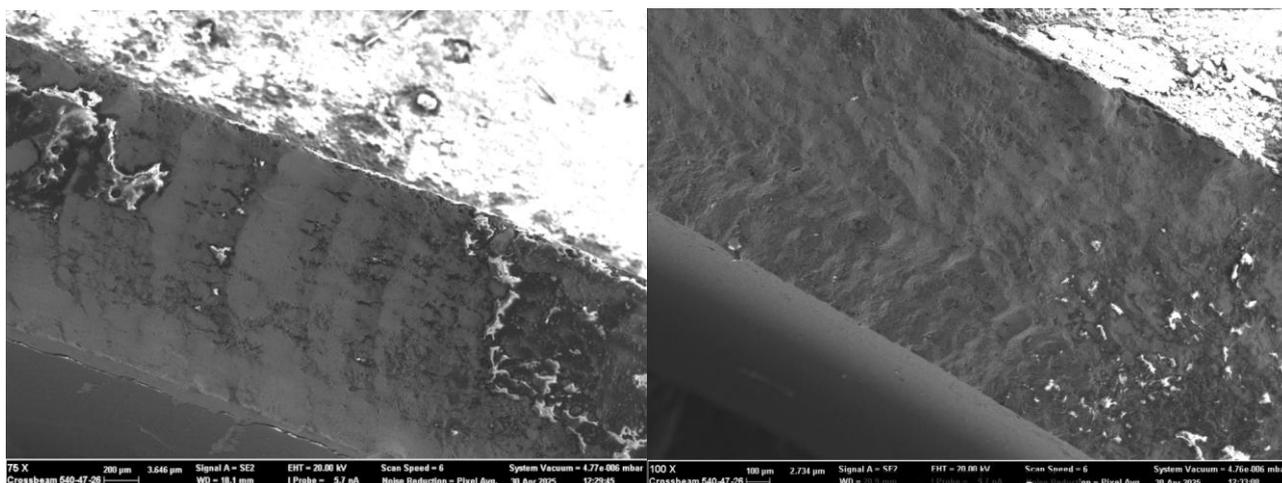
Fractograph 5: Fracture surface damages (76-100X, 20kV, SE, FEGSEM)
