LIMITED OCCURRENCE INVESTIGATION REPORT – FINAL

Reference Number	CA18/2/3/10523						
Classification	Accident	Date	24 October 2024		Time	1400Z	
Type of Operation	Private (Part 91)						
Location							
Place of Departure	Secunda Aerodrome (FASC), Mpumalanga Province			Place of Intended Landing	Secunda Aerodrome (FASC), Mpumalanga Province		
Place of Occurrence	Left of Runway 29 at Secunda Aerodrome (FASC)						
GPS Co-ordinates	Latitude	26°31'27.11" S	Longitude	029°09'59.72" E	Elevation	5 248 feet	
Aircraft Information							
Registration	ZS-III						
Make; Model; S/N	Cessna Aircraft Company; 310Q (Serial Number: 310Q-0255)						
Damage to Aircraft	Substantial			Total Aircraft Hours	2 912.2		
Pilot-in-command							
Licence Type	Commercial Pilot Licence (CPL)		Gender	Male		Age	45
Licence Valid	Yes	Total Hours	1 449.0		Total Hours on Type	45.0	
Total Hours Past 30 Days	34.4		Total Hours on Type Past 90 Days			8.8	
People On-board	1 + 3	Injuries	0	Fatalities	0	Other (on ground)	0

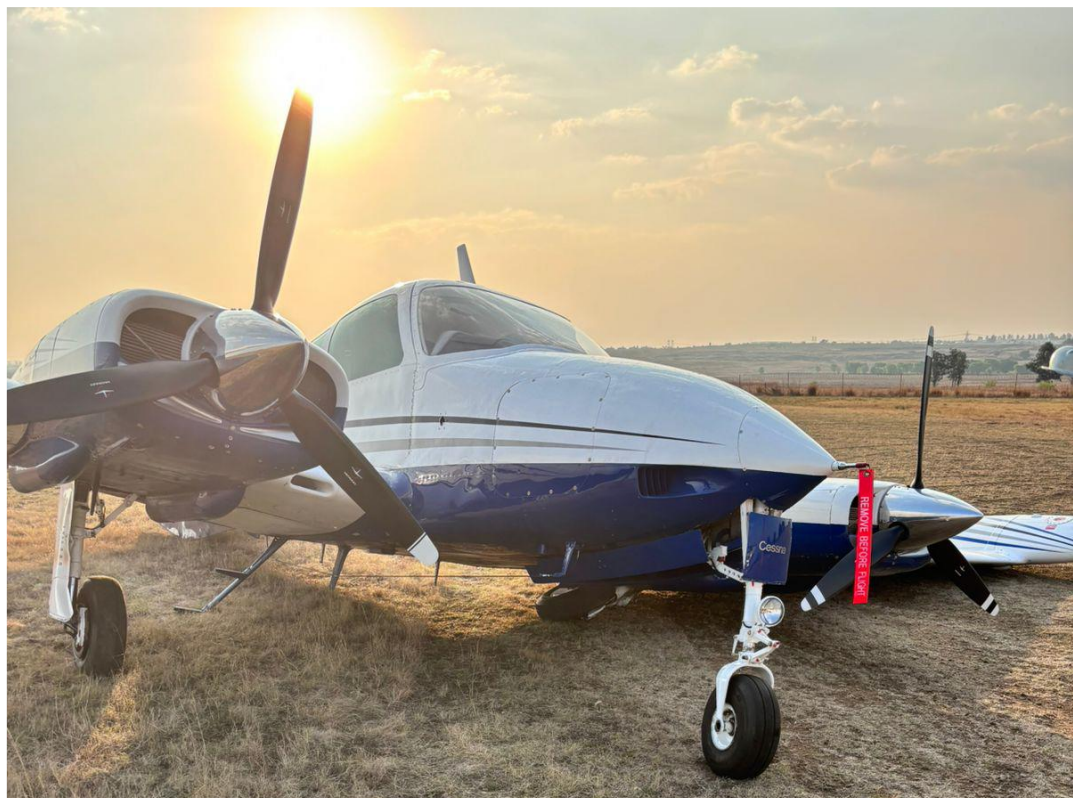
What Happened							
<p>On Thursday afternoon, 24 October 2024, a pilot and three passengers on-board a Cessna 310 with registration ZS-III took off on a private flight from Secunda Aerodrome (FASC) with the intention to land back at the same aerodrome. The flight was conducted under visual meteorological conditions (VMC) by day and under the provisions of Part 91 of the Civil Aviation Regulations (CAR) 2011 as amended.</p> <p>The pilot stated that they were airborne for approximately 30 minutes. Upon their return to FASC, they opted to perform a touch-and-go landing on Runway 29. He stated that after the touch-and-go landing, he could not retract the landing gear but confirmed the three green gear position lights. <i>(The three green lights are a cockpit indication to the pilot that the landing gear is down and locked, see Figure 7.)</i> The pilot then decided to perform a full-stop landing. After touch down, he felt the aircraft jerk heavily to the left, followed by noise associated with something breaking. The pilot then shut down both engines; he was able to maintain runway heading with the right rudder and the right brake. However, as the aircraft slowed down, it veered to the left and came to a halt. The left main gear collapsed and, as a result, the left wing rested on the grass next to the runway. After examination, it was noted that the left main landing gear torque link centre hinge had separated, and the landing gear assembly had rotated 180°. The nose and right main landing gears had remained extended.</p>

Figure 2: The aircraft as it came to rest on the side of the runway. (Source: Pilot)

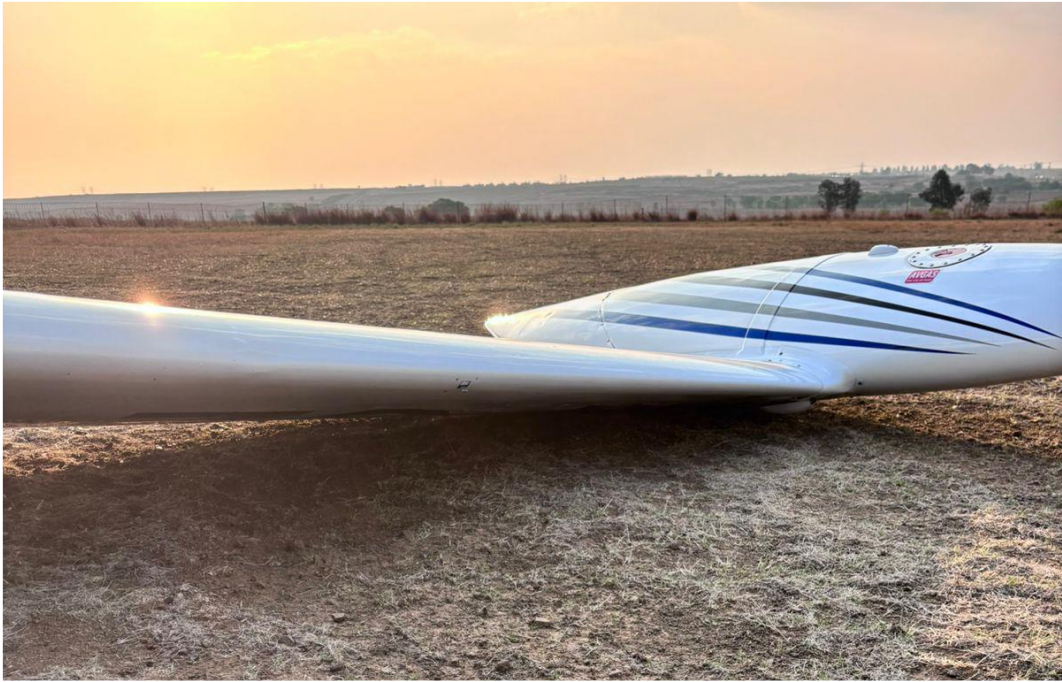
Figure 3: The left wing rested on the grass post-accident. (Source: Pilot)

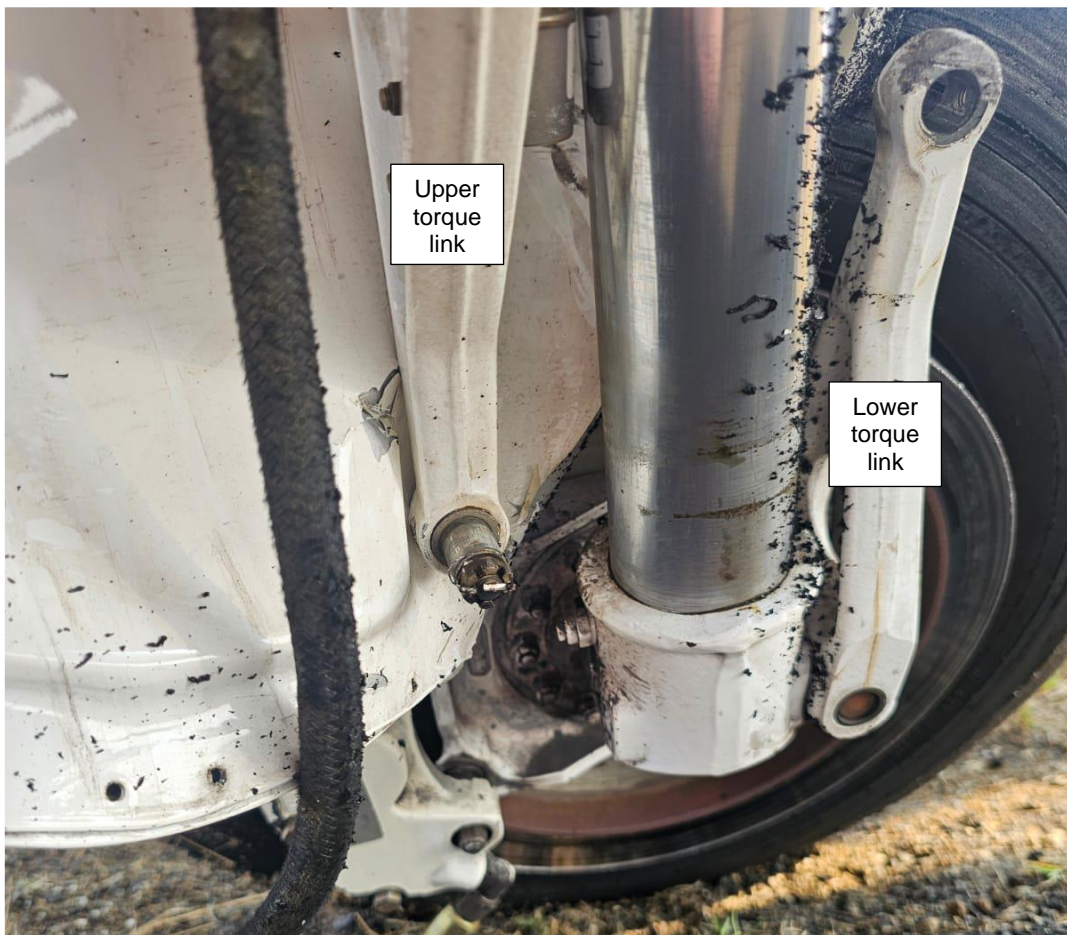
Further inspection of the left main landing gear torque link (Part No. 5041114) by the aircraft maintenance organisation (AMO) personnel at Secunda who had assisted in the recovery of the aircraft as it was obstructing the runway, revealed that the centre hinge point attachment bolt, spacer, washers, nut and split pin were still secured to the upper torque link (see Figure 3). The lower torque link had dislodged at the attachment point (as it pulled through) which caused the wheel assembly to rotate 180°.

Figure 4: The upper and lower torque links dislodged from each other. (Source: AMO)

Probable Cause
The left main landing gear collapsed when the upper and lower torque links disconnected from each other due to excessive wear on the two retaining washers; the lower strut including the wheel assembly rotated 180°. This resulted in substantial drag on the trunnion support which failed due to overload, as well as the gear collapse.
Contributing Factors
The possibility that the nut, spacer, washers, bolt and split pin were not replaced during the repair of the aircraft after the left main gear collapse on 2 April 2023.
Safety Action(s)
None.
Safety Recommendation and Safety Message
<ol style="list-style-type: none"> 1. It is recommended that the Director of Civil Aviation issue an Advisory Notice which calls for the re-inspection of all Cessna 300 and 400 series aircraft in accordance with the Cessna Service Bulletin MEB02-12 that was issued on 4 November 2002. This should be a re-occurring inspection to prevent similar failures. 2. Pilots flying the Cessna 300 and 400 series aircraft should be cognitive of this possible failure and should conduct a proper pre-flight inspection on these bolts and associated hardware to prevent similar failures.

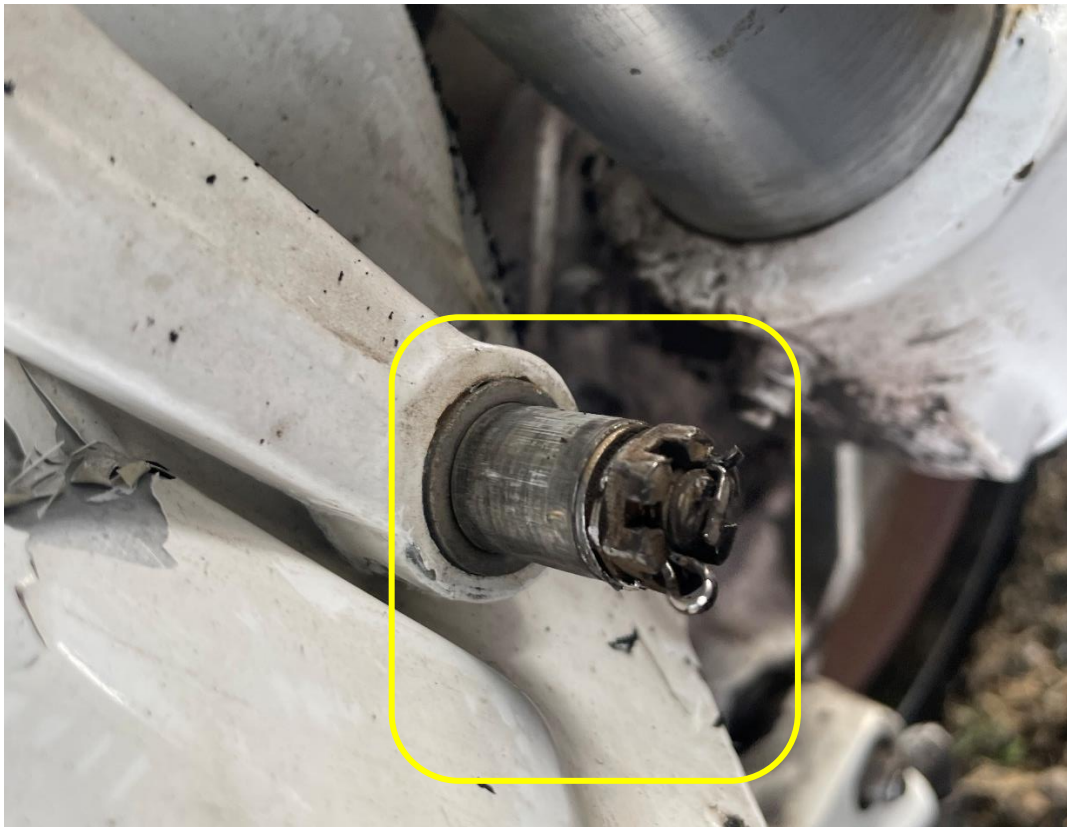
Figure 5: The torque links connecting bolt with the two washers and nut still secured. (Source: AMO)

This picture was obtained from the AMO at Secunda Aerodrome. From the picture, it could be seen that the bolt, the spacer, the two washers, the nut, and the split pin are still in place.

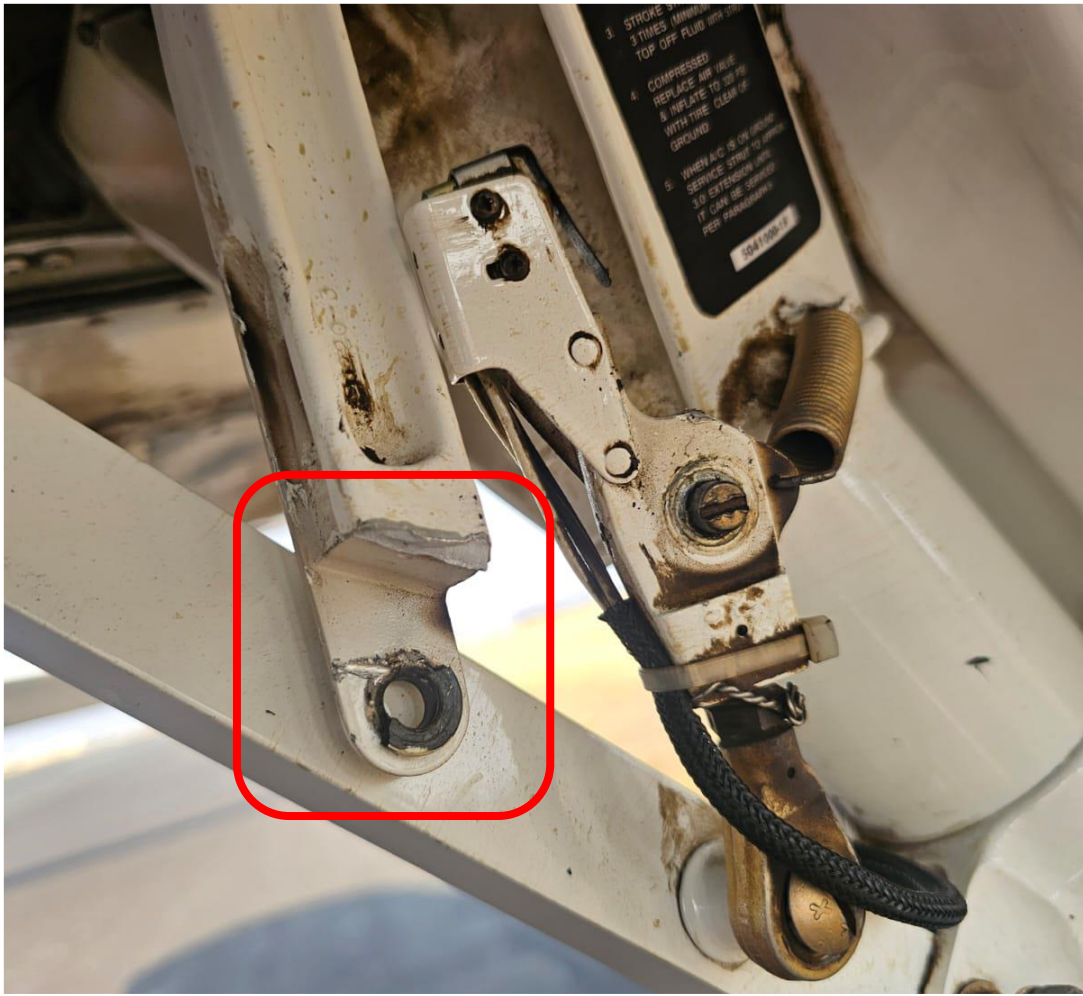
Figure 6: The broken lug on the bell crank assembly. (Source: AMO)

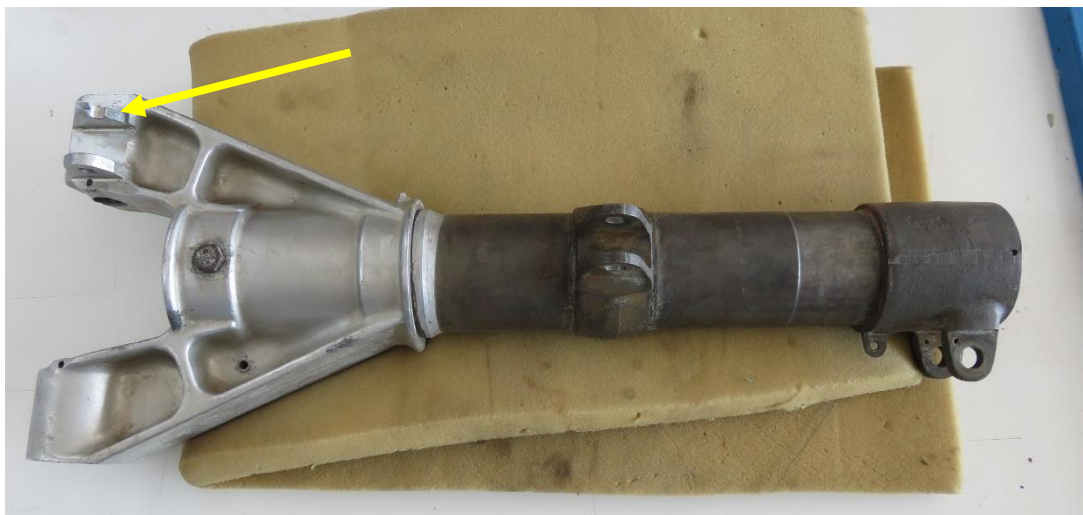
Figure 7: The yellow arrow indicates the left main gear trunnion with the broken lug.

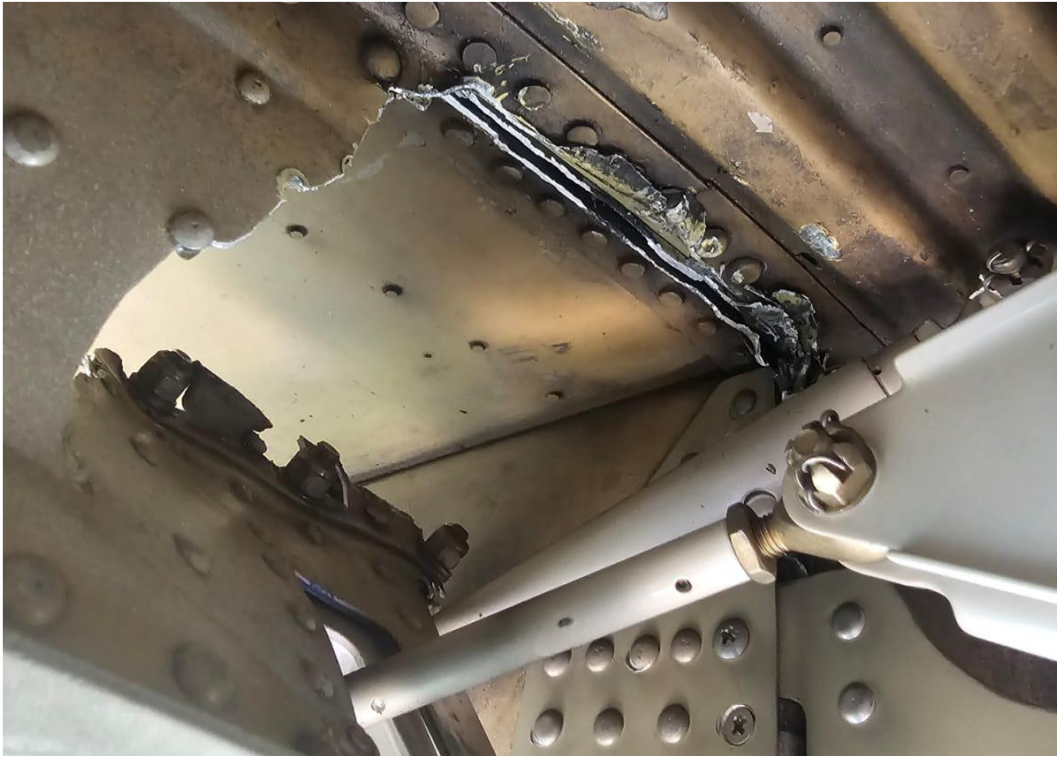
Figure 8: Some structural damage to the left wing. (Source: AMO)

- 2.5 The outer lower surface of the left wing sustained sheet metal damage; also, the inner area of the wheel well required structural repairs.
- 2.6 The Cessna 300 and 400 series aircraft have the same main landing gear design; hence, the Federal Aviation Administration (FAA) had issued Special Airworthiness Information Bulletin (SAIB) CE-14-19 on 30 May 2014 with special emphasis to inspect the main landing gear torque link assembly to ensure that the correct thickness washers are installed in the correct position.

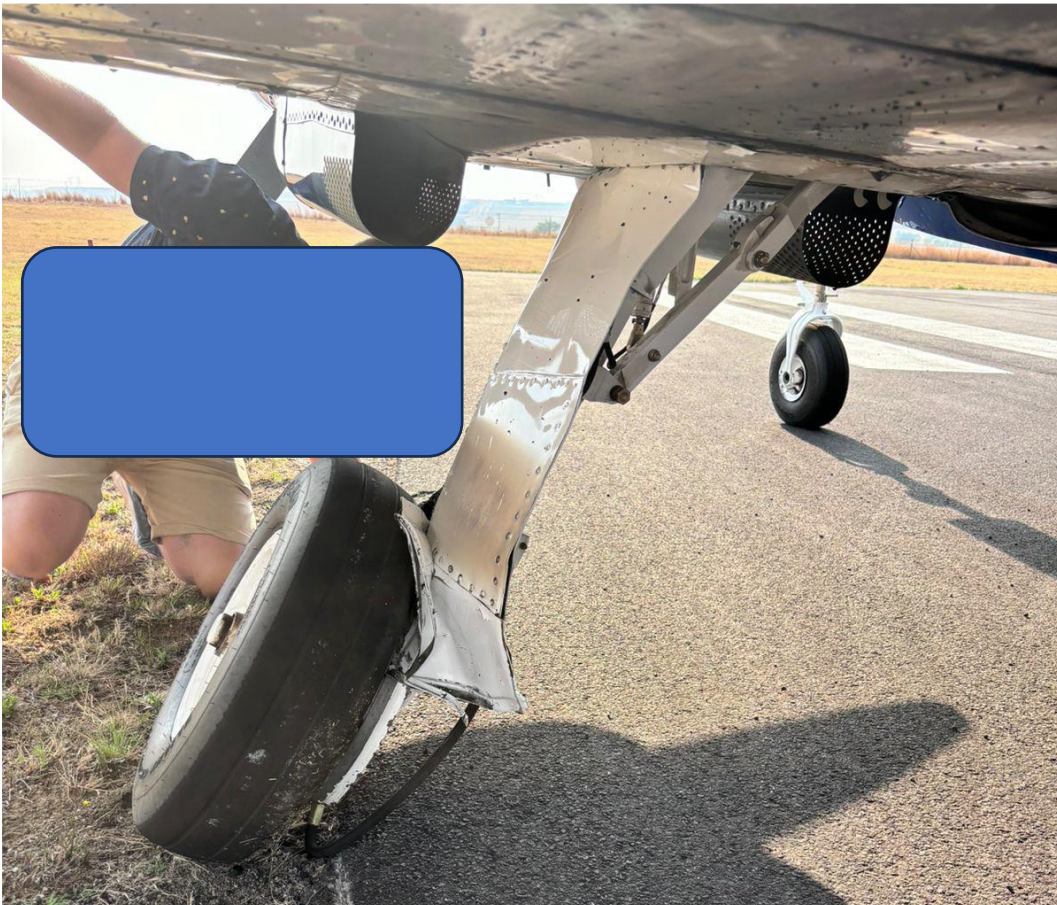
Figure 9: The left main wheel assembly rotated 180°. (Source: AMO)
