## LIMITED OCCURRENCE INVESTIGATION REPORT – FINAL

| <b>Reference Number</b> | CA18/2/3/10524 | | | | | | |
| <b>Registration</b> | ZU-EOE | | | | | | |
| <b>Make; Model; S/N</b> | Jabiru; J430 (S/N: 421) | | | | | | |

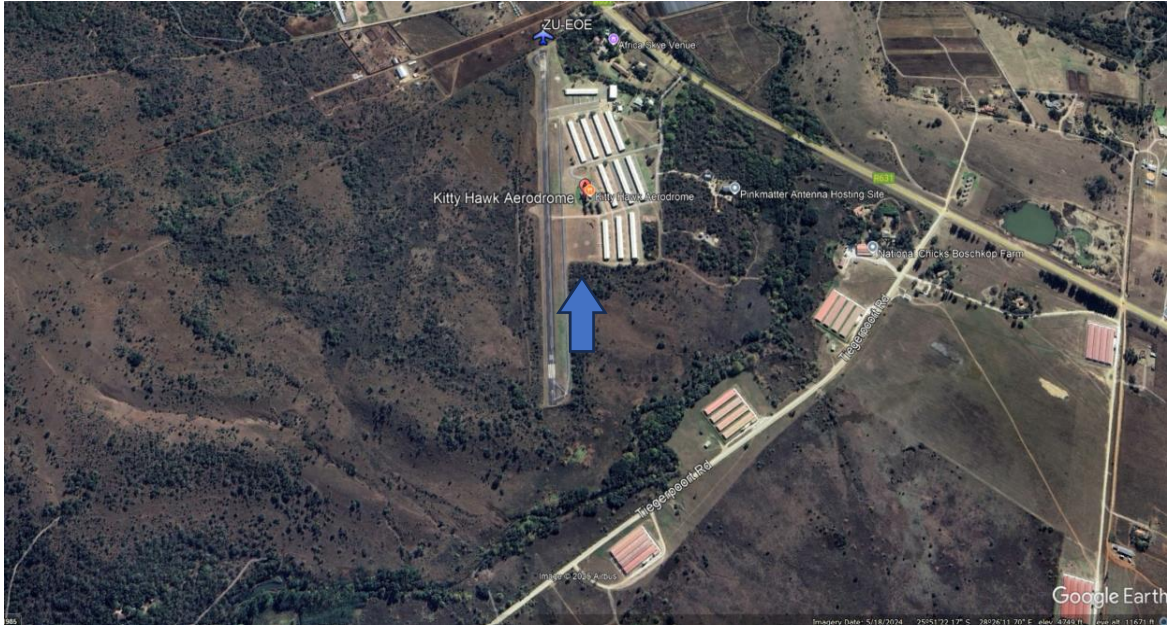
**Figure 1:** The arrow indicates the direction and approximate landing point at FAKT. (Source: Google Earth)

The pilot stated that he landed more than a third of the way down the runway, which reduced the available distance to bring the aircraft to a safe stop. There are powerlines about 2000m south of RWY 01 at approximately 700 feet (ft) elevation, which meant that an early touchdown would have potentially resulted in a collision with the powerlines on final approach.

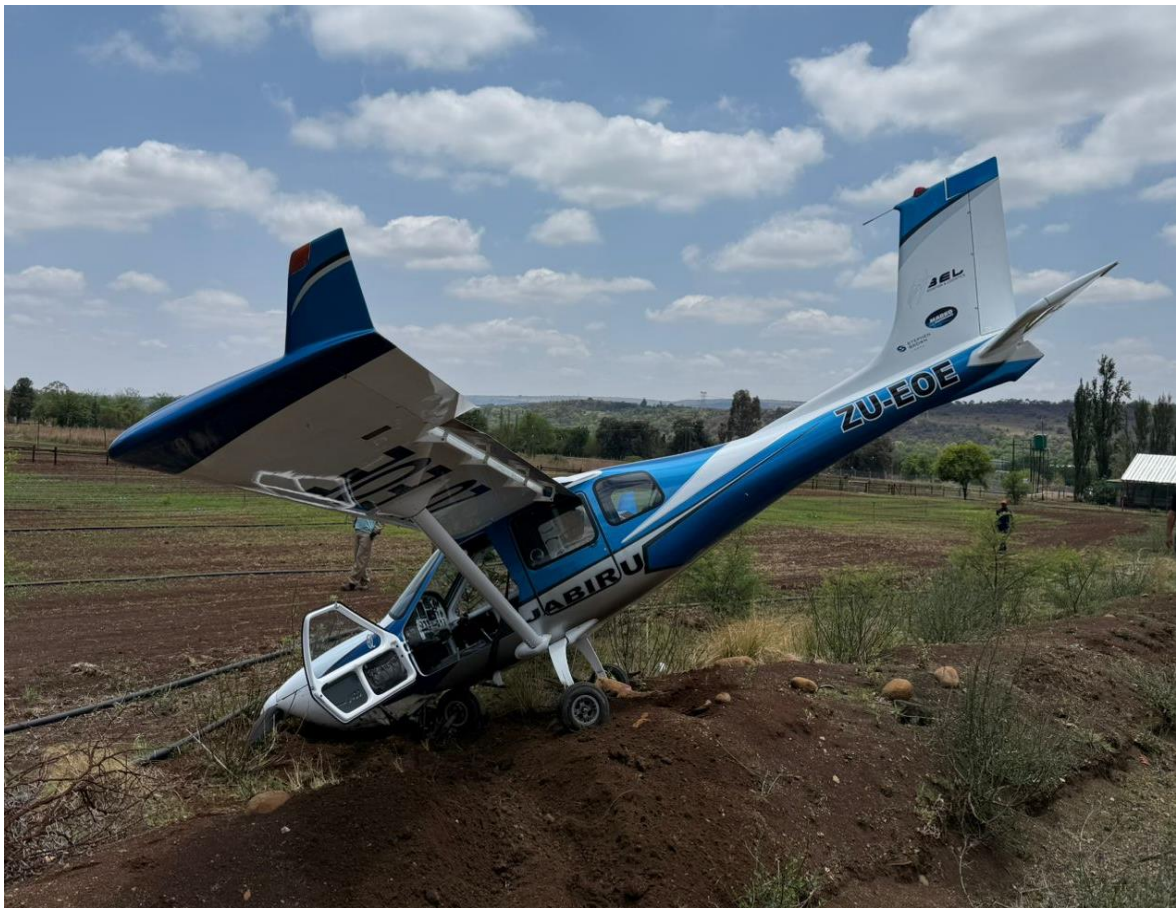
tarred surface. The two occupants were not injured. During the accident sequence, the aircraft sustained substantial structural damage to the nose, left main gear and propeller.

**Figure 2:** The aircraft as it came to rest. (Source: Pilot)

2.5 The aircraft landed deep on RWY 01, leaving an insufficient runway for effective braking. As a result, the aircraft overran the runway and came to a stop in a ditch beyond RWY 01.

The aircraft landed deep to avoid powerlines and failed to stop, thus, overran the runway and rolled into a ditch.
