LIMITED OCCURRENCE INVESTIGATION REPORT – FINAL

Reference Number	CA18/2/3/10525						
Classification	Accident	Date	21 November 2024	Time	0842Z		
Type of Operation	Private (Part 91)						
Location							
Place of Departure	Grand Central Aerodrome (FAGC), Gauteng Province		Place of Intended Landing	Grand Central Aerodrome (FAGC), Gauteng Province			
Place of Occurrence	At a nursery in Glen Austin residential area, north-east of Grand Central Aerodrome (FAGC) Runway 35						
GPS Co-ordinates	Latitude	25°58'.42" S	Longitude	028°08'.09" E	Elevation	5 300 feet	
Aircraft Information							
Registration	ZS-FXX						
Make; Model; S/N	Cessna Aircraft Company; C172K Skyhawk (Serial Number: 172-58556)						
Damage to Aircraft	Substantial		Total Aircraft Hours	18 845			
Pilot-in-command							
Licence Type	Private Pilot Licence (PPL)		Gender	Male		Age	28
Licence Valid	Yes	Total Hours	95.1		Total Hours on Type	95.1	
Total Hours 30 Days	3.8		Total Hours on Type Past 90 Days		3.8

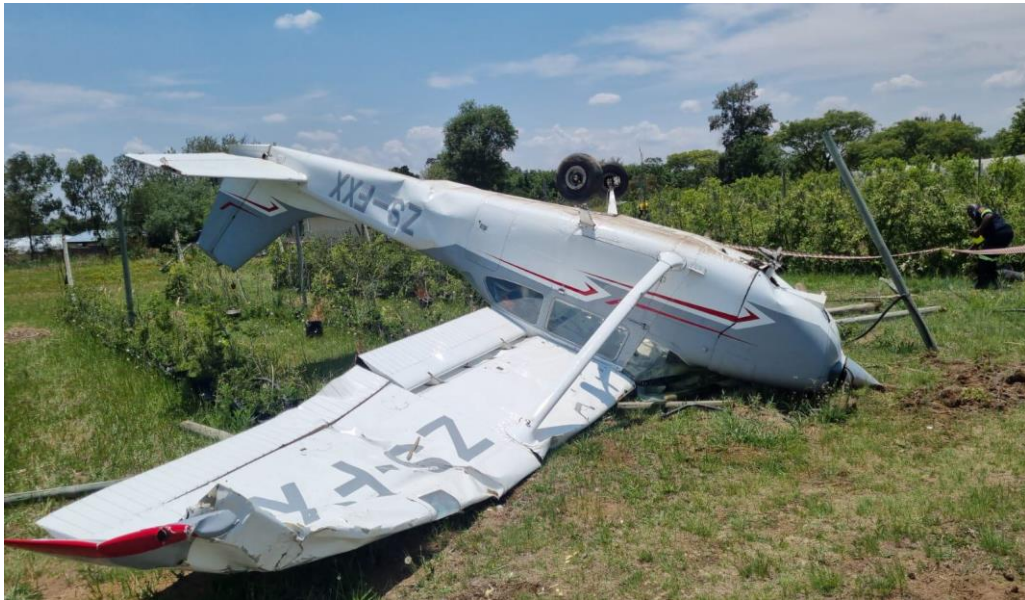
Figure 2: The aircraft at the accident site.

The aircraft touched down deep on Runway 35 and, during the landing roll, the pilot realised that the available runway was not adequate to bring the aircraft to a stop and the pilot executed a go-around. Consequently, the aircraft stalled due to insufficient air speed and crashed at a nursery situated in Glen Austin residential area, north-east of Runway 35.

In the interest of safety and to avoid injury and damage to property, pilots should be vigilant during the critical phases of flight such as take-offs and landings; this accident could have been avoided if the pilot executed a go-around early after noticing that the aircraft's height and speed were high.

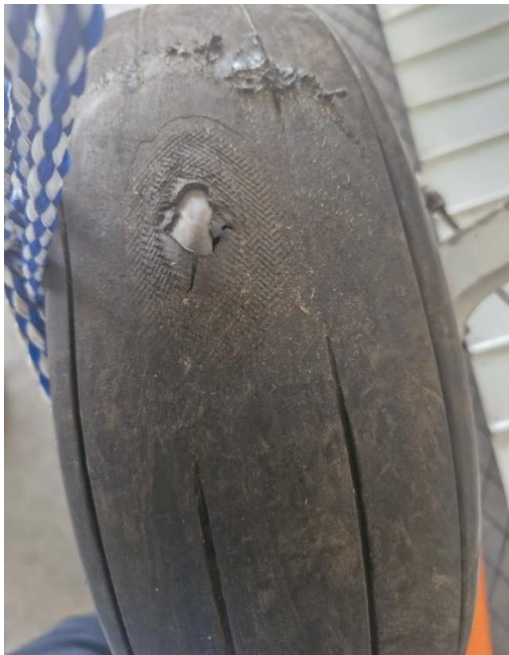
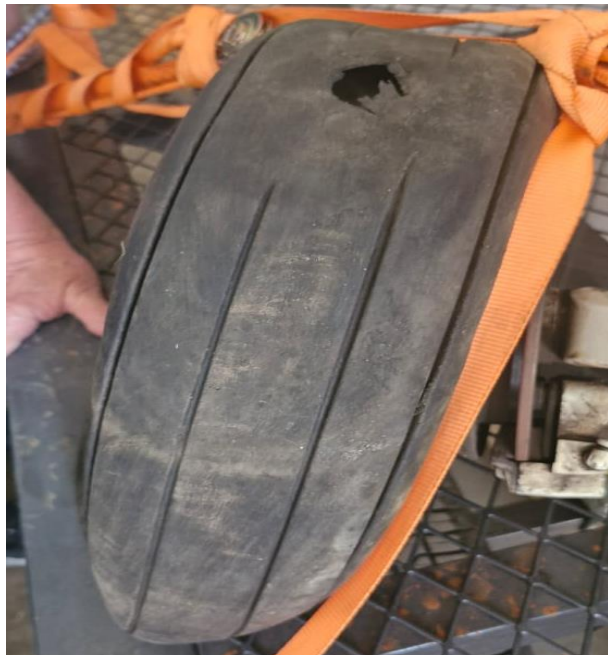
Figures 3 and 4: Damage on the aircraft's left and right main wheel tyres due to excessive braking.
