AIRCRAFT ACCIDENT REPORT AND EXECUTIVE SUMMARY

Reference:		CA18/2/3/10526		
Aircraft Registration		ZS-RWG	Date of Accident		21 November 2024	Time of Accident		0923Z
Type of Aircraft		Eurocopter AS350B3		Type of Operation		Surveillance (Part 127)		
Pilot-in-command Licence Type		Airline Transport Pilot Licence (ATPL)		Age	38	Licence Valid	Yes	
Pilot-in-command Flying Experience			Total Flying Hours		4 542	Hours on Type	1 506	
Last Point of Departure		Ultimate Heliport, Midrand, Gauteng Province						
Next Point of Intended Landing		Ultimate Heliport, Midrand, Gauteng Province						
Damage to Aircraft		Substantial						
Location of the accident site with reference to easily defined geographical points (GPS readings if possible)								
On a field of plot 399 JR in Brakfontein, near Midstream Estate, Centurion, Gauteng Province								
Meteorological Information		Wind direction: 350°; Wind speed: 5 kt; Temperature: 28°C; Dew Point: 10°C; Visibility: 9999; Cloud cover: FEW; Cloud Base: 2000 ft

Synopsis

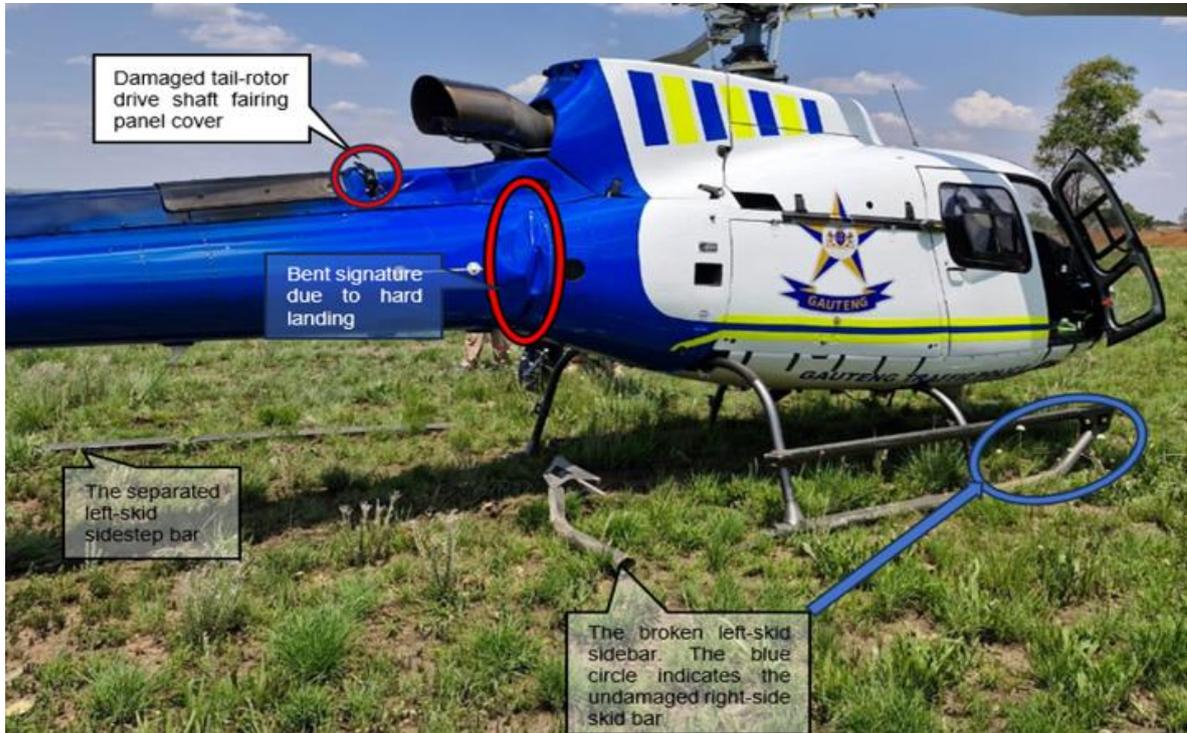
1.3.1. The helicopter’s left landing skid, tail boom and left side of the nose section were substantially damaged. Moreover, the rotating shaft decoupled during the accident sequence.

Figure 2: The helicopter post-accident.

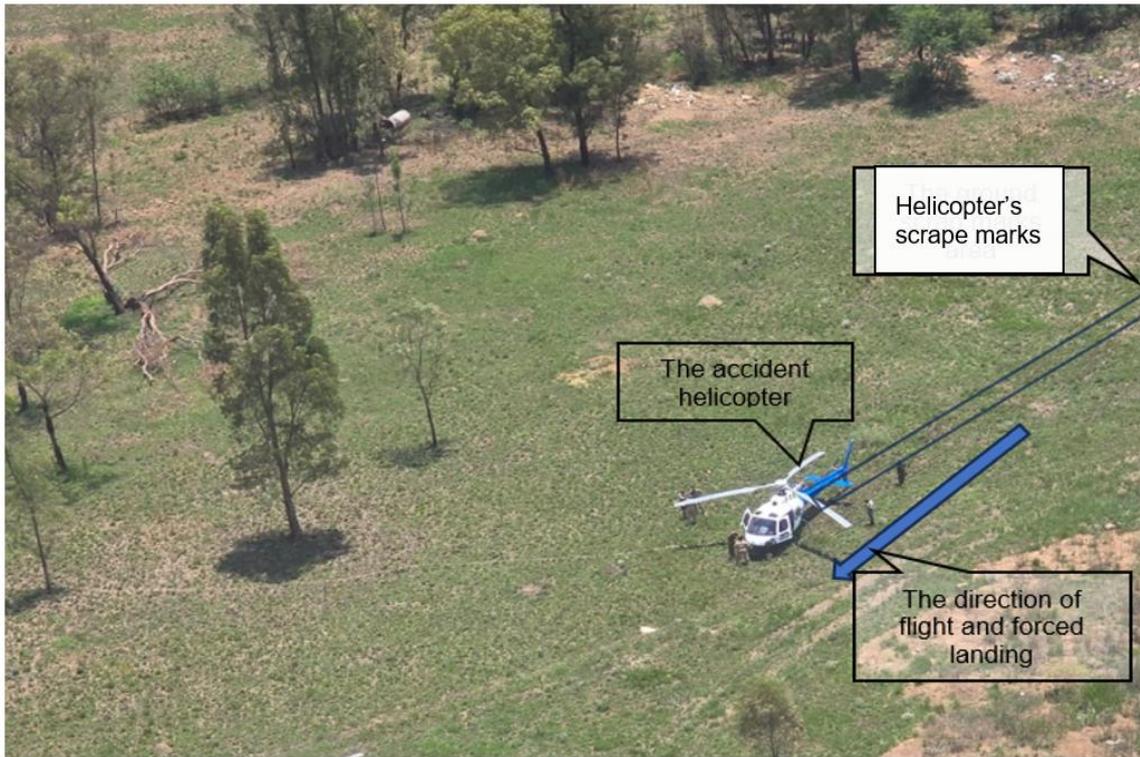
1.12.1. The accident occurred on a field within the borders of Plot 399 JR, Brakfontein. The accident site was also approximately 200m from the industrial and residential areas (see Figure 1). The site had potential obstacles, including tall trees to the north (direction of approach) and high-tension electrical power lines.

Figure 3: The accident site showing obstacles in the vicinity as well as scrape marks on the ground.
 (Source: Operator)

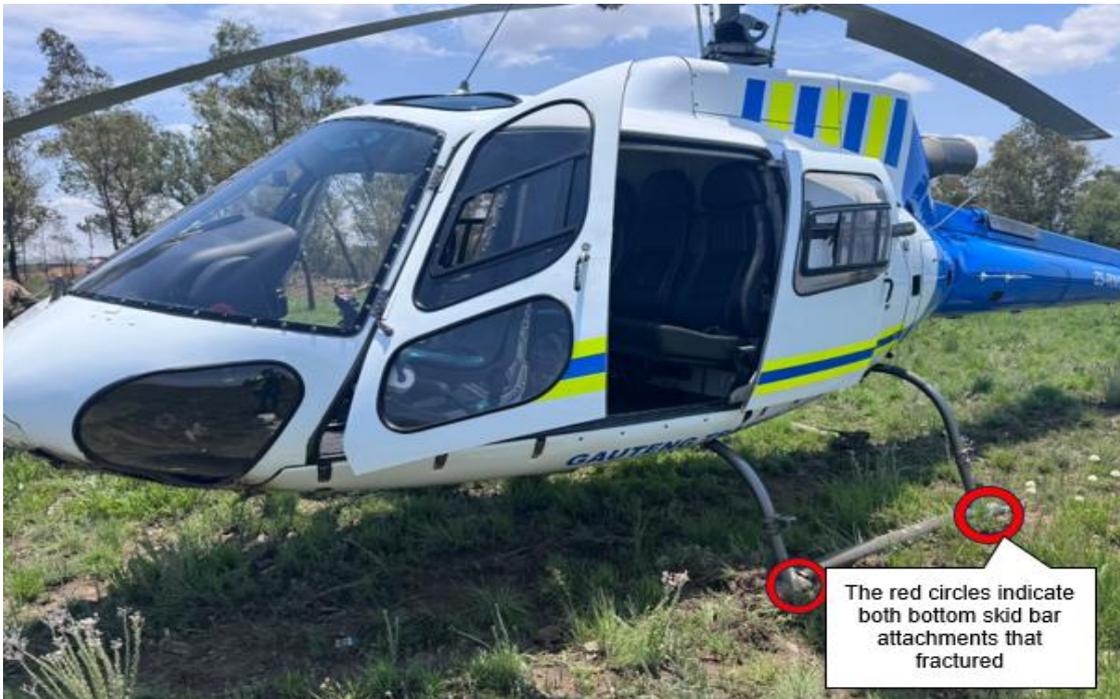
1.12.2. Post-accident, the helicopter fuselage was found relatively intact, except for the severely damaged left skid gear and the separated side-step bar (see Figure 4).

Figure 4: Damage on the left skid bar.

1.12.3. The bottom skid bar had broken into three pieces (segments) during the accident sequence. The damage pattern suggested that it was subjected to significant impact forces, likely from a heavy object, which resulted in its structural failure (see Figure 4).

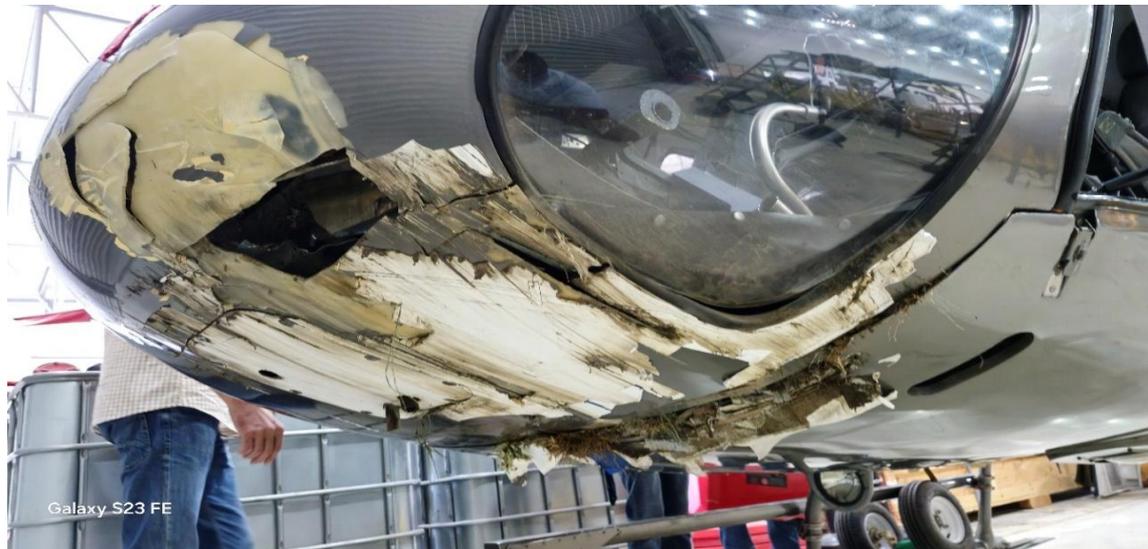
1.12.4. The bottom of the nose section towards the left side had damage that was consistent with contact with the ground (skidding), possibly as a result of heavy, momentary forces.

Figure 5: Damage on the bottom nose section.

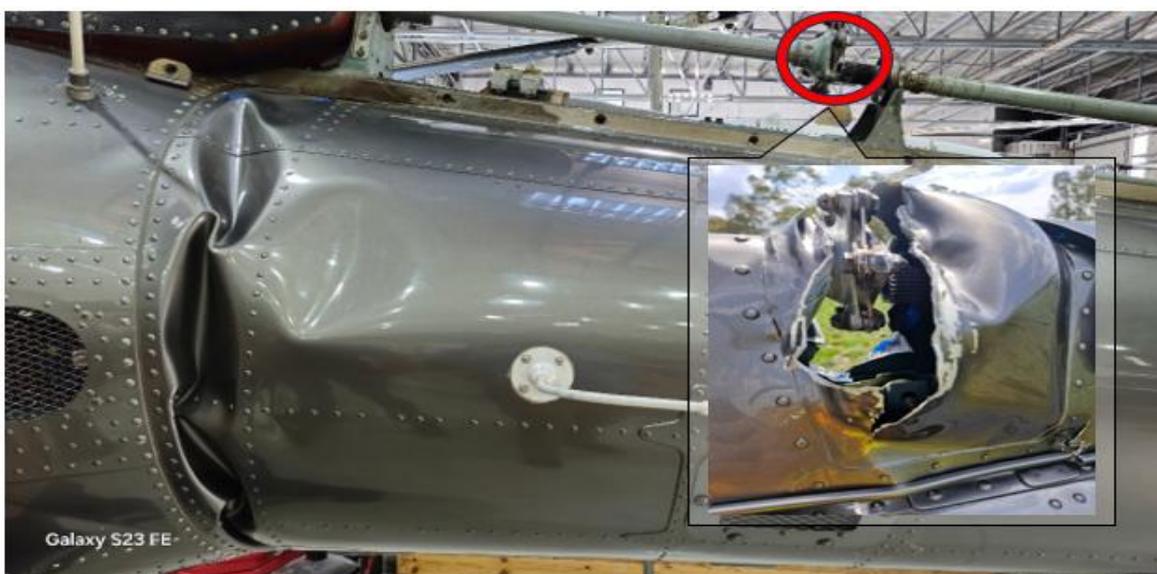
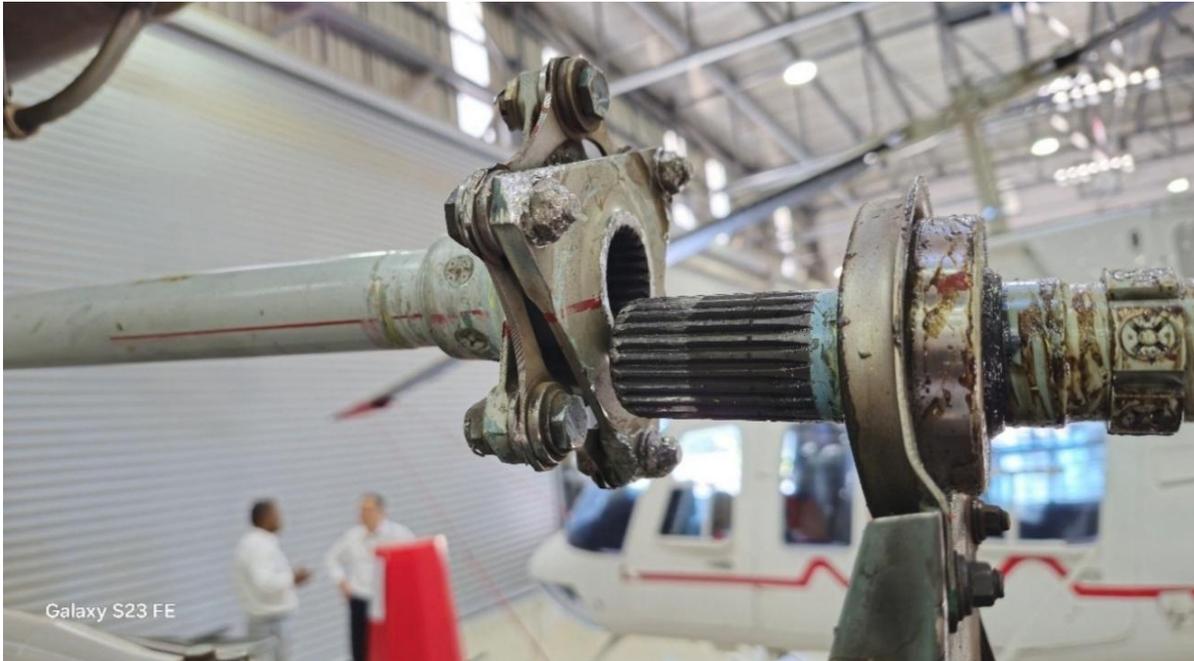
1.12.5. The helicopter's tail boom had bent near the attachment points, which led to the tail rotor shaft decoupling. Both components (coupler and shaft) sustained minor damage during decoupling whilst the helicopter was rotating. The decoupling further caused damage to the tail rotor shaft fairings panels (see Figures 6 and 7).

Figure 6: Damage to the tail boom attachment section and the decoupled tail rotor shaft. (Photo was taken after recovery).

Figure 7: Decoupled tail rotor drive shaft.

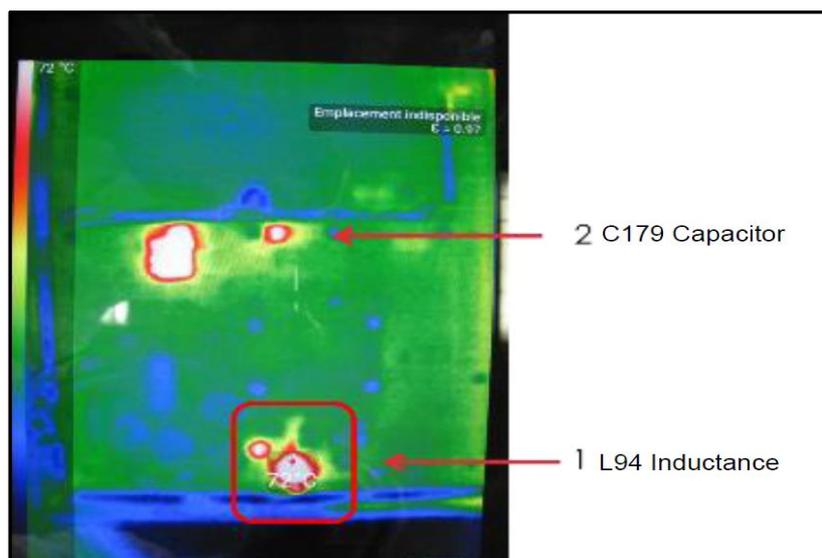
Figure 8: Abnormal thermal detection on the circuit board of components C179 and L94.

Signs of abnormal thermal dissipation were observed on components (1) L94 inductance and (2) C179 capacitor. A crack was also evident on the C179 component, and an audible noise

was heard during the application of both the battery and alternator power supplies. The DC converter test failed. The manual operational test failed because the switch between battery mode and alternator mode did not work, leading to inconsistent results on channel A. To proceed with further testing, all defective components were replaced with new, functional parts.

Examination of the EECU confirmed that it was inoperative. Inspection revealed a failed capacitor on the Lane A power-supply board. The capacitor's failure caused a loss of electrical power to the stepper motor which controls the fuel-metering needle. With the stepper motor unpowered, the metering needle was free to move and, most likely, migrated to the closed position under fuel-system pressure, resulting in fuel starvation and the subsequent engine flameout.

The root cause of the capacitor failure could not be conclusively determined. Functional testing of the alternator supplying the EECU showed no evidence of overvoltage, making an external electrical surge unlikely. Component ageing remains the most plausible factor, consistent with known in-service cases where ceramic capacitors without polymer terminations have deteriorated over time.

On 3 September 2013, the manufacturer issued Service Bulletin SB-C12380-49-009-01, recommending the replacement of a ceramic capacitor. This service bulletin had not been incorporated in the EECU installed on the occurrence aircraft.

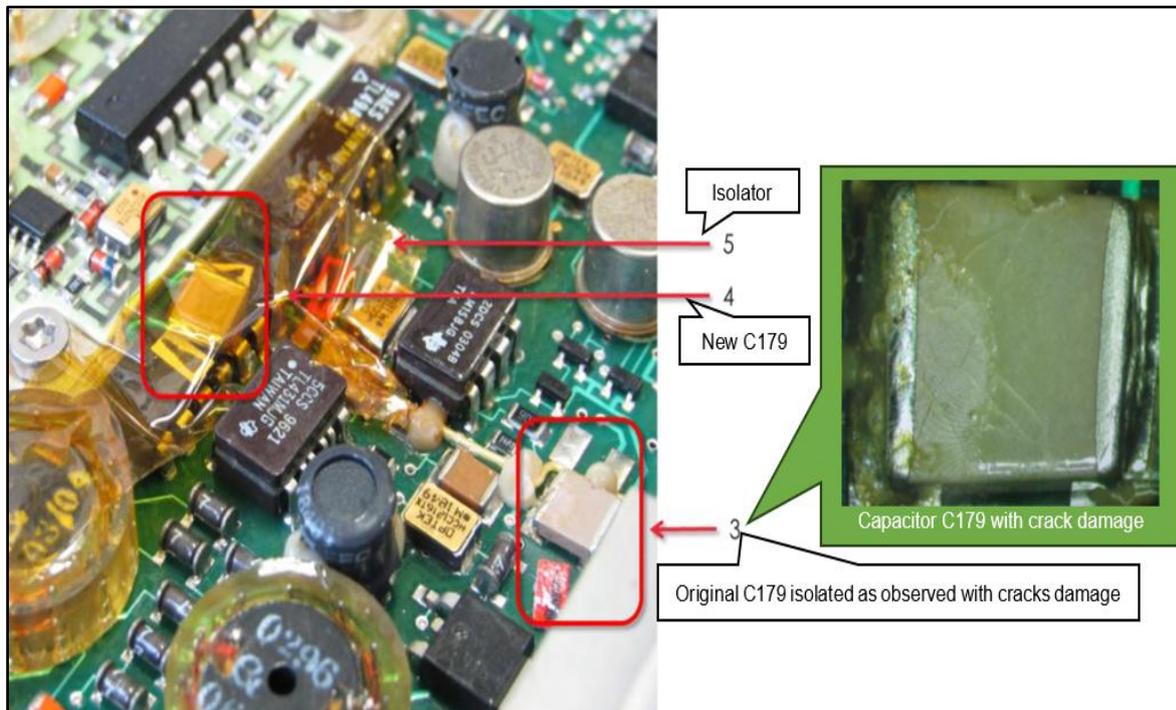
Figure 9: Temporary replacement of defective components.
