LIMITED OCCURRENCE INVESTIGATION REPORT – FINAL
--

Reference Number		CA18/2/3/10527									
Classification		Accident		Date		22 November 2024	Time		1300Z		
Type of Operation		Private (Part 91)									
Location											
Place of Departure		Swellendam Grebel Airfield (FASX), Western Cape Province			Place of Intended Landing			Mossel Bay Airfield (FAMO), Western Cape Province			
Place of Occurrence		300m from the threshold of Runway 15 at Swellendam Grebel Airfield (FASX)									
GPS Co-ordinates		Latitude		34°2'25.8" S	Longitude		020°27' 46.2" E	Elevation		536ft	
Aircraft Information											
Registration		ZS-EJE									
Make; Model; S/N		Cessna; C150F (Serial Number: 150-62539)									
Damage to Aircraft		Substantial			Total Aircraft Hours			3 926.8			
Pilot-in-command											
Licence Type		Commercial Pilot Licence (CPL)			Gender		Male		Age	22	
Licence Valid		Yes		Total Hours		255		Total Hours on Type		4.3	
Total Hours 30 Days		29.6			Total Flying on Type Past 90 Days				2.3

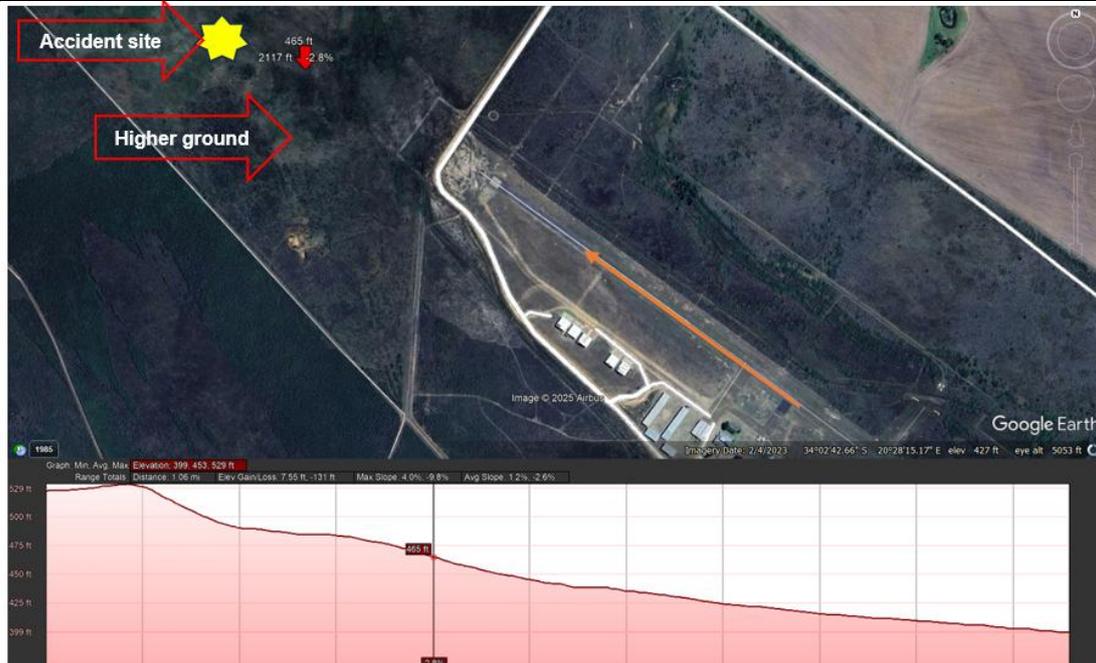
Figure 1: Aerial view of the accident site, elevation profile and the direction of flight. (Source: Google Earth)

On hot windy days, there are downdrafts on the extended centreline of Runway 33. The investigator found out that local pilots usually turn left into the wind towards lower ground on the western side of the airfield. The last time the pilot flew to FASX was on 14 November 2023. Therefore, he had used the airfield in the past.

The pilot reported that after passing the end of the runway, whilst flying over higher ground, the aircraft flew into a downdraft, which pushed it down. There was no thunderstorm activity in the vicinity at the time.

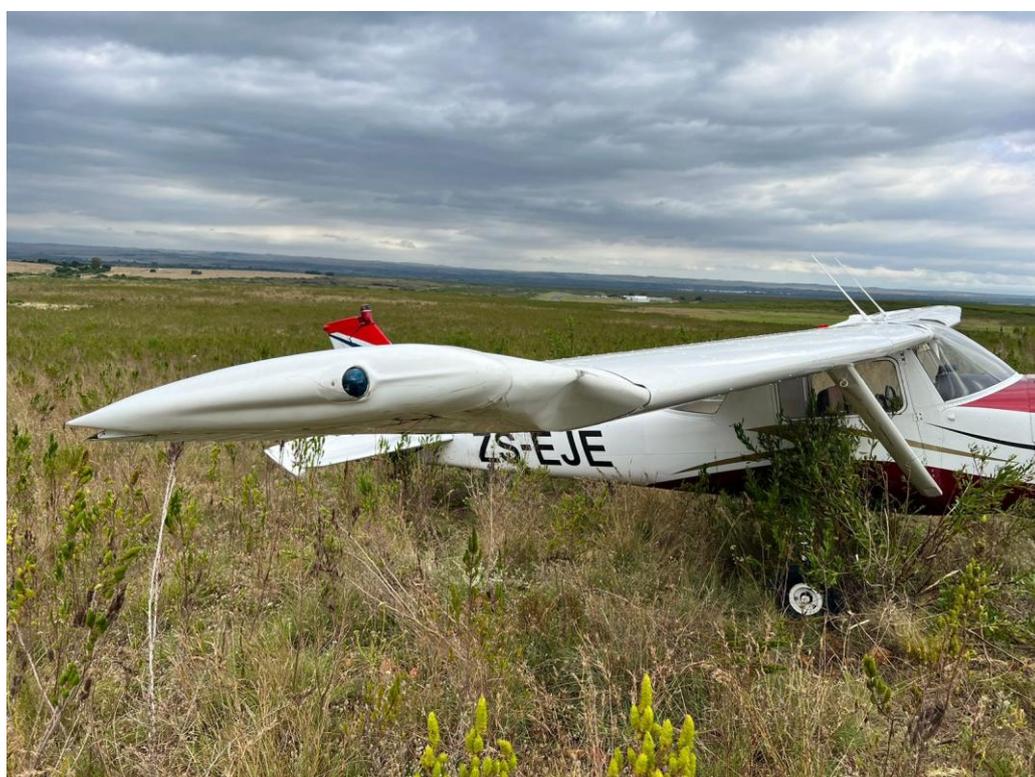
Figure 2: The damaged right-side wing. (Source: Pilot)

During the accident sequence, both wing tips impacted the ground successively. The propeller, undercarriage and fuselage were not damaged. The occupants exited the aircraft safely; they were not injured.
