LIMITED OCCURRENCE INVESTIGATION REPORT

Reference Number	CA18/2/3/10528				
Classification	Accident	Date	24 November 2024	Time	0825Z
Type of Operation	Private (Part 91)				
Location					
Place of Departure	Bram Fischer International Airport (FABL), Free State Province		Place of Intended Landing	Wonderboom Aerodrome, (FAWB) Gauteng Province	
Place of Occurrence	About 200m from the threshold of Runway 06 at Wonderboom Aerodrome (FAWB)				
GPS Co-ordinates	Latitude	25°39'57" S	Longitude	28°12'44.76" E	Elevation 4 060 ft
Aircraft Information					
Registration	N441AG				
Make; Model; S/N	Textron Aviation, Cessna 172P (Serial Number: 17276091)				
Damage to Aircraft	Substantial		Total Aircraft Hours	14 350	
Pilot-in-command					
Licence Type	Private Pilot Licence (PPL)		Gender	Male	Age 24
Licence Valid	Yes	Total Hours	160.5	Total Hours on Type	25.2
Total Hours Past 30 Days	25.2		Total Flying Hours on Type Past 90 Days	25.2	
People On-board	1 + 2	Injuries	0	Fatalities	0

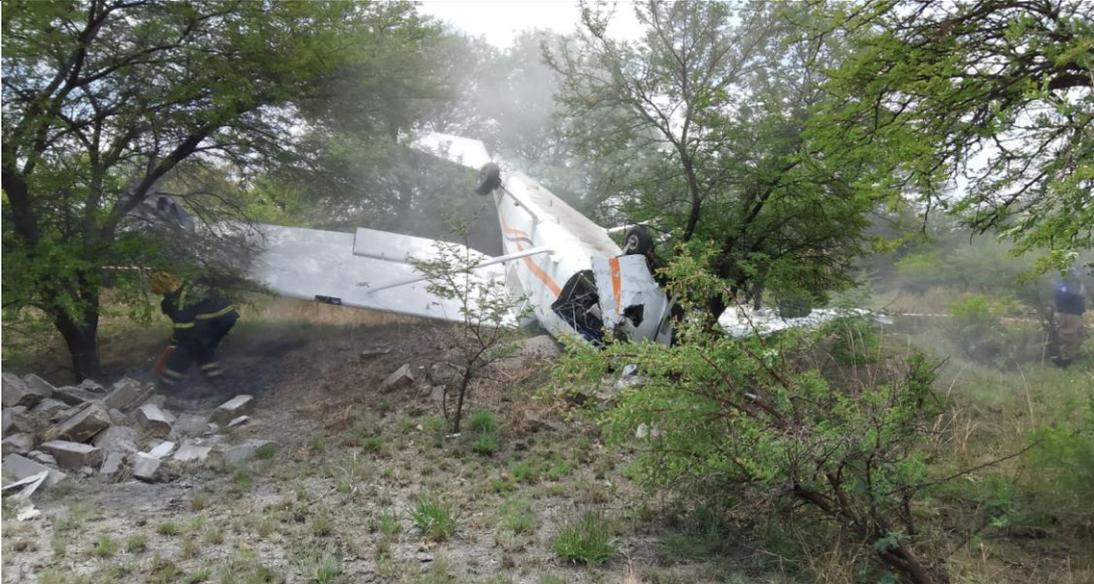
landing due to low fuel. At this point, the aircraft's altitude was 6000 feet (ft). The FAWB tower granted the request. During the final approach for landing on Runway 06, the engine stopped, and the aircraft landed on the trees, approximately 200 metres (m) from the threshold of Runway 06. The pilot and the passengers were not injured; however, they were taken to the hospital for a check-up. The aircraft was substantially damaged.

Figure 2: The aircraft post-accident. (Source: Operator)

The aircraft crashed 200m before the threshold of Runway 06 at FAWB due to fuel exhaustion.

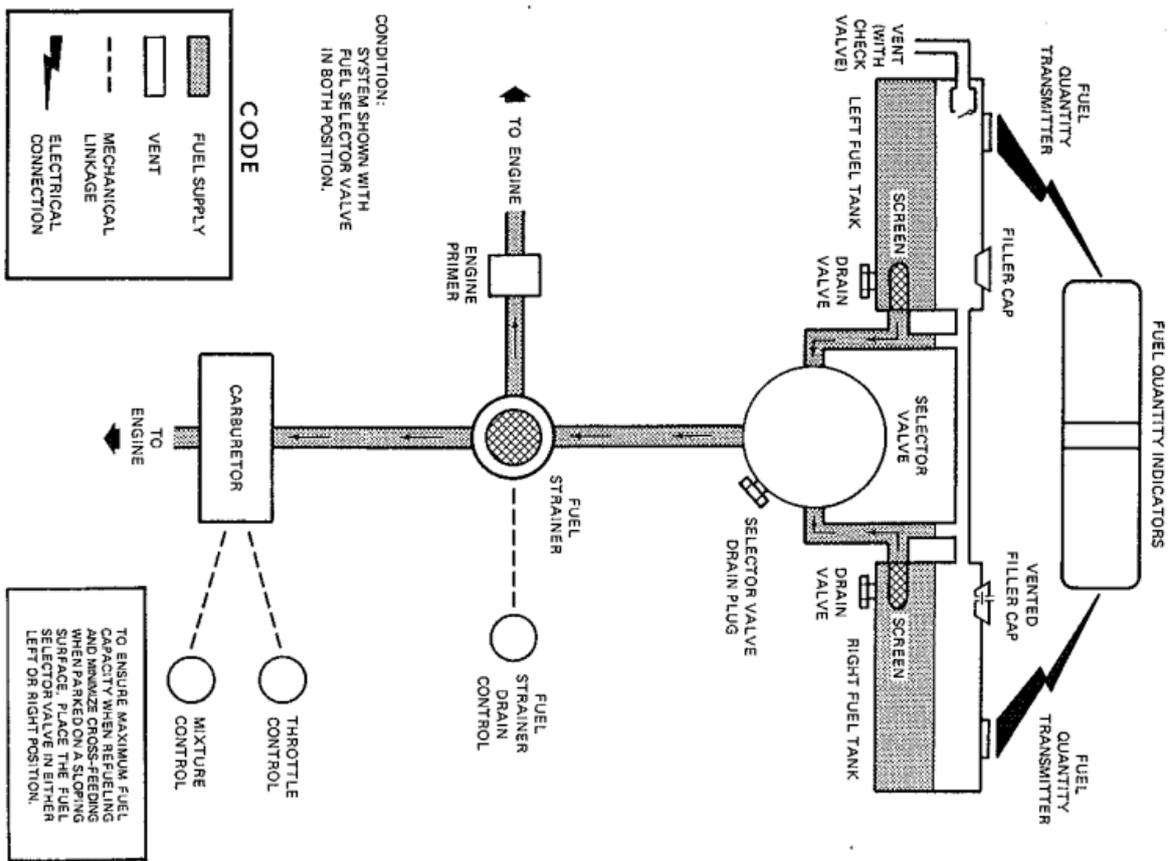
The Aircraft Fuel System and Description: (Source: Aircraft Pilot's Operating Handbook [POH])

The aircraft was equipped with a standard fuel system consisting of two vented fuel tanks, one on each wing, a four-position selector valve, fuel strainer, manual primer, and carburettor. Fuel flows by

gravity from the two wing tanks to a four-position selector valve, labelled BOTH, RIGHT, LEFT and OFF. With the selector valve in either the BOTH, LEFT or RIGHT position, fuel flows through a strainer to the carburettor. From the carburettor, mixed fuel and air flow to the cylinders through intake manifold tubes. The manual primer draws its fuel from the strainer and injects into the cylinder intake ports.

The fuel selector valve should be in BOTH position for take-off, climb, landing and manoeuvres that prolonged slips or skids. Operation from either left or right is reserved for cruising flights.
