LIMITED OCCURRENCE INVESTIGATION REPORT – FINAL

Reference Number	CA18/2/3/10529						
Classification	Accident	Date	20 November 2024	Time	0820Z		
Type of Operation	Private (Part 91)						
Location							
Place of Departure	Kroonstad Aerodrome (FAKS), Free State Province			Place of Intended Landing	Kroonstad Aerodrome (FAKS), Free State Province		
Place of Occurrence	Left of Runway 07 at Kroonstad Aerodrome (FAKS)						
GPS Co-ordinates	Latitude	27°39'36.57" S	Longitude	027°18'56.66" E	Elevation	4 690 feet	
Aircraft Information							
Registration	ZS-OSU						
Make; Model; S/N	Cessna Aircraft Company; T188C (Serial number: T188-03876T)						
Damage to Aircraft	Substantial			Total Aircraft Hours	4 064.0		
Pilot-in-command							
Licence Type	Airline Transport Pilot Licence (ATPL)		Gender	Male		Age	47
Licence Valid	Yes	Total Hours	6 402.9		Total Hours on Type	110.6	
Total Hours Past 30 Days	17.3		Total Hours on Type Past 90 Days	14.8			
People On-board	1 + 0	Injuries	0	Fatalities	0	Other (on ground)	0

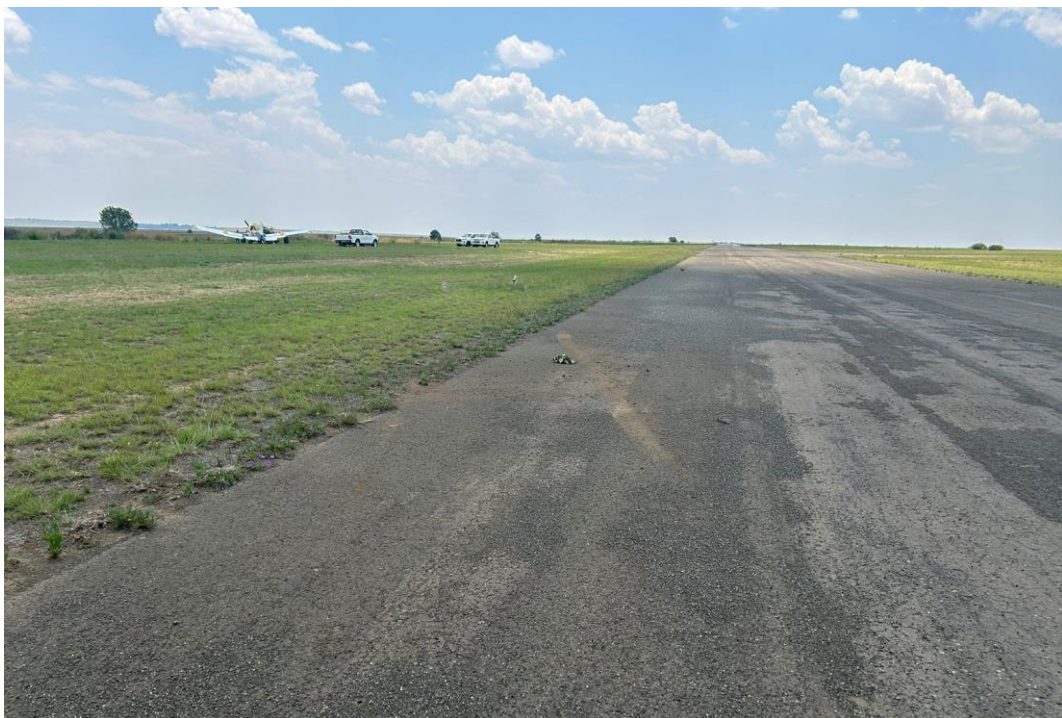
Figure 2: Tyre markings on the runway indicate the point at which the aircraft veered off to the left. (Source Pilot)

The pilot lost directional control of the aircraft when it experienced a sudden gust of wind from the left; the aircraft veered off to the left of the runway. The pilot applied the right rudder to counteract the yaw, but the rudder was ineffective.

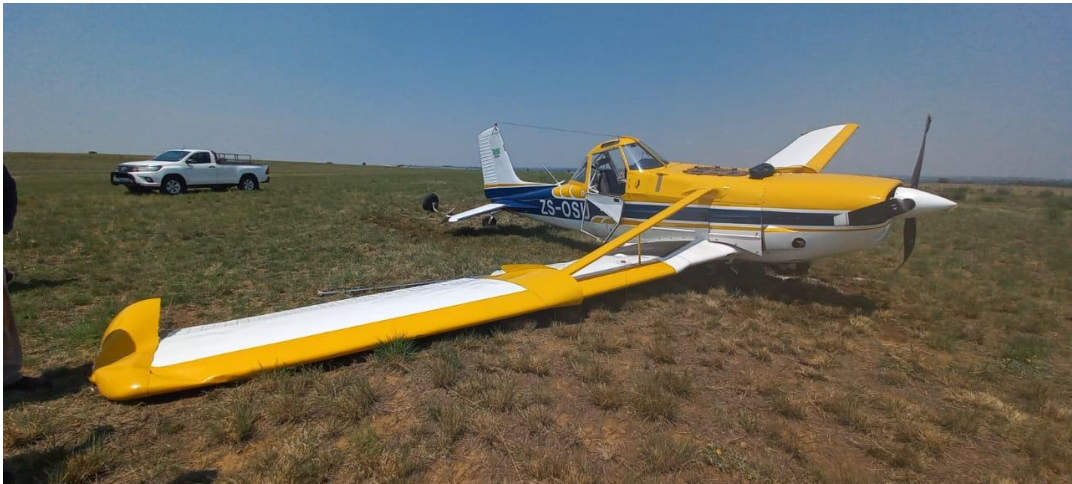
Figure 3: The aircraft as it came to rest. (Source: Pilot)

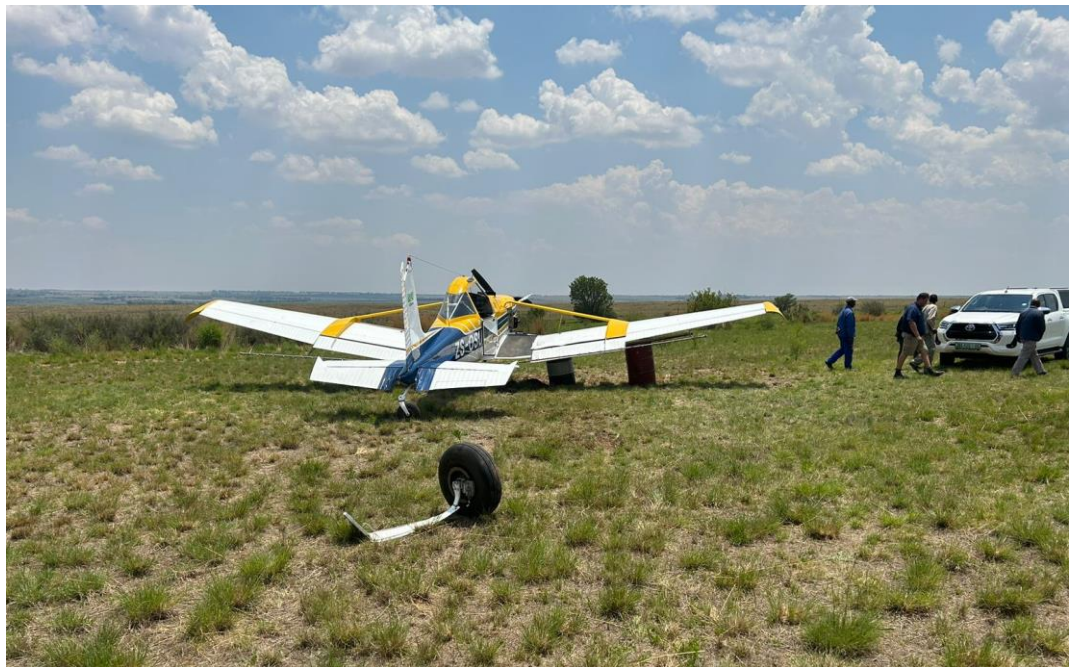
What Happened							
<p>On Thursday morning, 20 November 2024, a pilot on-board a Cessna T188C with registration ZS-OSU took off on a private flight from Kroonstad Aerodrome (FAKS) with the intention to land back at the same aerodrome. The flight was conducted under visual meteorological conditions (VMC) by day and under the provisions of Part 91 of the Civil Aviation Regulations (CAR) 2011 as amended.</p> <p>The pilot stated that the aircraft was recently fitted with a new engine, and it was required to fly for approximately 25 hours to complete the engine break-in process before it could be used for agricultural spraying. At the time of the accident, the aircraft had flown 19.9 hours since the newly overhauled Continental TSIO-520-T engine with serial number 515358 was installed. During the last maintenance inspection that was certified on 5 June 2024, the McCauley D3A34C402-C propeller with serial number 170530 was in operation for 820.9 hours since new.</p> <p>The pilot stated that he opted to use Runway 07 for take-off due to the prevailing wind from the north. During the take-off roll as the tail lifted off the ground (tail dragger), the aircraft experienced a sudden gust of wind from the left. The pilot applied the right rudder, but it had no effect. The aircraft veered off to the left of the runway and careered for some distance over the grass before it came to a stop. The aircraft sustained substantial damage when the right main landing gear and wheel assembly</p>

broke off (see Figure 4). As a result, the propeller and the right wing struck the ground. No person was injured.

Figure 4: The right main landing gear strut and wheel assembly that broke off. (Source: Pilot)

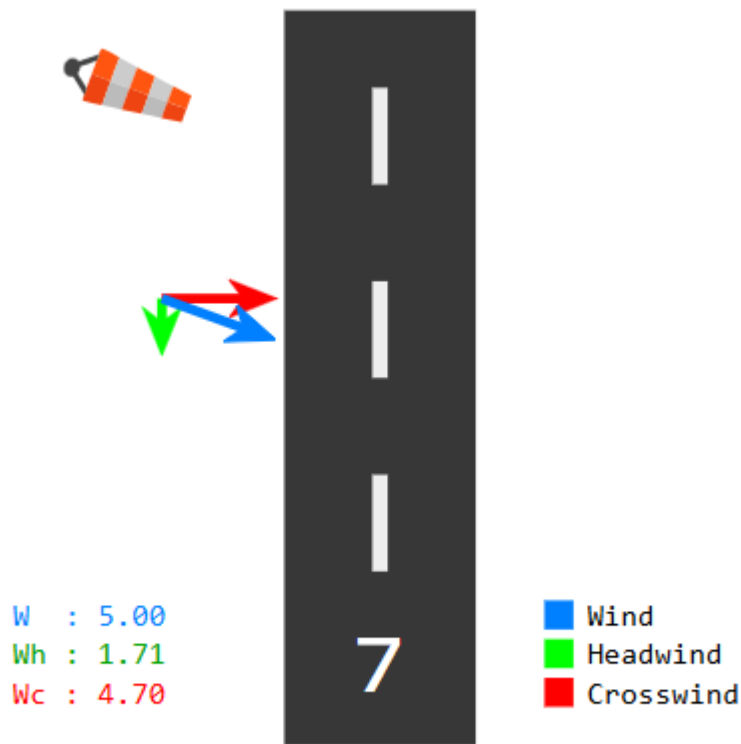
The weather data in the table above was used to determine the crosswind component. It does not include the gust of wind that the aircraft experienced during the take-off roll as it could not be measured.

Figure: 5 Crosswind component calculations. (Source: <https://e6bx.com/wind-components>)

3.1 According to the pilot, the wind was 360°/5 knots. He opted to use Runway 07 for take-off. Using the weather data obtained from the pilot, the crosswind component was calculated to be 4.7 knots before take-off.
