LIMITED OCCURRENCE INVESTIGATION REPORT – FINAL

Reference Number	CA18/2/3/10530						
Classification	Accident	Date	26 November 2024	Time	1545Z		
Type of Operation	Private (Part 91)						
Location							
Place of Departure	Mequatling Private Farm, Free State Province		Place of Intended Landing	Mequatling Private Farm, Free State Province			
Place of Occurrence	Open field with tall grass						
GPS Co-ordinates	Latitude	28° 58' 11.3" S	Longitude	027° 021' 31.7" E	Elevation	5255 ft	
Aircraft Information							
Registration	ZS-RZK						
Make; Model; S/N	Robinson R44; Raven II (Serial Number: 11041)						
Damage to Aircraft	Destroyed		Total Aircraft Hours	2170.4			
Pilot-in-command							
Licence Type	Commercial Pilot Licence		Gender	Male	Age	54	
Licence Valid	Yes	Total Hours	3576.2		Total Hours on Type	942.8	
Total Hours 30 Days	2.4		Total Flying on Type Past 90 Days	8.6			
People On-board	1+1	Injuries	0	Fatalities	0	Other (on ground)	0
What Happened

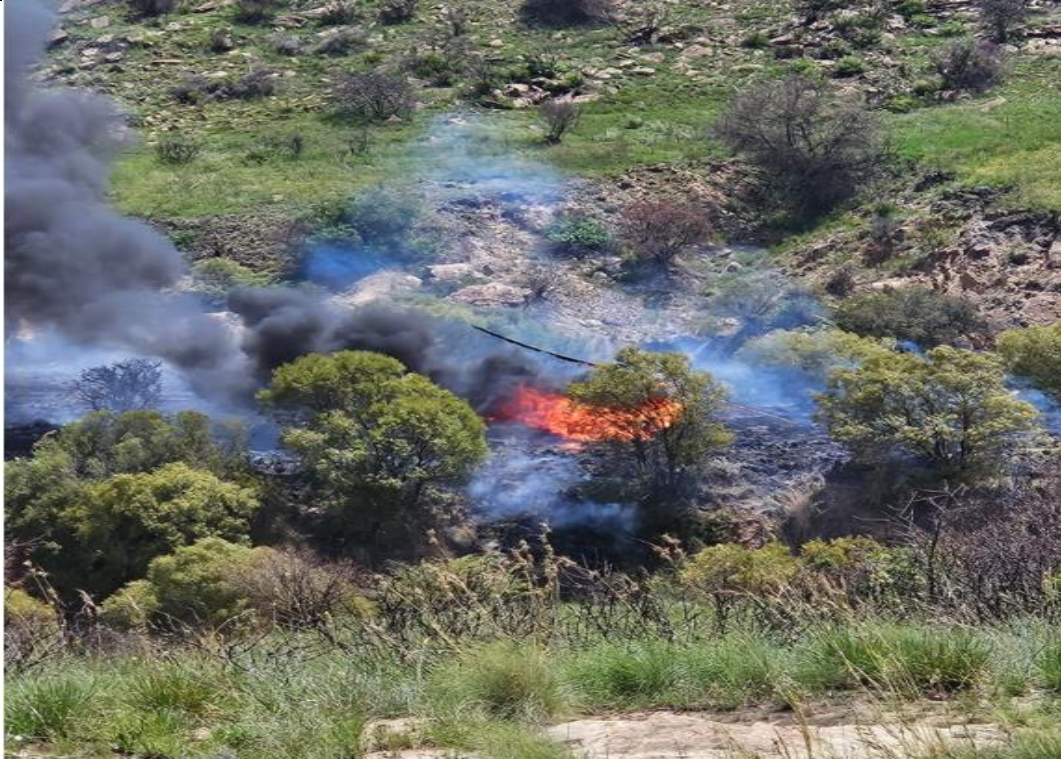
Figure 1: The helicopter engulfed in flames. (Source: Operator)

The picture above was taken by the pilot after all their efforts to extinguish the fire were exhausted. The fire also rapidly spread across a large portion of the accident site.

The helicopter landed on a tall, grass-covered area after the passenger experienced motion sickness. The hot exhaust ignited the grass, and the fire spread quickly and engulfed the helicopter, destroying it.

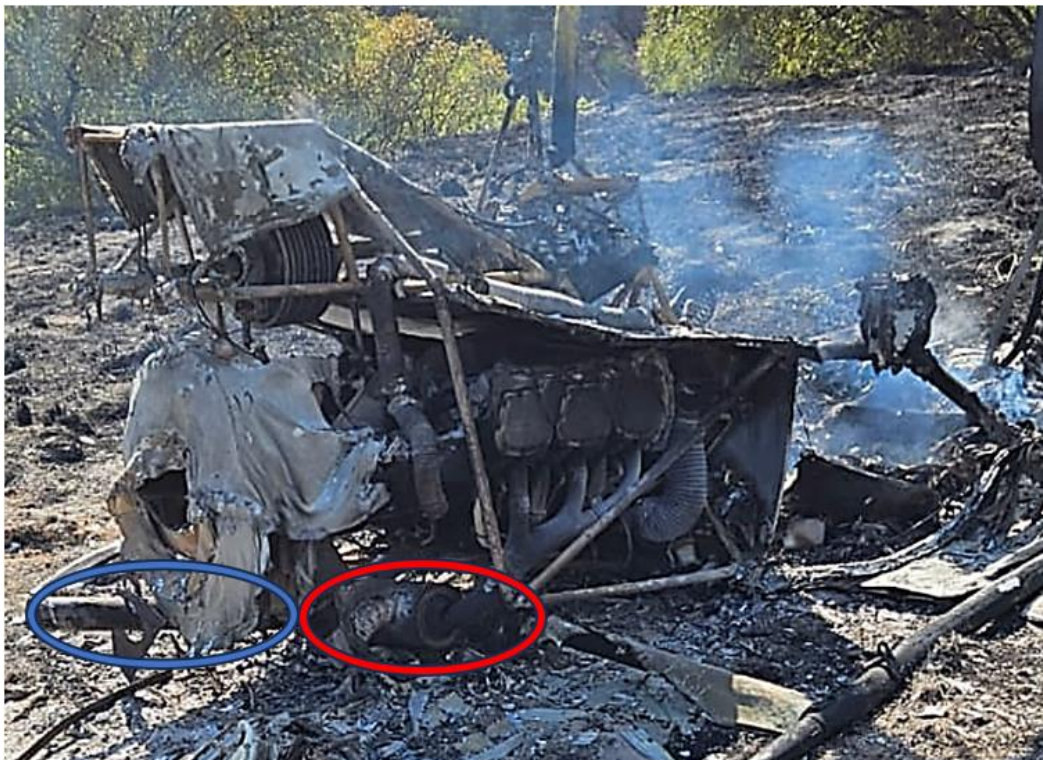
Figure 2: The wreckage. The blue circle shows the exhaust tailpipe (blue circle), and the red circle depicts the exhaust pipeline (red circle) with no shield and muffler.

The investigation (to this accident) revealed that there was no compliance with Service Bulletin-46 (SB-46) as the muffler and the tailpipe shield were not fitted to the helicopter.

The investigating team was informed that the accident helicopter was equipped with this kit during manufacture in 2008. Therefore, the SB-46 was not considered in the helicopter's maintenance records. The attachment clamps found at the mounting positions of the muffler and tailpipe confirmed the above statement. A review of the helicopter type in relation to the serial number range of the affected helicopters revealed that the kit was installed but there was no reference to it in the maintenance records. Additionally, a review of other helicopter types with the same serial number showed that these helicopters were also equipped with the kit during manufacture, yet there was no mention of it in their maintenance records.

6. The muffler and tailpipe shield kit were installed on the accident helicopter during manufacture; therefore, the SB-46 did not apply to this helicopter type. The helicopter was landed on tall grass which was ignited by the hot exhaust; the fire rapidly spread and engulfed the helicopter. This action violated Safety Tip: 15 which was issued by the helicopter manufacturer advising against landing in areas with tall, dry grass. Although the grass appeared green at the time of landing, the hot exhaust, despite being installed with a kit, was still capable of igniting the vegetation. The fire ultimately destroyed the helicopter.

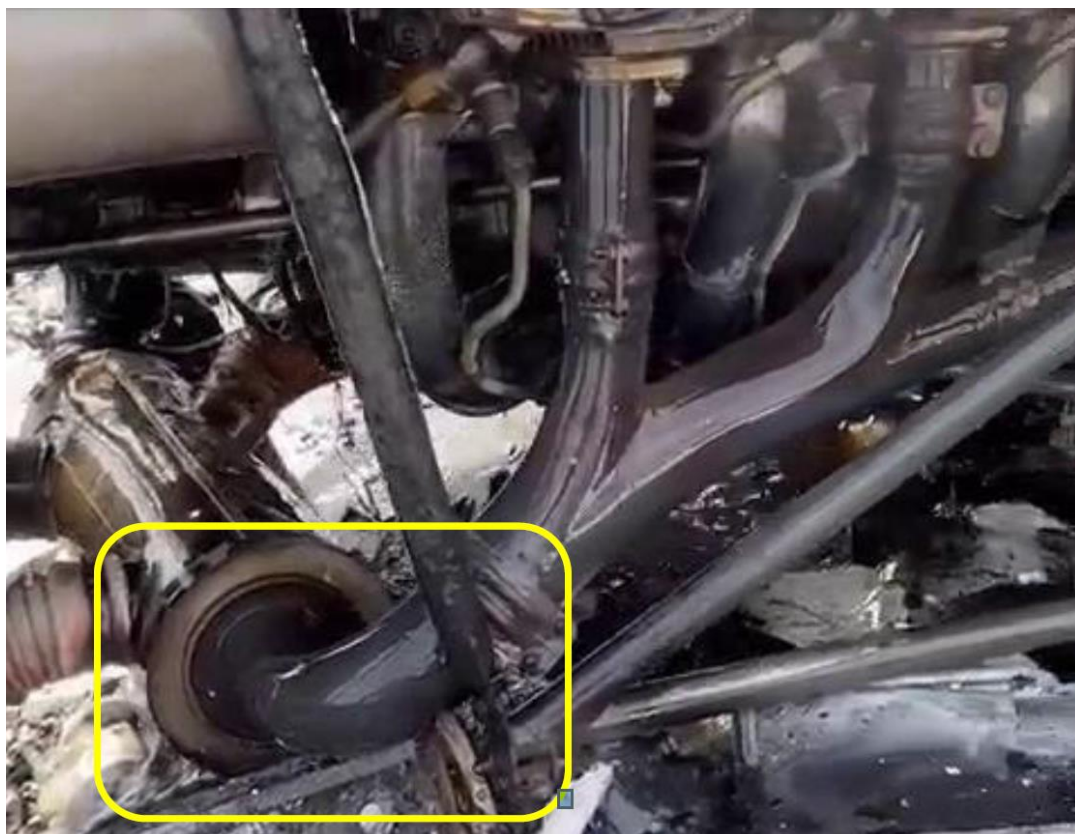
Figure 3 is a depiction of a similar Robinson R44 helicopter with registration ZS-RKK which suffered the same fate on 8 September 2024 after it landed on tall, dry grass in North West province. The exhaust, which was hot, ignited the grass whereafter the fire engulfed and destroyed the helicopter.

Figure 3: Similar exhaust system to the accident helicopter. (Source: Report CA18/2/3/10364)

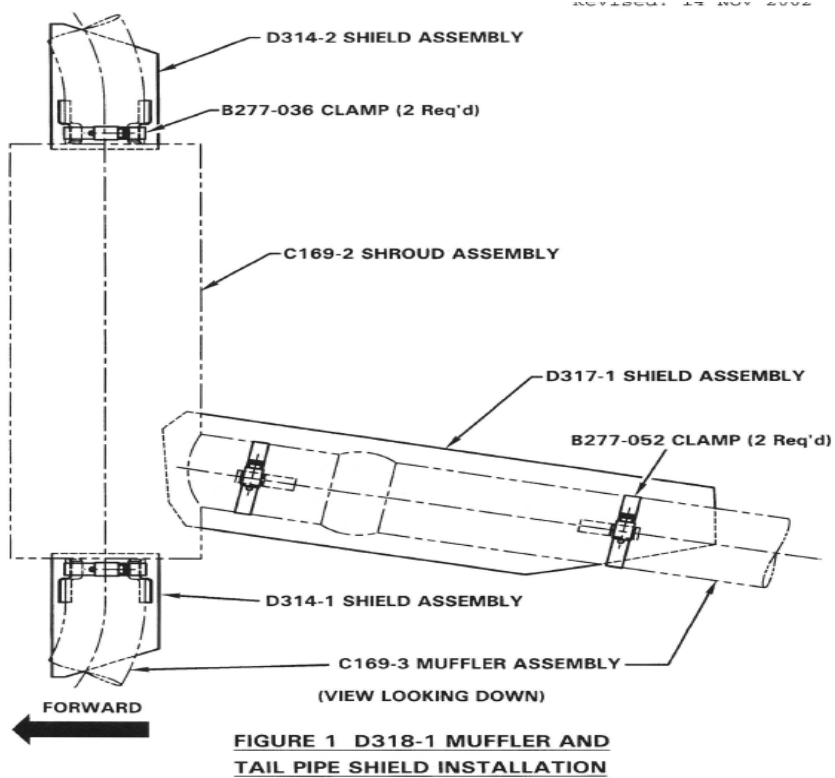
The helicopter's maintenance records, including the airframe and powerplant logbooks, flight folio and the mandatory periodic inspection (MPI) work pack were reviewed and found to be in order. The Airworthiness Directives (ADs) and SBs were also reviewed and it was found that SB-46 which was issued by the helicopter manufacturer on 15 November 2002 was not complied with. The SB, which applies to all owners, operators, and service centres of R44 recommended that a D318 muffler and a tailpipe shield be installed on R44 helicopters with serial numbers ranging from 0001 to 1265. The objective of this SB is to reduce the risk of fire igniting during landing in areas covered with dense dry grass.

Figure 4: Schematics of the muffler and the tail pipeline shield installation.

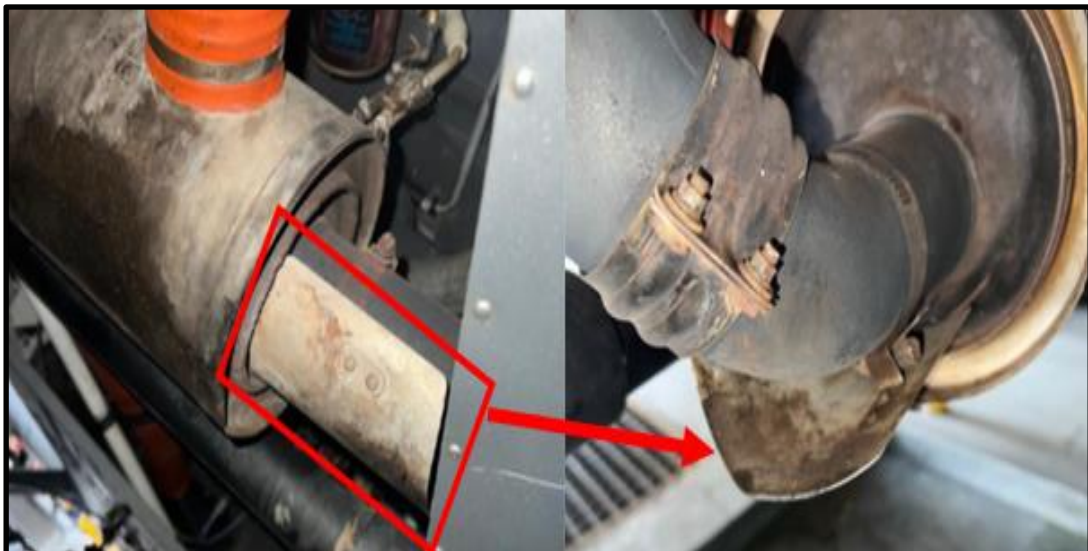
Figures 5 and 6 show a R44 helicopter type fitted with both the muffler and the tailpipe shield kits.

Figure 5: The muffler shield on the right side of the helicopter (left) and a muffle taken from a different angle (right).

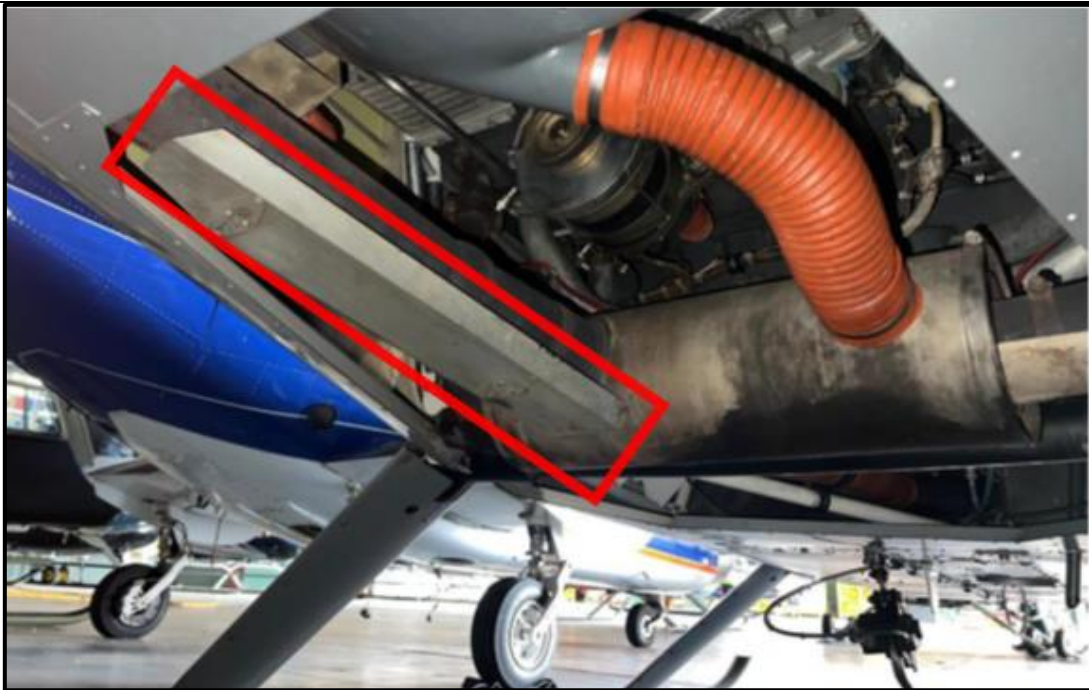
Figure 6: The red window shows a tailpipe shield.
