LIMITED OCCURRENCE INVESTIGATION REPORT – FINAL

Reference Number	CA18/2/3/10532						
Classification	Accident	Date	29 November 2024		Time	0828Z	
Type of Operation	Private (Part 94)						
Location							
Place of Departure	Willow Valley Farm Airstrip, Lephalale, Limpopo Province			Place of Intended Landing	Willow Valley Farm Airstrip, Lephalale, Limpopo Province		
Place of Occurrence	Bushy terrain in Weltevreden Game Farm, Lephalale, Limpopo Province						
GPS Co-ordinates	Latitude	23°54'.12" S	Longitude	27°56'.50" E	Elevation	4 831 feet	
Aircraft Information							
Registration	ZU-COC						
Make; Model; S/N	Micro Aviation SA; Bat Hawk R (Serial Number: 0104)						
Damage to Aircraft	Substantial			Total Aircraft Hours	192.8		
Pilot-in-command							
Licence Type	Private Pilot Licence		Gender	Male		Age	23
Licence Valid	Yes	Total Hours	180.7		Total Hours on Type	73.5	
Total Hours 30 Days	27.5		Total Hours on Type Past 90 Days	27.5			
People On-board	1 + 1	Injuries	0	Fatalities	0	Other (on ground)	0

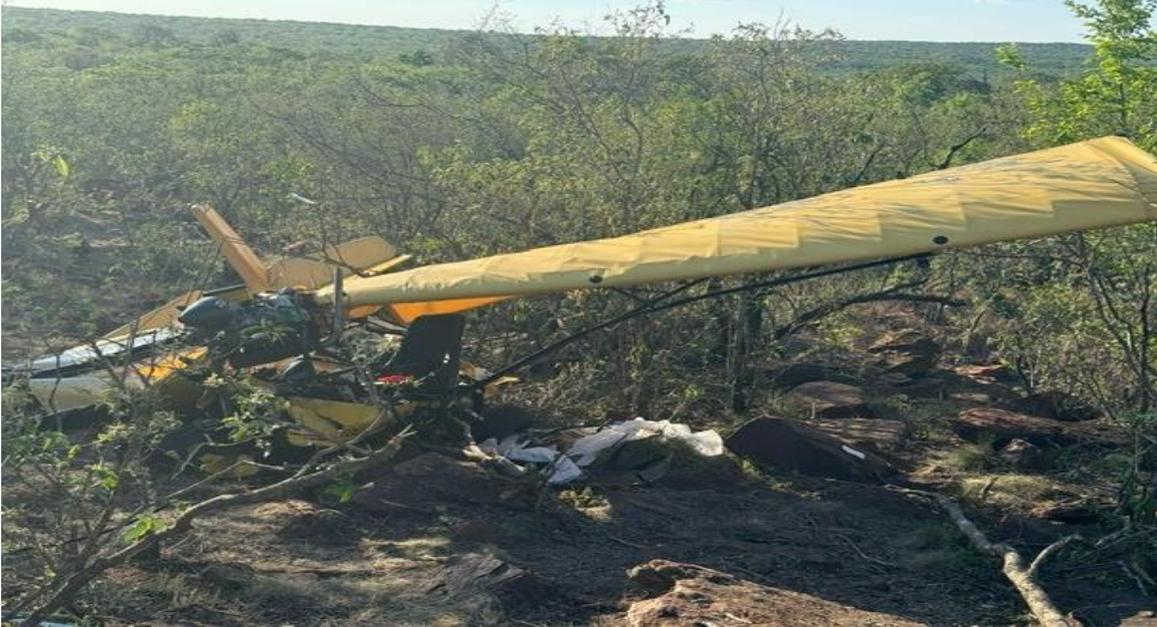
Figure 2: The aircraft at the accident site.

The aircraft's impact heading was approximately 265°magnetic in a westerly direction. On-site examination of the wreckage indicated that the aircraft sustained substantial damage during the accident sequence. The severed tree-tops showed that the aircraft struck the ground in a nose-down attitude and swerved to face the direction of approach. The ignition and the fuel pump switches were found in OFF position, they were switched off by the pilot after the accident. The continuity of the control system was confirmed from the flight control surfaces to the vicinity of the impact-damaged cockpit. There was no pre- or post-impact fuel-fed fire. One of the propeller blades had broken at the tip; the other two had broken near the root after impacting the rocks. Damage on the blades indicated that the propeller was not rotating at the time of impact. The spinner also did not exhibit any rotational signatures, which was consistent with the engines not producing power at the time of impact. The reduction gearbox was examined externally, and the propeller shaft was rotated by hand to check for anomalies; none was found. No anomalies were found with the gearbox after hand rotation was completed. Compression and suction were confirmed on all four cylinders.

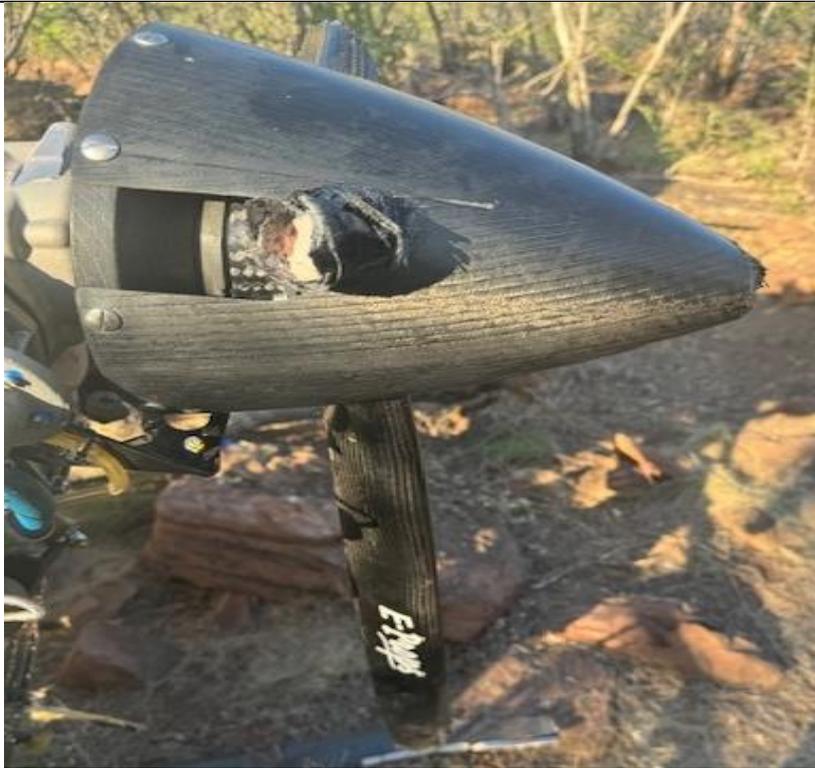
Figure 3: The view of the spinner and broken propeller blades.

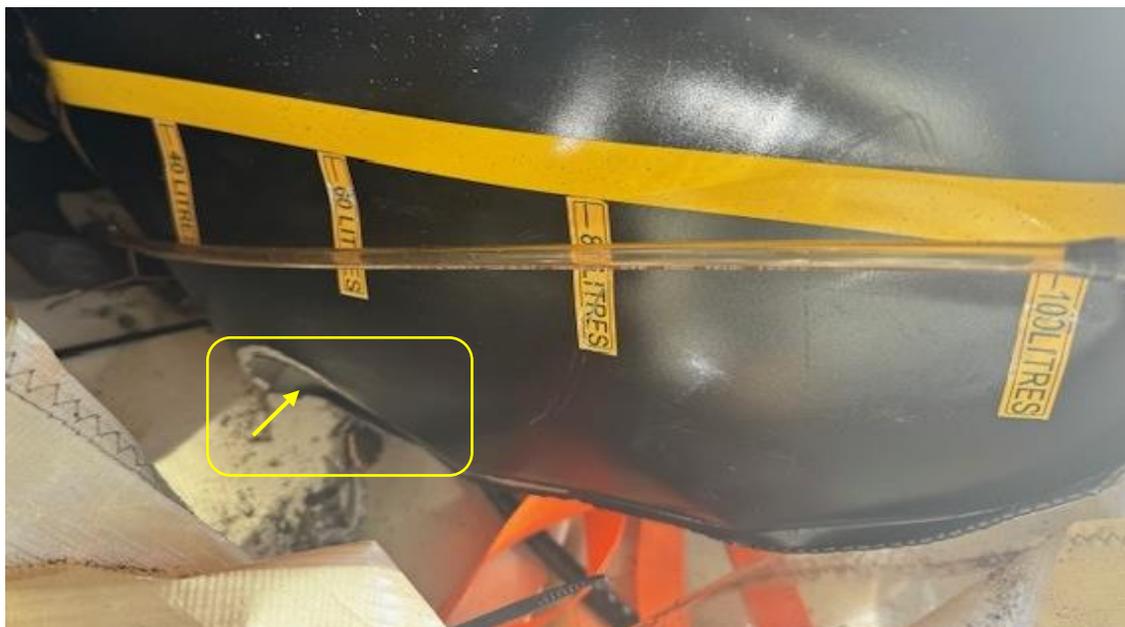
Figure 4: The damaged fuel tank (yellow window highlights a hole in the fuel tank).

The fuel system was examined and no evidence of disconnection on the fuel lines was found. The 100L capacity fuel tank, which is located behind the seats, had a rupture underneath after it hit the rocks during the accident sequence; however, there was no evidence of fuel spillage or smell of fuel around the aircraft and on the fabric underneath the fuel tank.

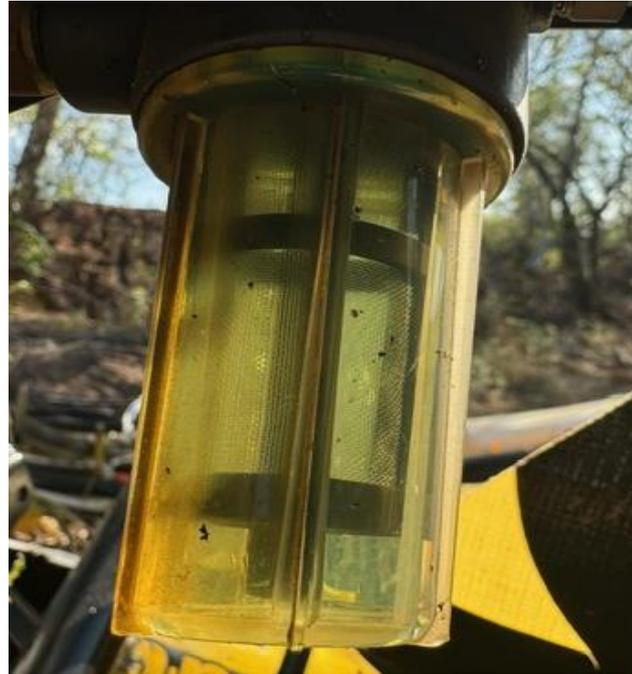
The gascolator was examined, and it contained no fuel. The plastic screen type fuel filter also contained no fuel. The two carburetors were correctly synchronised, and the throttle levers and springs were in place and intact. The engine-related control linkages were continuous and operational. The retention clips were intact, unbroken, and secured to the carburetors. The empty fuel filter and the carburettor bowls indicated that the aircraft did not have sufficient fuel for the planned flight, which was in contravention of Part 91.07.12 of the CAR 2011 as amended.

Figure 5: A picture of the fuel filter assembly showing the absence of fuel.

2.5 The fuel filter, gascolator and the carburettor bowls were empty, an indication that the aircraft did not have sufficient fuel for the planned flight, which was in contravention of Part 91.07.12 of the CAR 2011 as amended.

2.6 Based on the available evidence, it is likely that the pilot did not verify the fuel quantity prior to departure; thus, he took off with less fuel than he had planned for, which resulted in the engine stoppage due to fuel exhaustion.

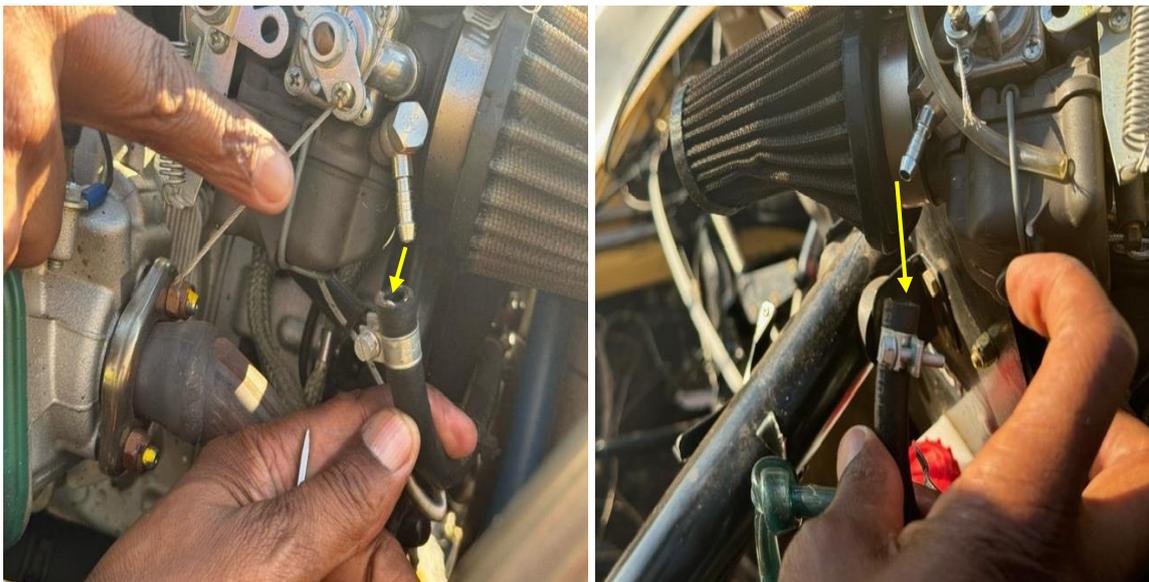
Figures 6 and 7: The right and the left carburettor bowls contained no fuel.

Based on the available evidence, it is likely that the aircraft's engine stopped in-flight due to fuel exhaustion which led to an unsuccessful forced landing on a bushy terrain at Weltevreden Game Farm in Lephalale.

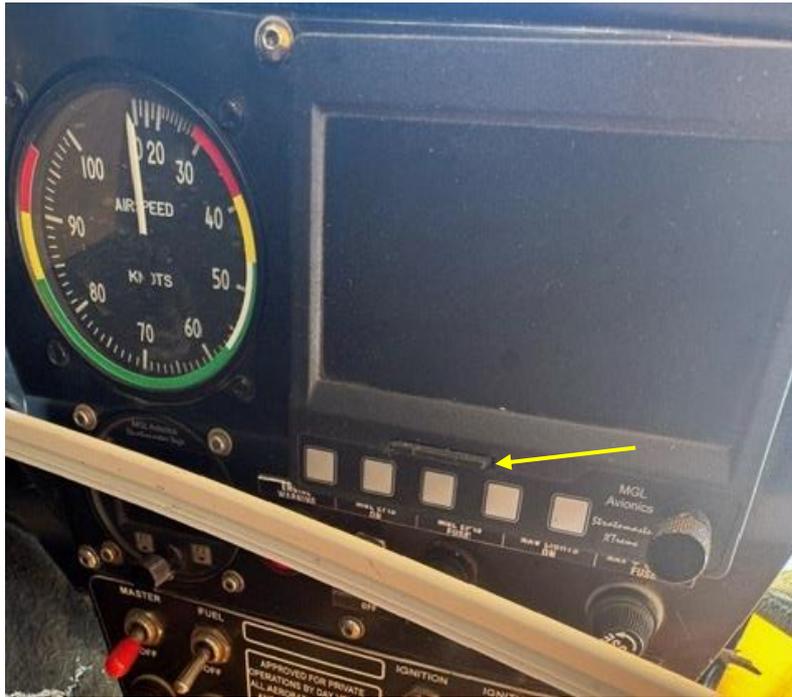
The wreckage was recovered to the aircraft maintenance organisation (AMO) in Mbombela, Mpumalanga province, for further investigation. The aircraft had the MGL Avionics Extreme Electronic Flight Instrument System (EFIS) that mainly serves as the engine monitoring system (EMS). According to MGL Avionics, the EFIS model does not have an internal data recording and has an external Secure Digital (SD) card. The approved person (AP) rated on the aircraft type examined the EFIS and informed the investigation team that it was on manual, meaning that no engine parameters were recorded in the SD card as it was not set to automatic during the accident flight. The EFIS model is designed in such a way that it would display the actual amount of fuel being burnt and the remaining fuel relative to tank capacity; however, in the absence of the recorded parameters, the actual amount of fuel that remained in the tank could not be determined. Also, the fact that the pilot could not remember the total amount of fuel in the tank after refuelling the aircraft on Friday, 1 November 2024, was a concern.

Figure 8: The EFIS with the SD card still in place (yellow arrow).
