**AIRCRAFT ACCIDENT REPORT AND EXECUTIVE SUMMARY**

<b>Reference:</b>		CA18/2/3/10533	
<b>Aircraft Registration</b>	ZU-DWY	<b>Date of Accident</b>	1 December 2024		<b>Time of Accident</b>	1330Z	
<b>Type of Aircraft</b>	Cubby		<b>Type of Operation</b>		Private (Part 94)		
<b>Pilot-in-command Licence Type</b>	National Pilot Licence (NPL)		<b>Age</b>	50	<b>Licence Valid</b>	Yes	
<b>Pilot-in-command Flying Experience</b>	<b>Total Flying Hours</b>		797.7		<b>Hours on Type</b>	Unknown	
<b>Last Point of Departure</b>	Highway Airfield, Western Cape Province						
<b>Next Point of Intended Landing</b>	Highway Airfield, Western Cape Province						
<b>Damage to Aircraft</b>	Substantial						
<b>Location of the accident site with reference to easily defined geographical points (GPS readings if possible)</b>							
Forest View Farm at Global Positioning System (GPS) position: 33° 56' 57.6" South 022° 58' 10.3" East, at an elevation of 790 feet (ft)							
<b>Meteorological Information</b>	Surface wind: 170° / 07 kt; Temperature: 20°C; Dew point: 15°C; Visibility: CAVOK

**Reference Number** : CA18/2/3/10533  
**Occurrence Category** : Accident (Category 1)  
**Type of Operation** : Private (Par

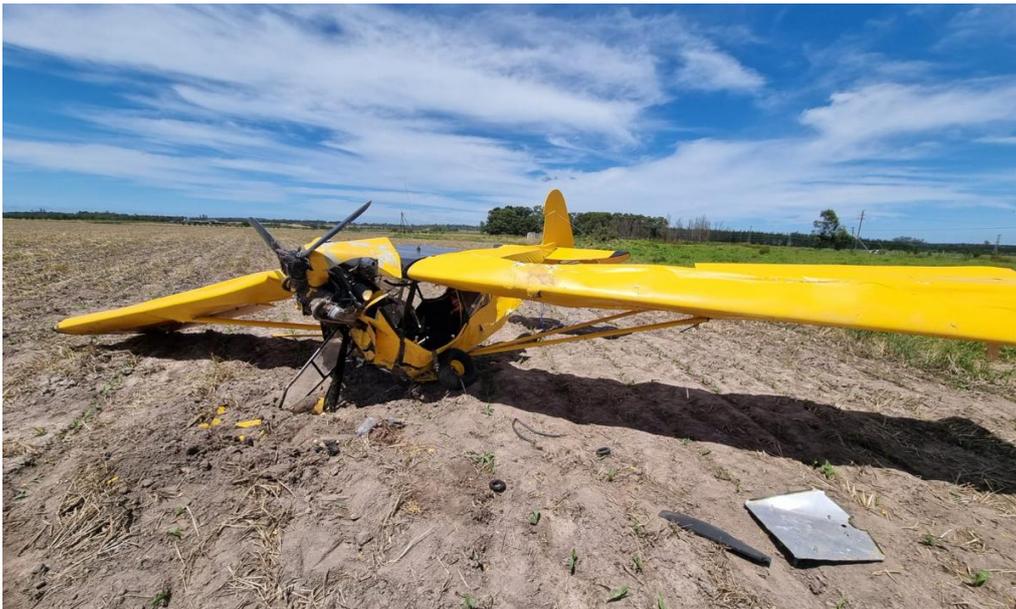
1.3.1. The aircraft sustained substantial damage when it impacted the ground.

**Figure 2:** The wreckage post-accident.

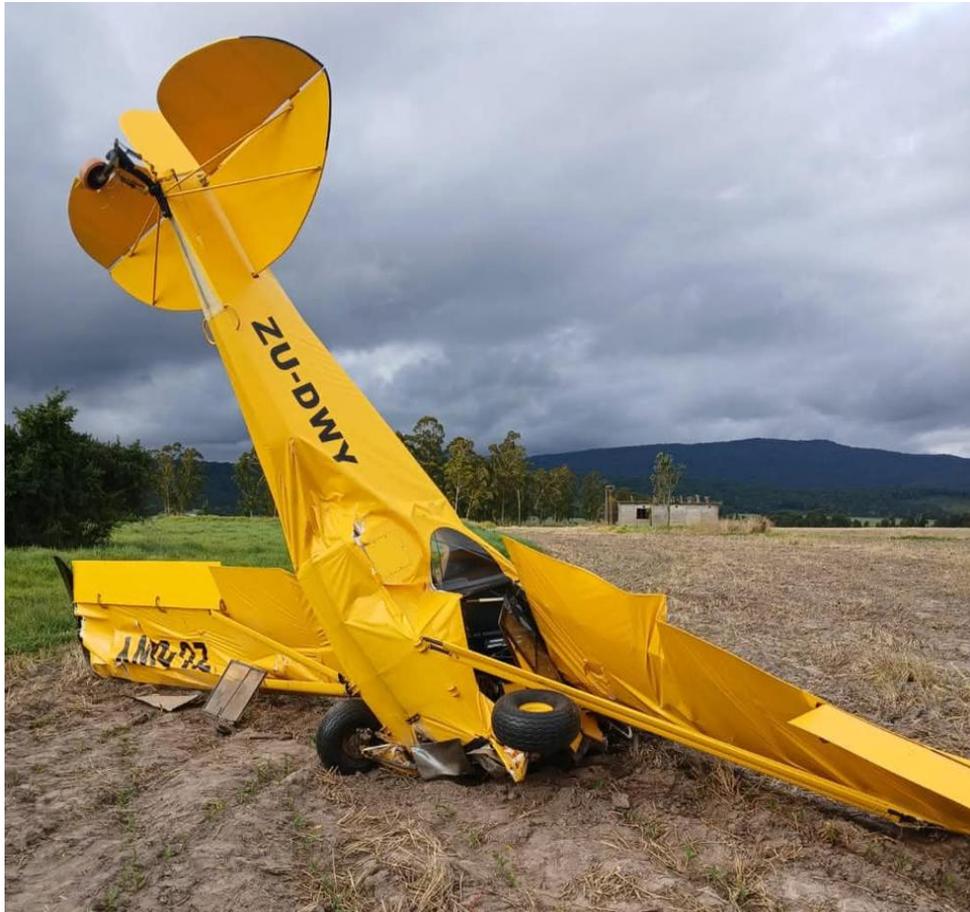
was found. The elevator (Figure 3) indicated the nose-up position which was likely caused by the impact force with the ground, pushing it back and, thus, resulting in the elevator indicating a nose-up position.

**Figure 3:** The aircraft as it was found at the accident site.

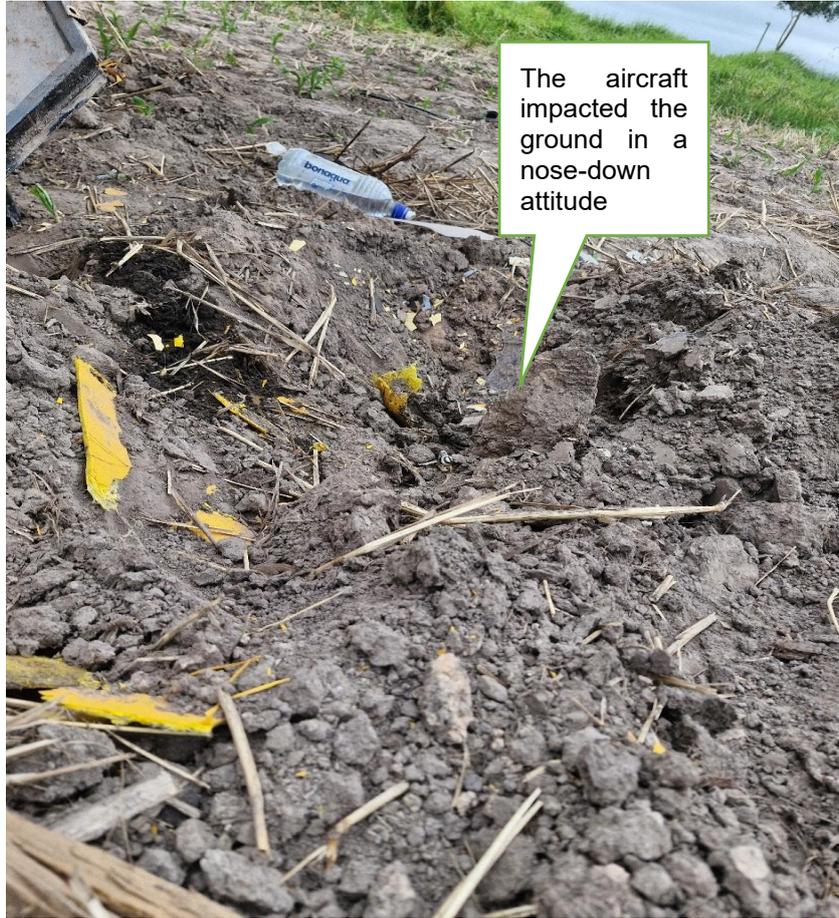
1.12.2 One of the three propeller blades broke off during impact which was consistent with the engine that had little or no power. The impact caused a crater that was approximately 60 centimetres (cm) deep, consistent with a nose-dive attitude at the time of the crash.

**Figure 4** The crater on the ground.

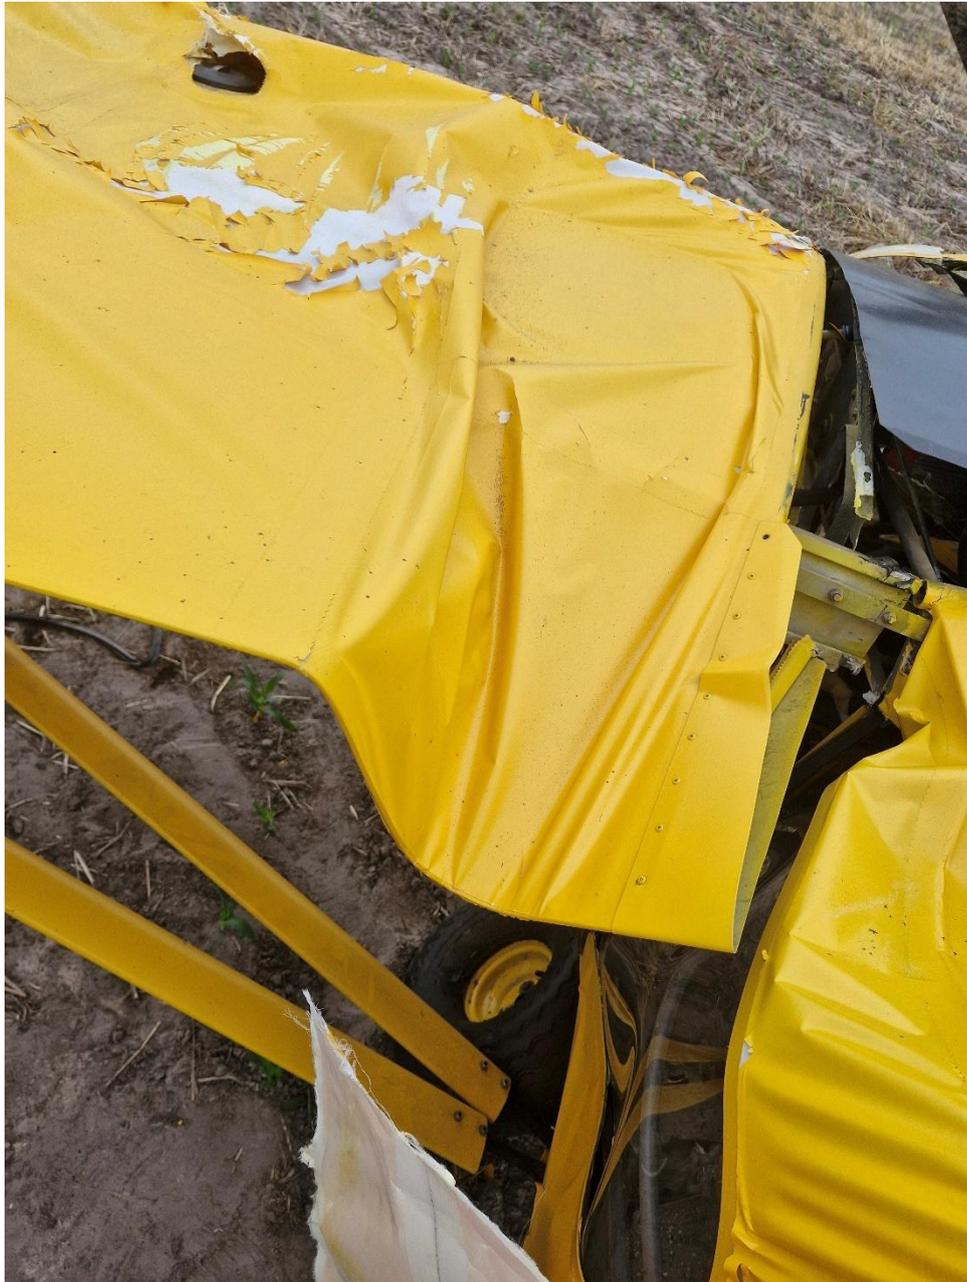
**Figure 5:** The damaged wing root.

1.12.3. The damage sustained by the wing on the root structure was consisted with the downward force when the aircraft impacted the ground. The wings leading edge did not suggest impact with the ground. The fuel tank ruptured during the crash; hence, sampling of fuel was not possible.
