AIRCRAFT ACCIDENT REPORT AND EXECUTIVE SUMMARY

| | | Reference: | | CA18/2/3/10534 | | | |
| Aircraft Registration | ZS-NDO | Date of Accident | 7 December 2024 | Time of Accident | 0632Z | | |
| Type of Aircraft | Cessna 177RG | | Type of Operation | Private (Part 91) | | | |

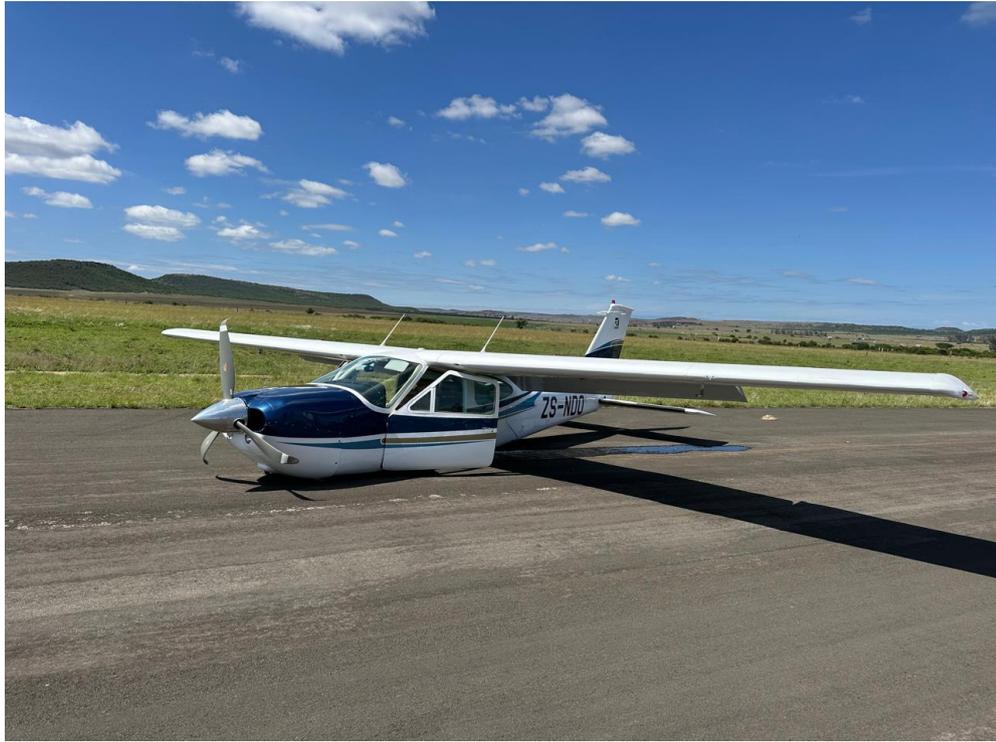
Figure 1: The ZS-NDO aircraft post-accident. (Source: Operator)

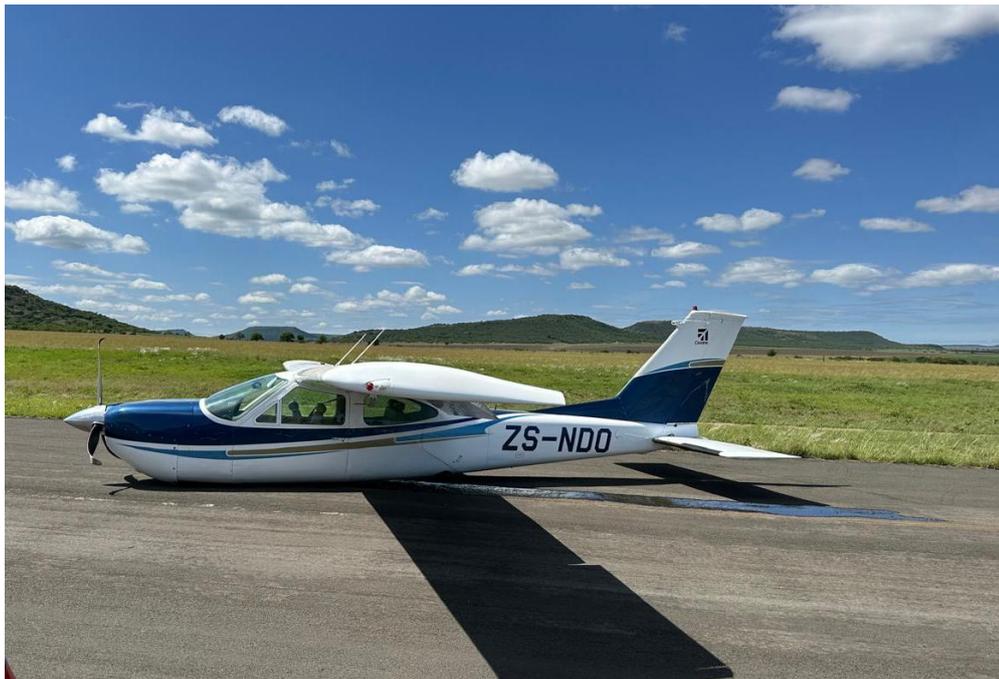
1.12.1. The aircraft landed on its belly and the propeller struck the ground; it came to a stop on the runway. The underbelly was scrapped, and the propeller blade tips were bent. There was no other damage recorded.

Figure 2: The aircraft on its belly with bent propeller blades after the accident. (Source: Pilot)

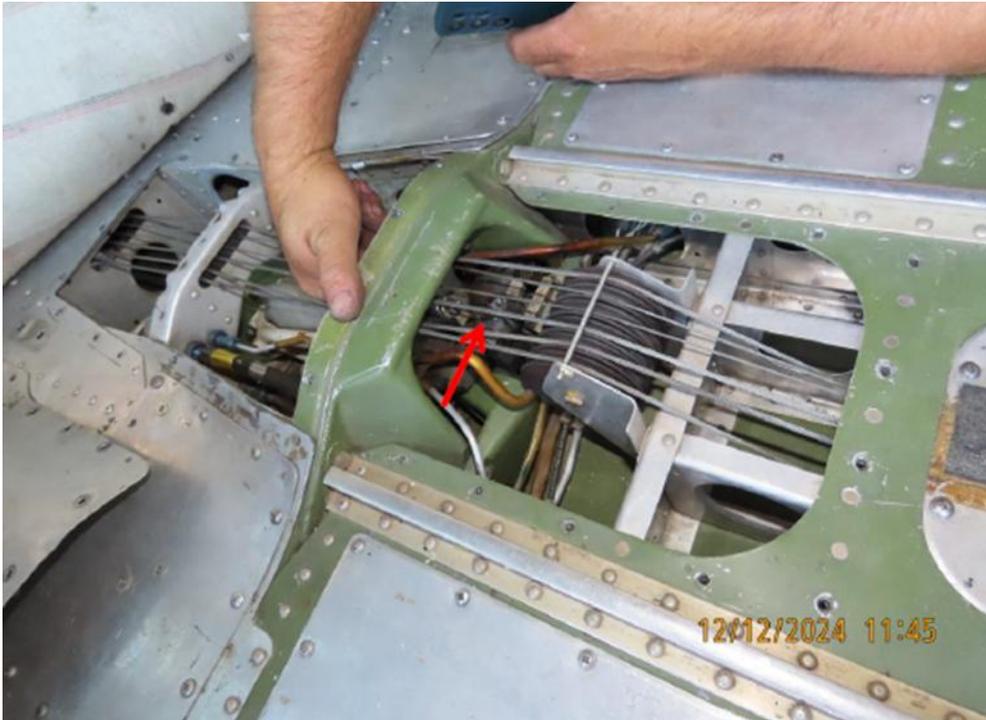
1.16.2. The aircraft was recovered to a hangar in Ladysmith Airport after the accident. On 11 December 2024, the aircraft was taken to a workshop in Wonderboom Airport for inspection and testing. According to the aircraft maintenance engineer (AME); the floor cover panel under the rear seats was removed to gain access to the main landing gear actuator. It was found that the threaded rod end on the actuator had failed.

Figure 3: The location of the landing gear actuator under the floor cover panel. (Source: AMO)

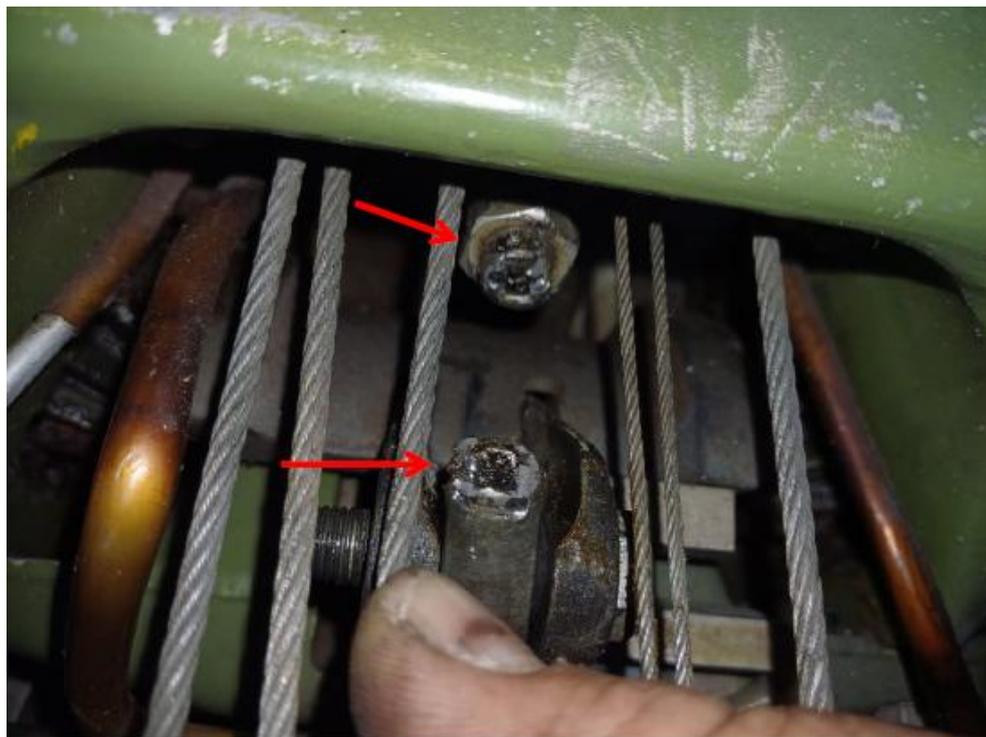
- 1.16.3. The failure of the threaded rod end meant that there was no mechanical connection between the hydraulic system (actuator) and the geared pinion assembly. Whilst the hydraulic system was fully functional, the mechanical connection to the main landing gear was disconnected completely. The nose gear actuator was found functional.

Figure 4: The broken rod end. (Source: AMO)

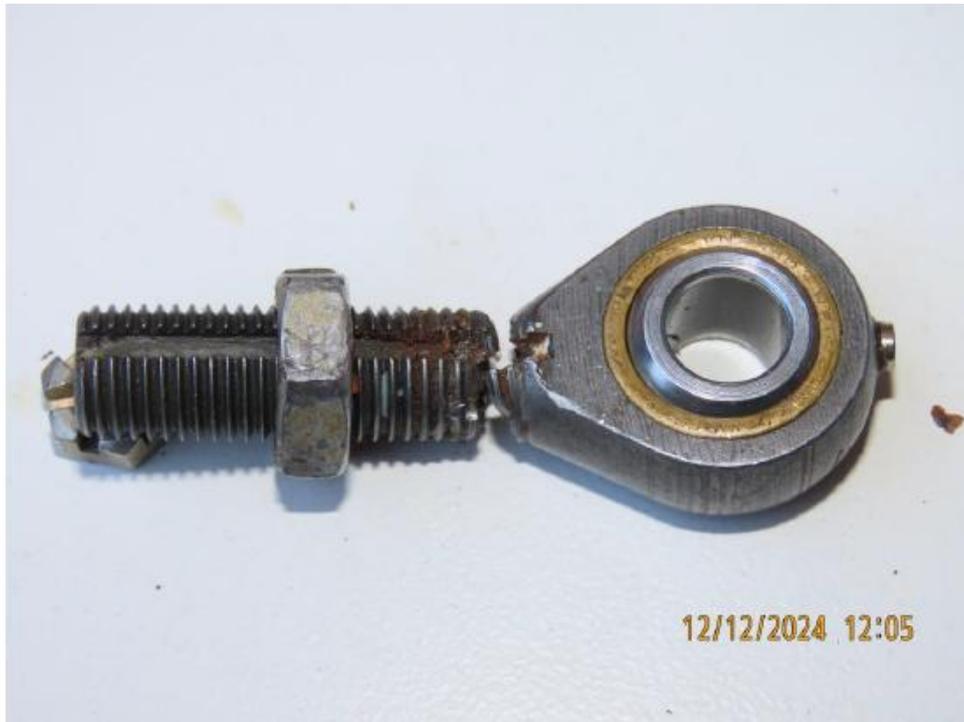
- 1.16.5. Examination of the failed rod end fitting revealed that the rod end with part number S2049M6FG was an old type. The Federal Aviation Administration (FAA), as per their Special Airworthiness Information Bulletin (SAIB) number CE-14-17, had issued a recommendation on 6 May 2014 that the afore-mentioned part be replaced with an improved part number S3469-1. The SAIB was issued in response to several reported incidents in which the rod end body fractured at the lubrication hole on the head of the rod end. However, this type of failure was not applicable in ZS-NDO, even though the part had not been replaced.

Figure 5: The broken actuator rod end that was removed from ZS-NDO. (Source: AMO)

- *Identify main landing gear actuator cracks and if cracks are present, replacement should be done to prevent the possibility of an airplane landing with the MLG not extended and locked down.*
- *Whether or not cracks are found, replace Cessna part numbers S2049-6FG or S2049M6FG with Cessna part number S3469-1 if not previously replaced by S2426-6 as per SE79-37R1.*
- *Comply with Cessna Service Information Letter SE79-37R1 dated 15 December 1980. Additional information is provided in Supplemental Inspection Number 32-10-01, D991-3-13 Temporary Revision Number 7, dated 1 December 2011 in Section 2A-14-03 of the Cessna Aircraft Company Model 177RG Series (1971-1975) Service Manual.*

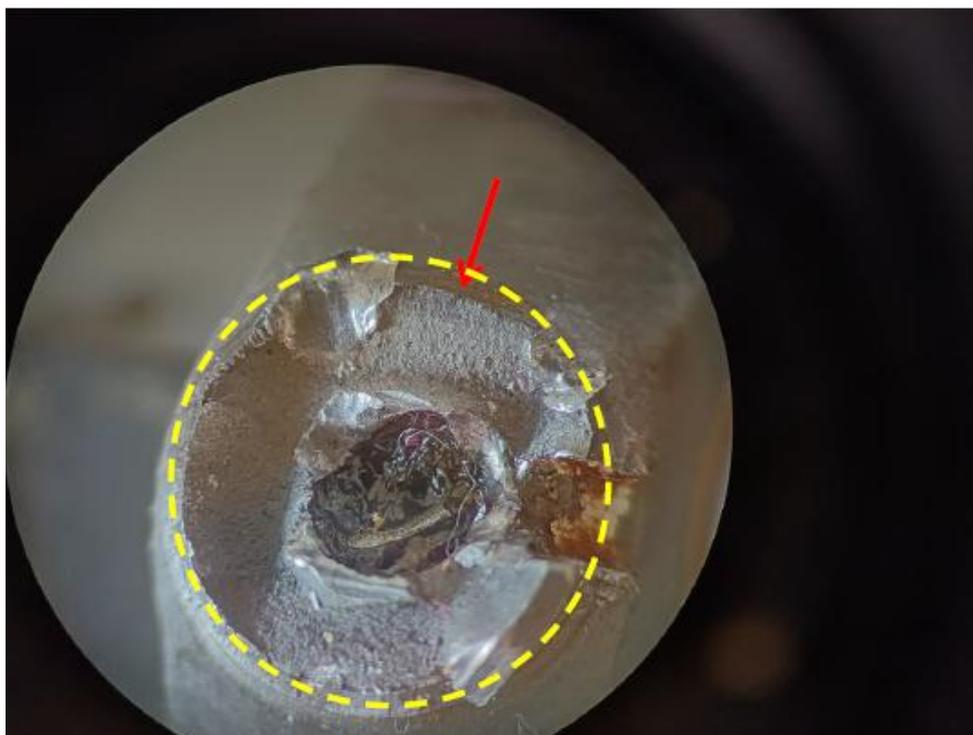
- 1.16.4. An examination of the failed rod end revealed that it had fatigue. There was evidence of a crack which initiated between the last thread cut and the rod end head. The actuator operation (of being extended and retracted) over the years placed cyclic loads on the rod end; the cyclic stresses are known to concentrate in the radius between the last thread cut and the rod end head.

Figure 6: The rod end fracture face. The arrow shows the fatigue fracture initiation point. (Source: AMO)

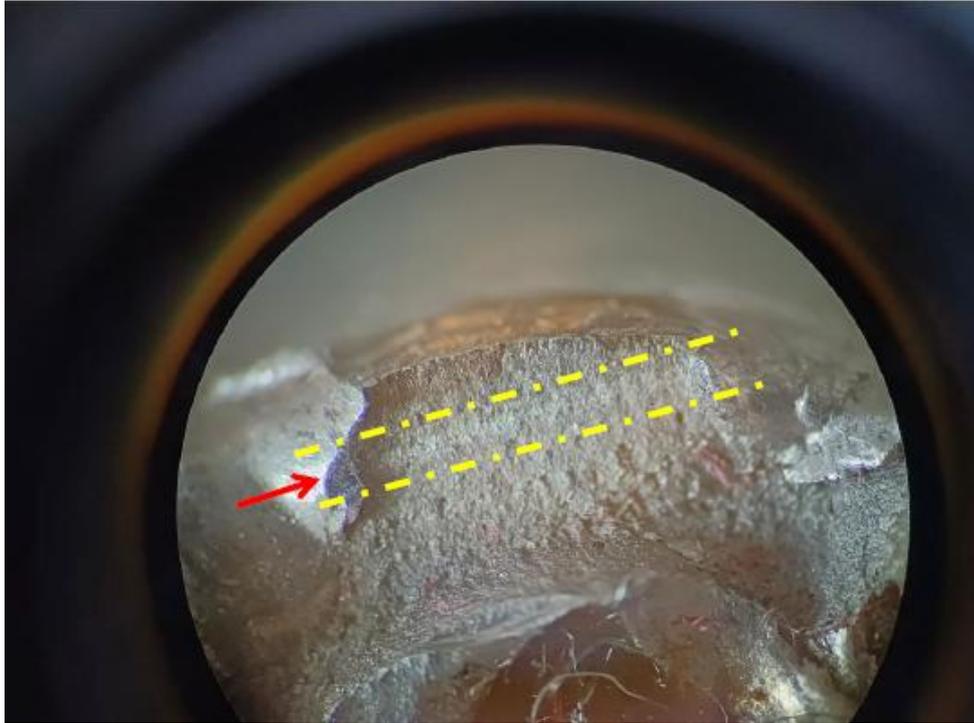
Figure 7: The fatigue fracture striations that formed as the fracture progressed during numerous operation cycles. (Source: AMO)

- 2.2.4. An examination of the failed rod end revealed that the failure was due to fatigue. Moreover, there was a crack that initiated between the last thread cut and the rod end head. The operation of the actuator (extensions and retractions) placed cyclic loads on the rod end. The cyclic stresses are known to concentrate in the radius between the last thread cut and the rod end head.
