Section/division Accident and Incident Investigations Division

LIMITED OCCURRENCE INVESTIGATION REPORT – FINAL

Reference Numbe	r	CA18/2	/3/10535											
Classification	Ac	ccident	cident Date 11 December 2024			Ti	ime 0405Z							
Type of Operation Private (Part 94)														
Location														
Place of Departure	arture Albert Falls Farm Airfield KwaZulu-Natal Province			,	Place of Intended Landing			Eva's Airfield, KwaZulu- Natal Province						
Place of Occurrence Runway 10 at Albert Falls Farm Airfield, approximately 21.7km north of Pietermaritzburg Airport (FAPM), KwaZulu-Natal Province														
GPS Co-ordinates	GPS Co-ordinates Lat		29°27′27" S			Longitude 0		30°22' 01	0°22' 01.0" E		Elevation		1200ft	
Aircraft Information														
Registration	Z	ZU-KAB												
Make; Model; S/N	N	Micro Aviation SA; Bat Hawk R (Serial Number: 0132)												
Damage to Aircraft	5	Substantial				Т	Total Aircraft Hours			5.7	5.7			
Pilot-in-command														
Licence Type P	rivat	ate Pilot Licence				Gender	N	Male			Age	40

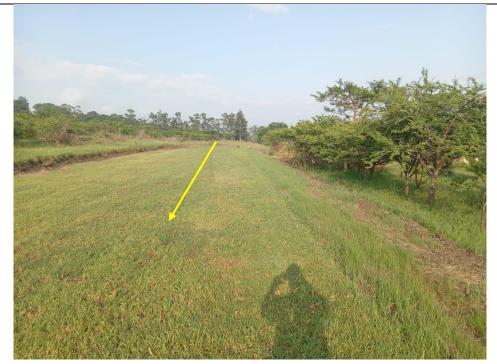
The pilot reported that he lost directional control of the aircraft during the take-off run on the grass-covered runway at Albert Falls Farm Airfield, and the aircraft drifted to the left side of the runway because he did not compensate the drift with the right rudder. The aircraft ultimately exited the runway during which the left wing impacted the trees. The aircraft came to a stop on the left side of the runway. The pilot switched off the fuel and master switch before he disembarked from the aircraft.

Figure 1: The arrow shows the direction of take-off on the runway used. (Source: Pilot)

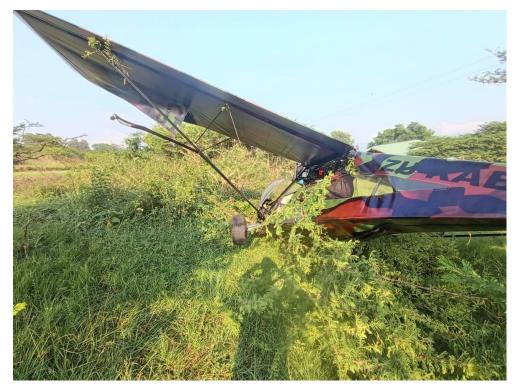
The pilot was not injured during the accident. The aircraft sustained damage to the propeller, wings, tail, windshield and undercarriage.

Figure 2: The aircraft at the accident site. (Source: Pilot)

Loss of directional control of the aircraft during take-off on the grass-covered runway due to the failure to compensate for the engine torque effect which resulted in the aircraft drifting to the left and exiting the runway. It came to rest in the shrubs.

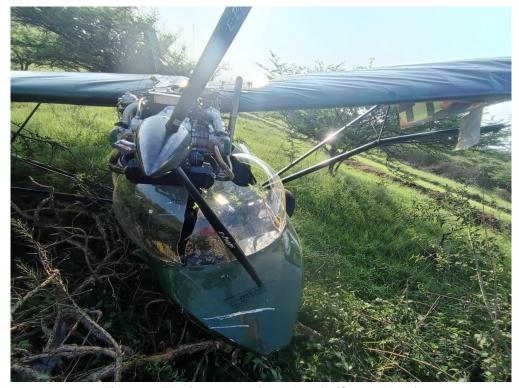
Figure 3: The front view of the aircraft. (Source: Pilot)

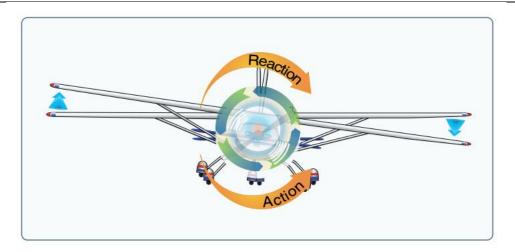
Figure 5-47. Torque reaction.

Torque reaction involves Newton's Third Law of Physics— for every action, there is an equal and opposite reaction. As applied to the aircraft, this means that as the internal engine parts and propeller are revolving in one direction, an equal force is trying to rotate the aircraft in the opposite direction. [Figure 5-47]

When the aircraft's wheels are on the ground during the take-off roll, an additional turning moment around the vertical axis is induced by torque reaction. As the left side of side of the aircraft is being forced down by torque reaction, more weight is being placed on the left main landing gear. This results in more ground friction, or drag, on the left tire than on the right, causing a further turning moment to the left. The magnitude of this moment is dependent on many variables. Some of these variables are:

This yawing moment on the take-off roll is corrected by the pilot's proper use of the rudder or rudder trim.
