AIRCRAFT ACCIDENT REPORT AND EXECUTIVE SUMMARY

Reference:		CA18/2/3/10536	
Aircraft Registration	ZS-ISI	Date of Accident	11 December 2024		Time of Accident	1020Z	
Type of Aircraft	Piper PA-28-180			Type of Operation	Private (Part 91)		
Pilot-in-command Licence Type	Private Pilot Licence		Age	21	Licence Valid	Yes	
Pilot-in-command Flying Experience	Total Flying Hours			113.4	Hours on Type	84.3	
Last Point of Departure	Springs Aerodrome (FASI), Gauteng Province						
Next Point of Intended Landing	Springs Aerodrome (FASI), Gauteng Province						
Damage to Aircraft	Substantial						
Location of the accident site with reference to easily defined geographical points (GPS readings if possible)							
On a field near Springs Aerodrome (FASI) at GPS co-ordinates: 26°14'34.0" South 028°23'50.8" East							
Meteorological Information	Surface wind: 300°/5 kt; visibility: 9999m; temperature: 31°C; CAVOK						
Number of People On-board	1 + 0	Number of People Injured	0	Number of People Killed	0	Other (On Ground)	0

Probable Cause/s and/or Contributory Factors							
Unsuccessful forced landing following an in-flight engine stoppage. The cause of the engine stoppage could not be determined with

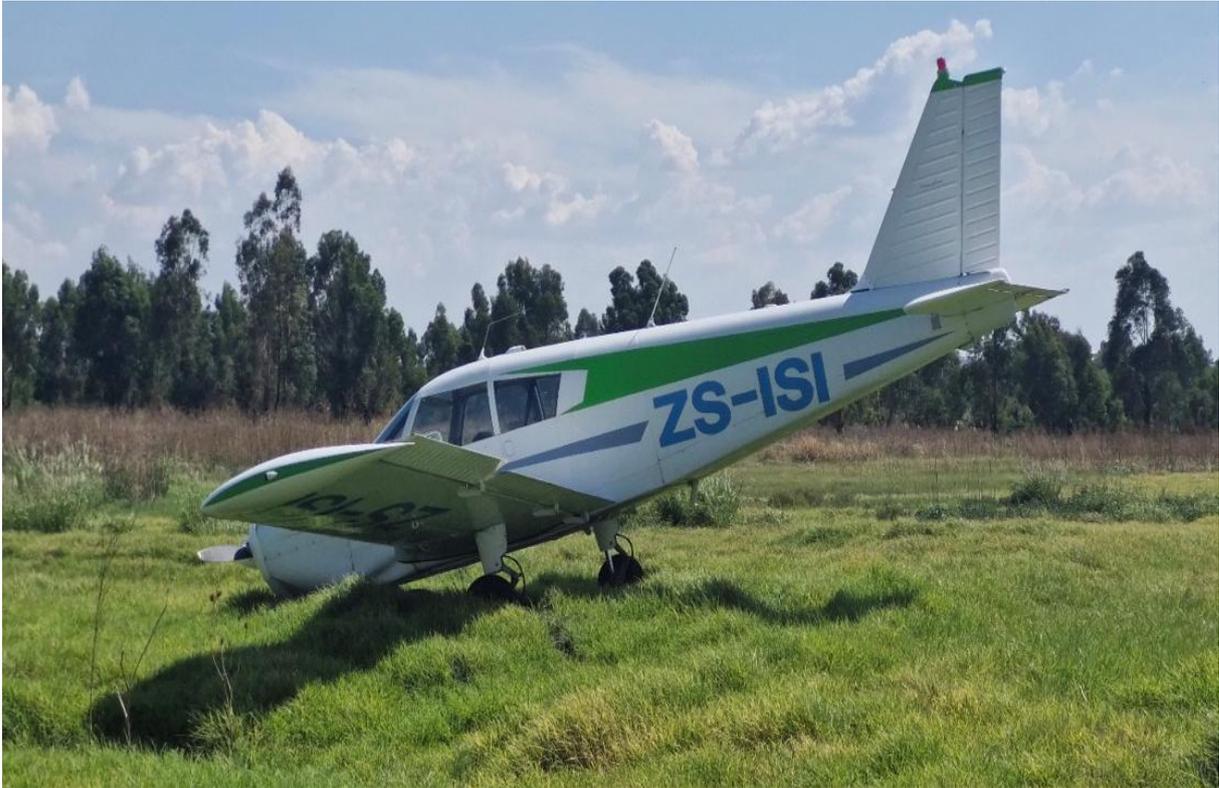
1.3.1. The aircraft sustained damage to the nose landing gear and nose section.

Figure 2: The aircraft as it came to a full stop with the damaged nose landing gear.

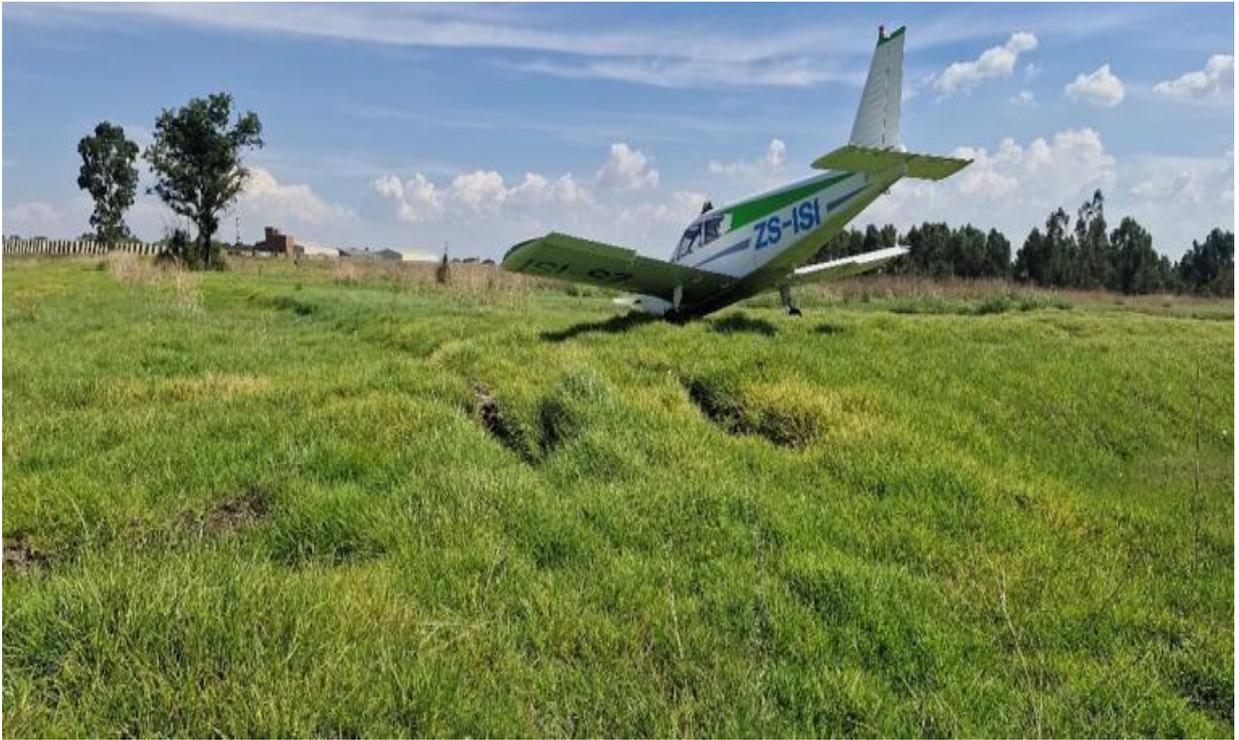
1.12.1. The accident occurred after take-off. The pilot opted to land the aircraft on a field near FASI. However, the terrain was uneven which caused the aircraft to bounce; as a result, the nose landing gear collapsed. The aircraft came to rest in a nose-down attitude approximately 15m after touchdown.

Figure 3: The aircraft at the accident site.

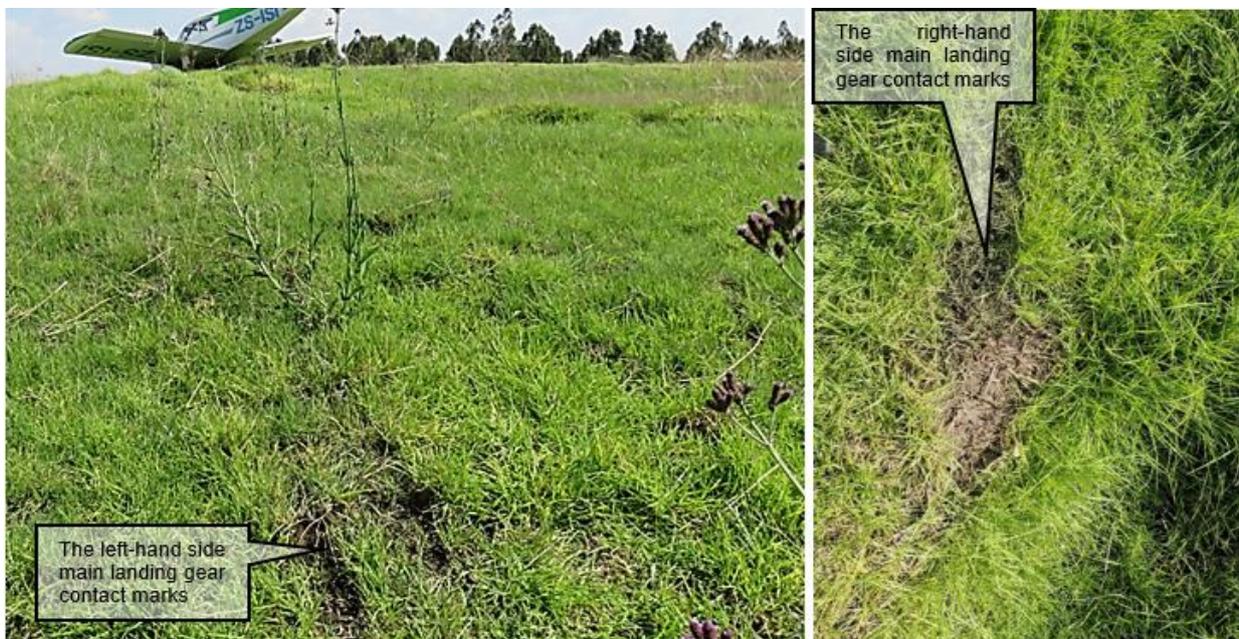
1.12.2. The aircraft's initial touchdown was approximately 12 metres from the bottom of an embankment at the field. There were marks on the ground associated with a hard impact with the main landing gear, which then a bounced onto the embankment (see Figure 4).

Figure 4: The initial impact marks of the left- and right-side of the main landing gears.

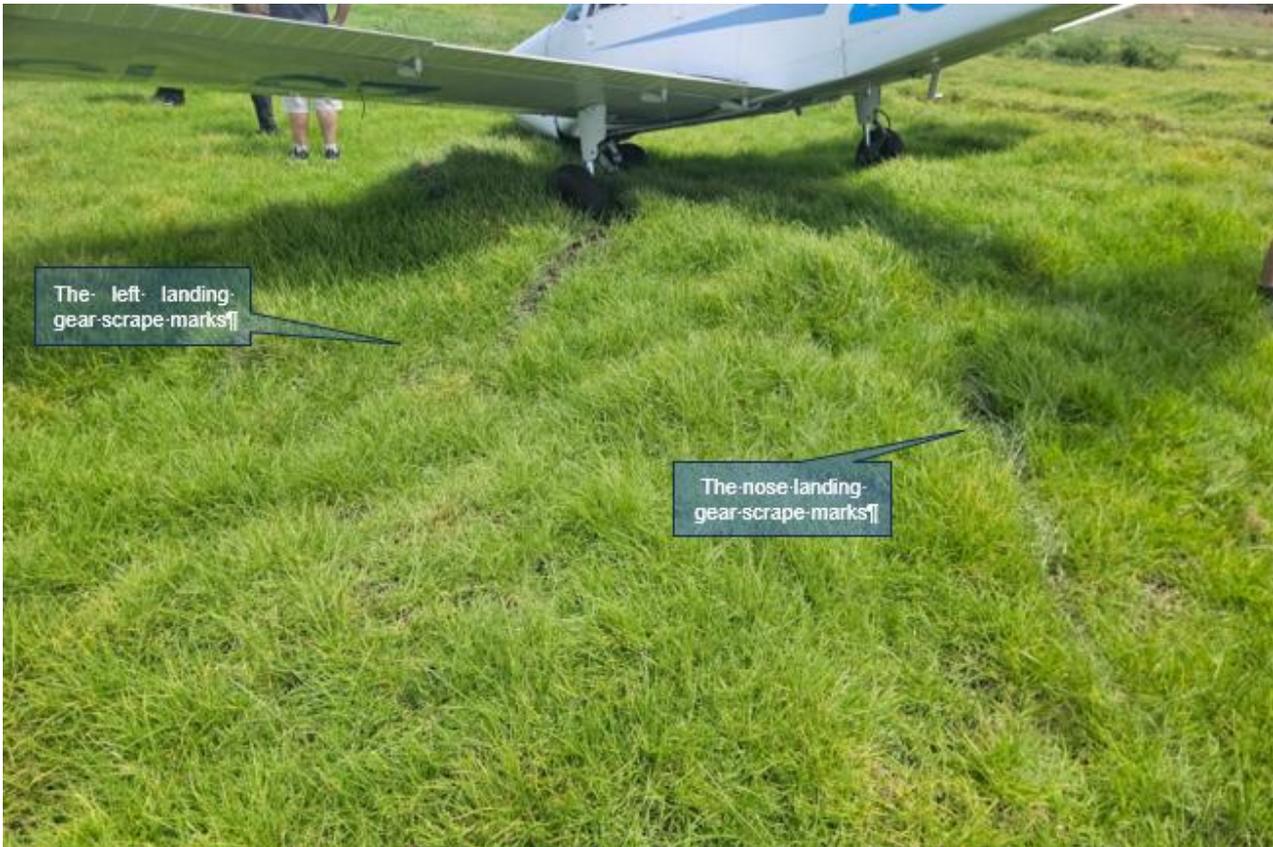
Figure 5: The landing gear scrape marks.

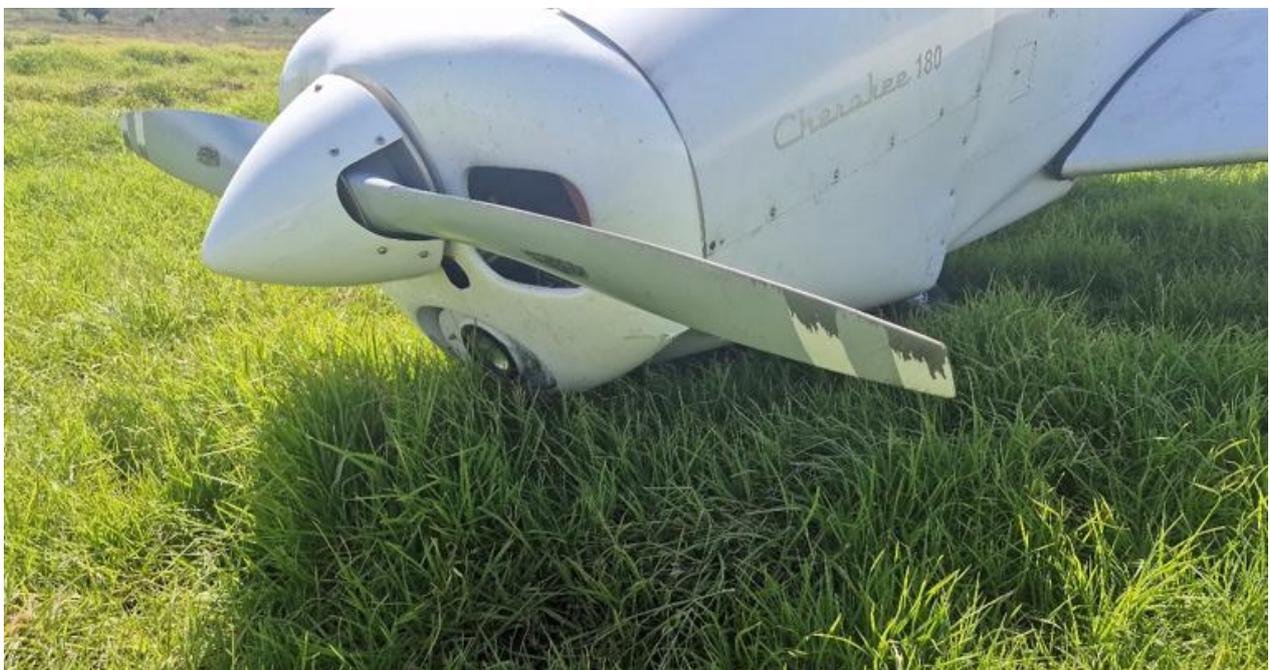
1.12.3. The aircraft sustained damage to the nose landing gear, engine mountings and the firewall.

Figure 6: The aircraft's nose section after the accident. There was no damage to the propeller.

1.12.4. There was no sign of damage (or contact with the ground) on the propeller blades. According to the observations, the propeller had stopped rotating and remained in a level position before the forced landing (see Figure 6).

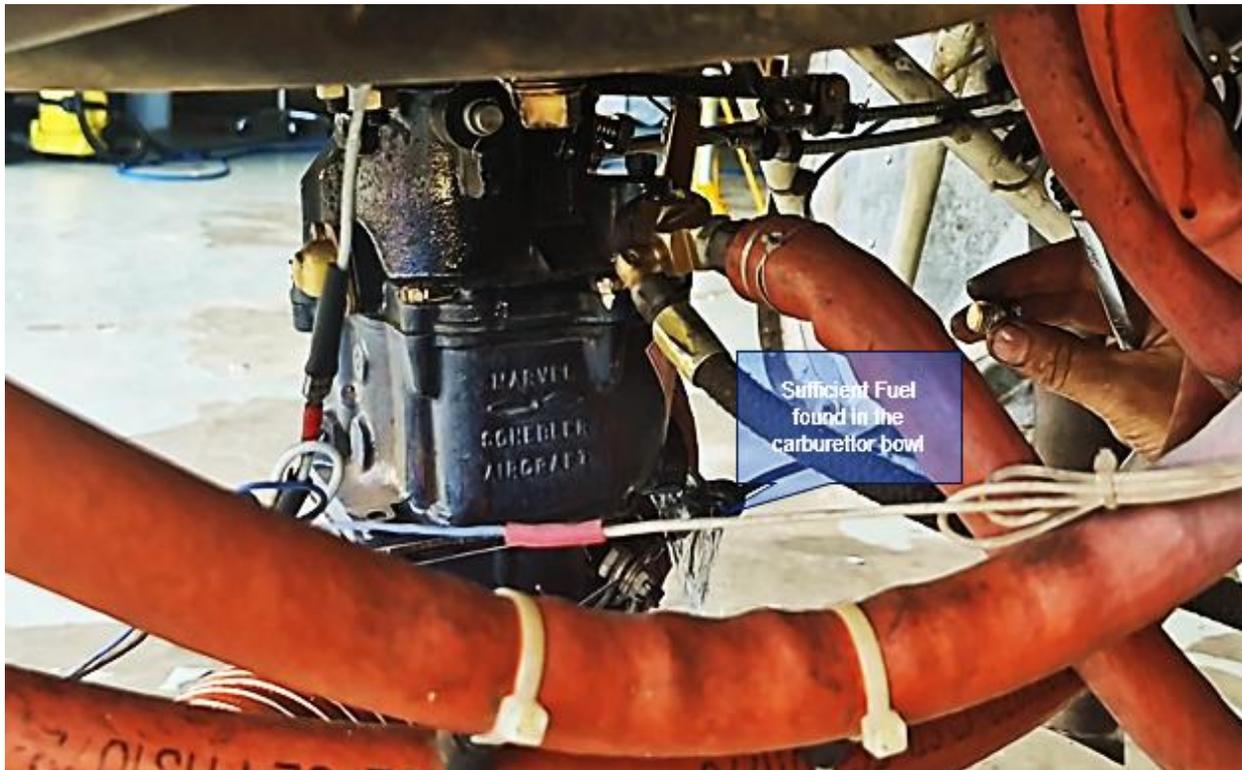
Figure 7: The carburetor bowl had sufficient fuel in it.

1.12.5. There was sufficient fuel in both tanks and the fuel system, including the fuel filter and carburetor bowl (see Figures 7 and 8).

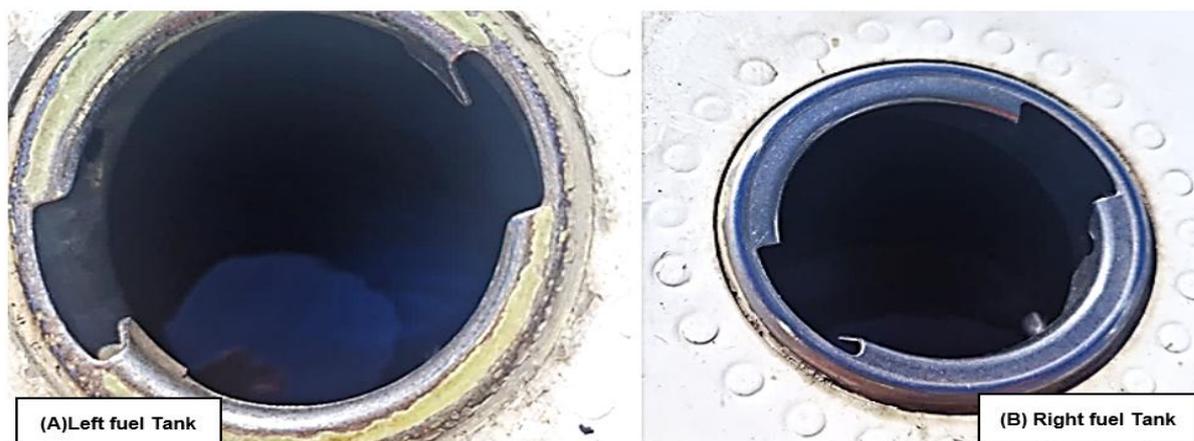
Figure 8: The filler caps of the left fuel tank (A) and right fuel tank (B).
