AIRCRAFT ACCIDENT REPORT AND EXECUTIVE SUMMARY

| | | | | Reference: | | CA18/2/3/10537 | |
| Aircraft Registration | ZS-KHZ | Date of Accident | 14 December 2024 | | Time of Accident | 0812Z | |
| Type of Aircraft | Piper PA-38-112 | | | Type of Operation | Training (Part 141) | | |

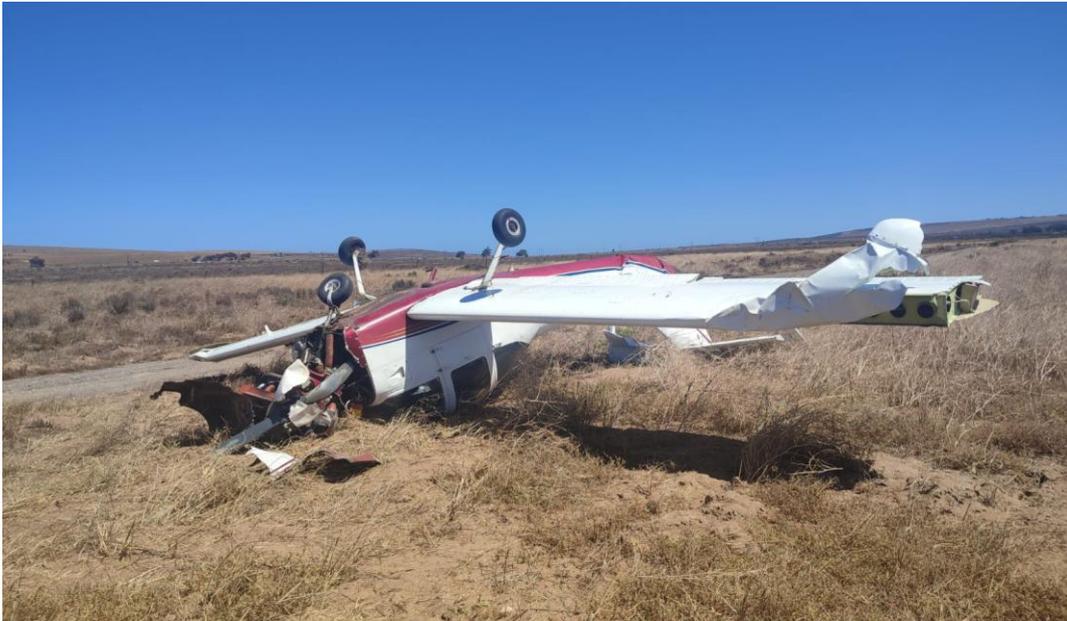
1.3.1 The aircraft was substantially damaged during the accident sequence.

Figure 2: The wreckage in an inverted attitude next to the runway.

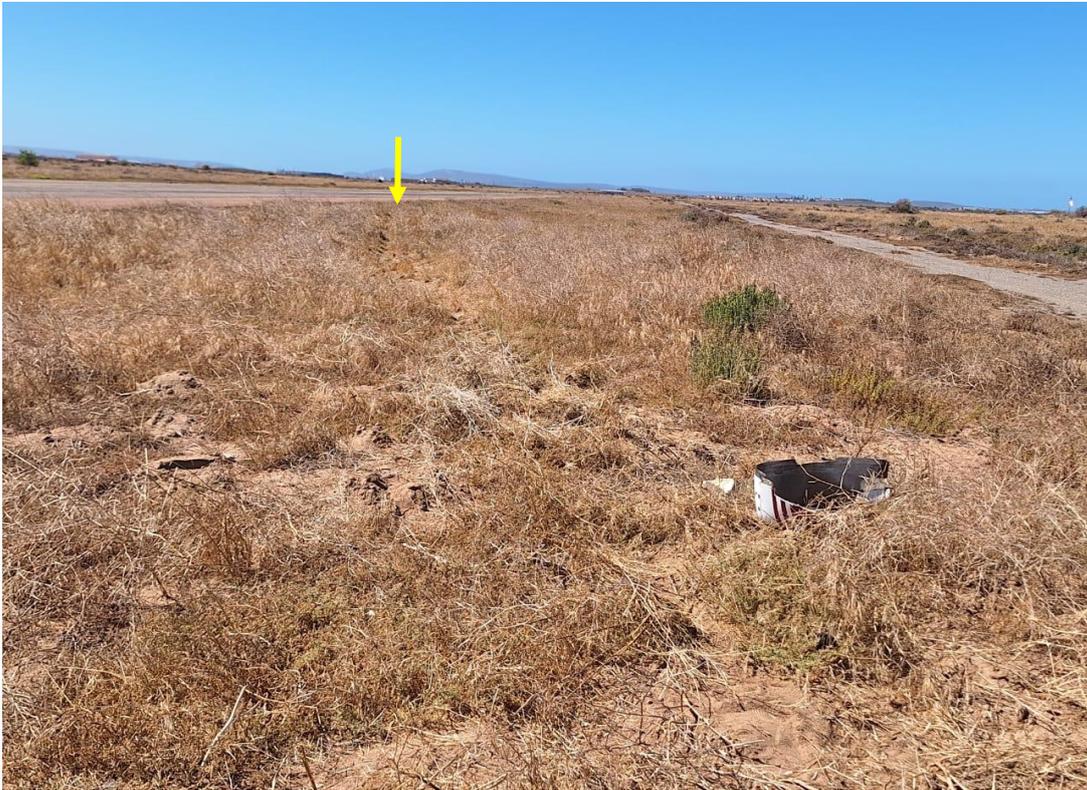
1.12.1 The aircraft veered off to the left of the runway, approximately 600 metres (m) past the threshold of Runway 02. It then careered over uneven terrain that was covered in dry grass for approximately 25m. The nose wheel strut assembly bent backward, and the aircraft nosed over, resting in that attitude.

Figure 6: The aircraft path on dry grass after it had veered off the runway.

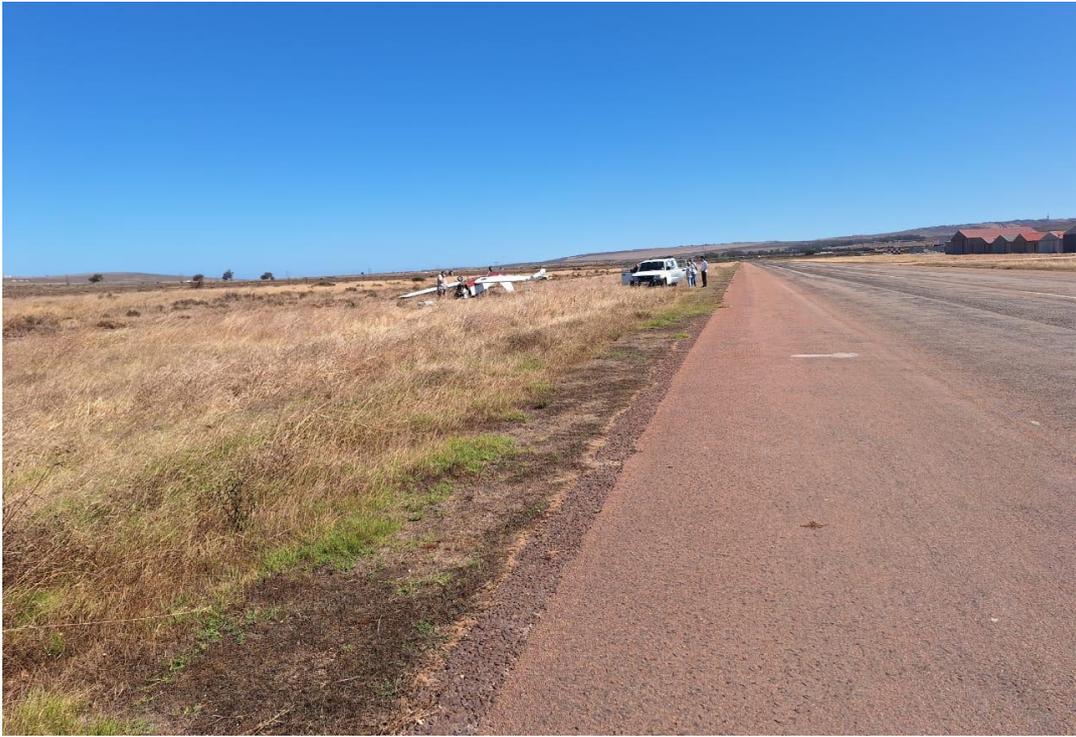
Figure 7: A section of the runway with the aircraft in an inverted attitude.

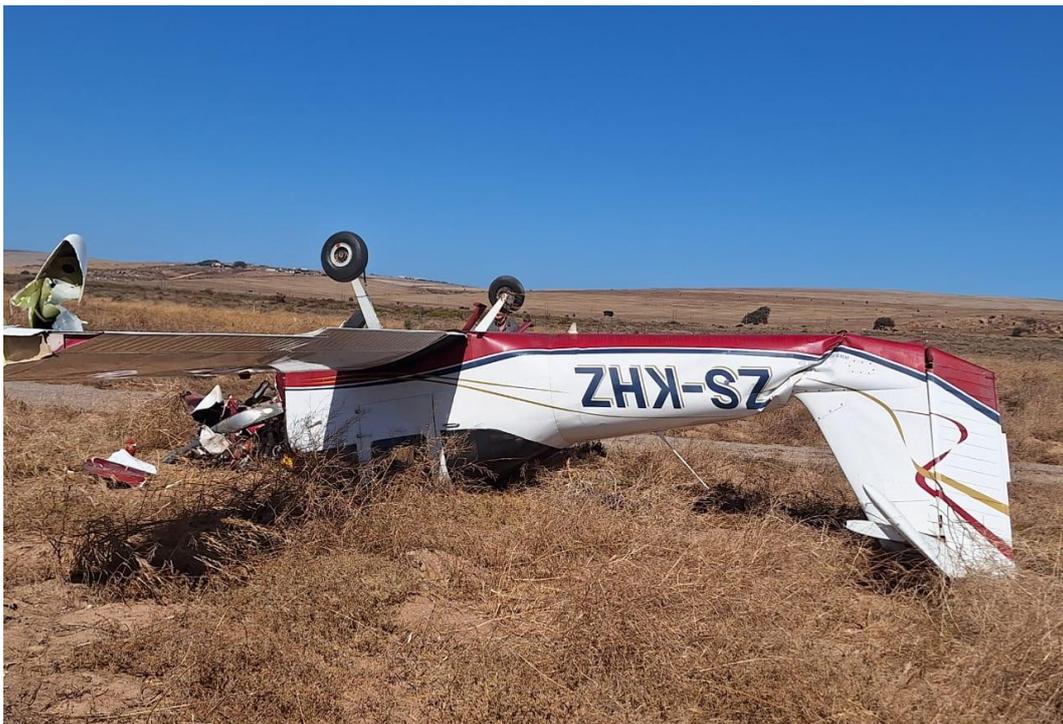
Figure 8: The aircraft as it came to rest.

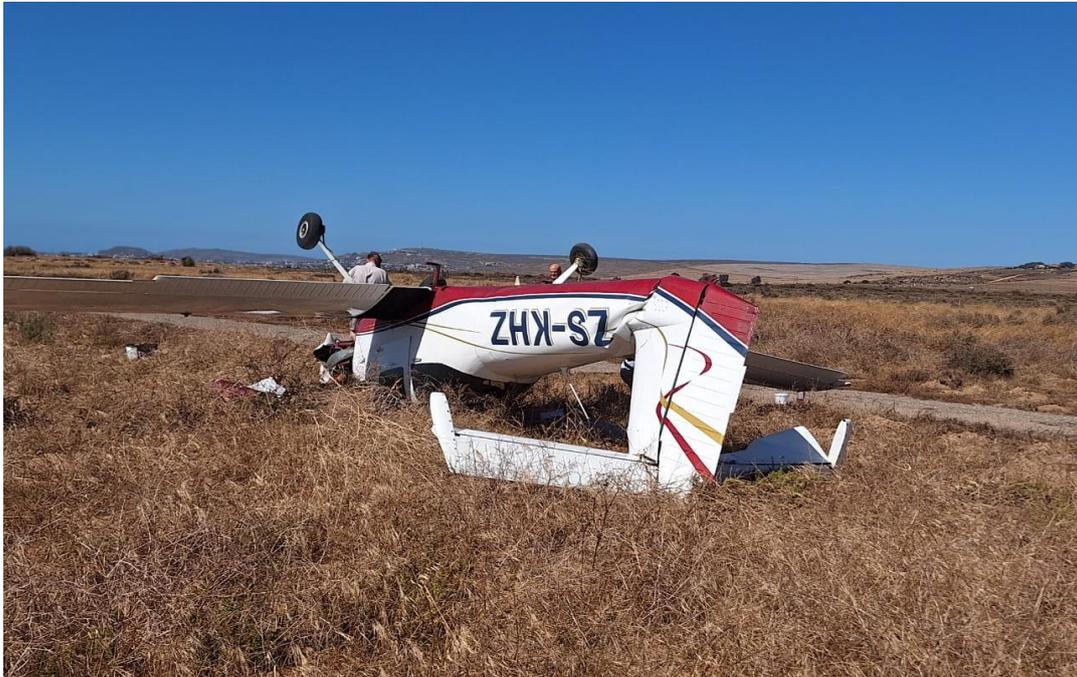
Figure 9: The aft view of the wreckage.
