**LIMITED OCCURRENCE INVESTIGATION REPORT – FINAL**

| <b>Reference Number</b> | CA18/2/3/10538 | | | | | | |
| <b>Registration</b> | ZU-JBU | | | | | | |
| <b>Make; Model; S/N</b> | Jabiru J430 (Serial Number: 1019) | | | | | | |

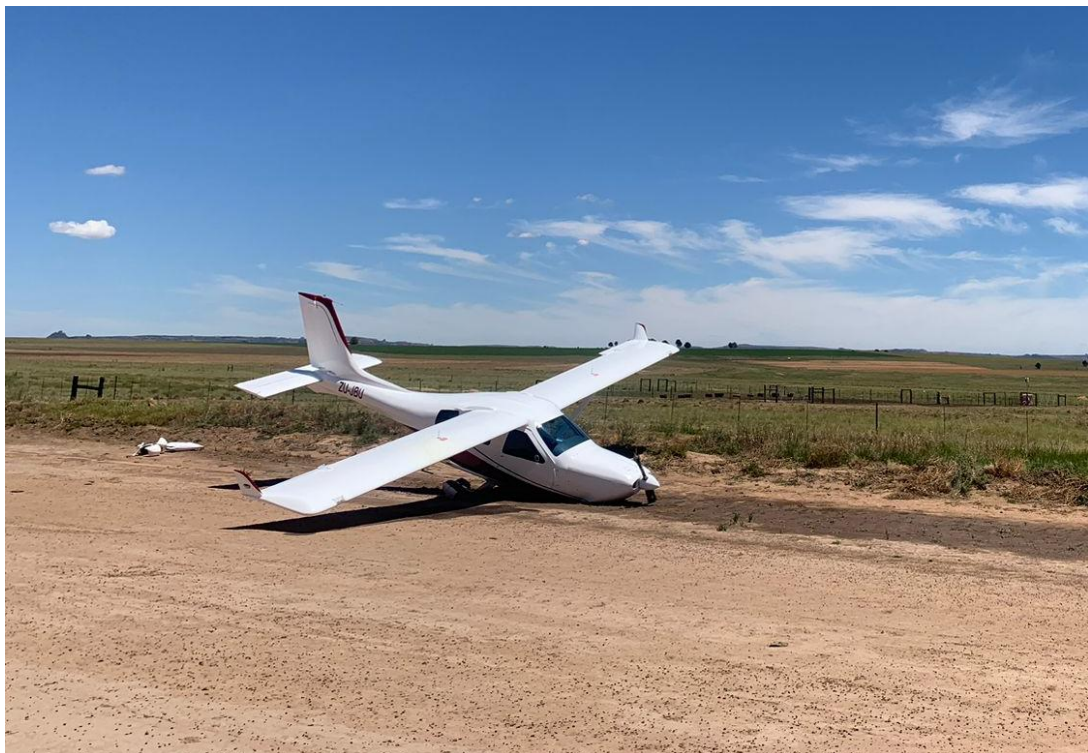
**Figure 2:** The aircraft at the accident site. (Source: Pilot)

The aircraft was not yet airborne when the accident occurred; both main landing gear wheels were still on the ground when the aircraft drifted to the left during the take-off roll. The nosewheel broke off, the propeller struck the ground and both main gear struts were damaged by horizontal forces.

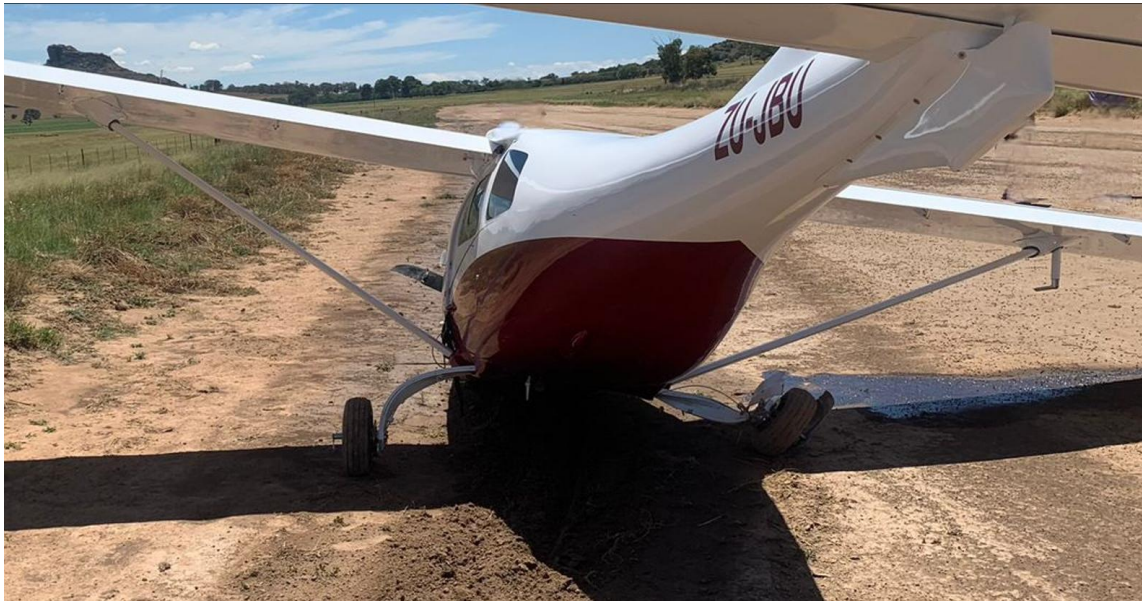
**Figure 3:** The rear view of the aircraft showing the damaged right main gear. (Source: Pilot)

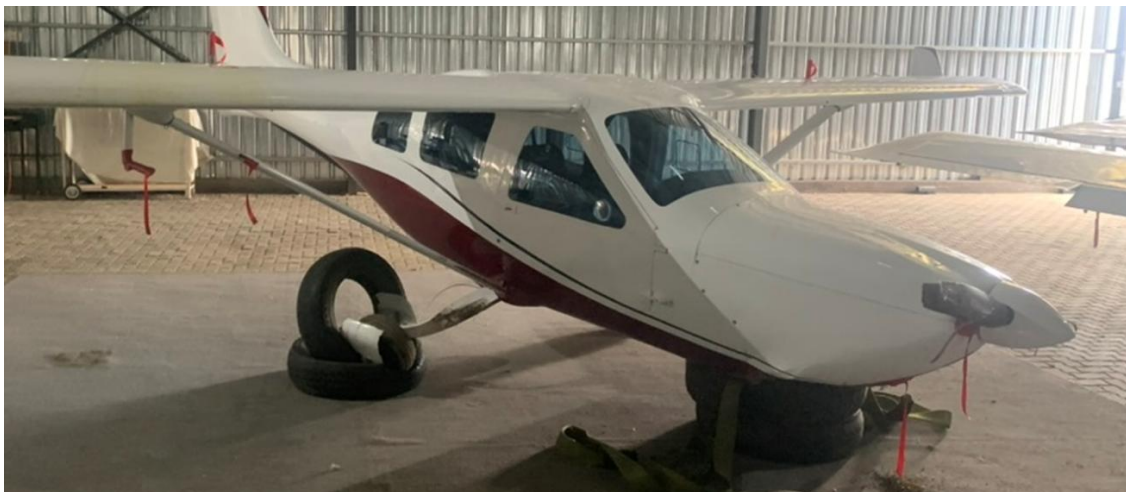
**Figure 4:** Right view of the aircraft showing the damaged right main gear strut. (Source: Pilot)
