LIMITED OCCURRENCE INVESTIGATION REPORT – FINAL

Reference Number	CA18/2/3/10539						
Classification	Accident	Date	24 December 2024		Time	1346Z	
Type of Operation	Private (Part 94)						
Location							
Place of Departure	Lanseria International Airport (FALA), Gauteng Province			Place of Intended Landing	Lanseria International Airport (FALA), Gauteng Province		
Place of Occurrence	Runway 07 at Lanseria International Airport (FALA)						
GPS Co-ordinates	Latitude	26°56'22.89" S	Longitude	027°55' 32.07" E	Elevation	4 521 feet	
Aircraft Information							
Registration	ZU-HUN						
Make; Model; S/N	Hawker Hunter T68 (Serial Number: 41HR003119)						
Damage to Aircraft	Substantial			Total Aircraft Hours	1 877.35		
Pilot-in-command							
Licence Type	Private Pilot Licence		Gender	Male		Age	69
Licence Valid	Yes	Total Hours	1 077.7		Total Hours on Type	155.2	
Total Hours 30 Days	14.2		Total Hours on Type Past 90 Days	14.2			
People On-board	1 + 1	Injuries	0	Fatalities	0	Other (on ground)	0

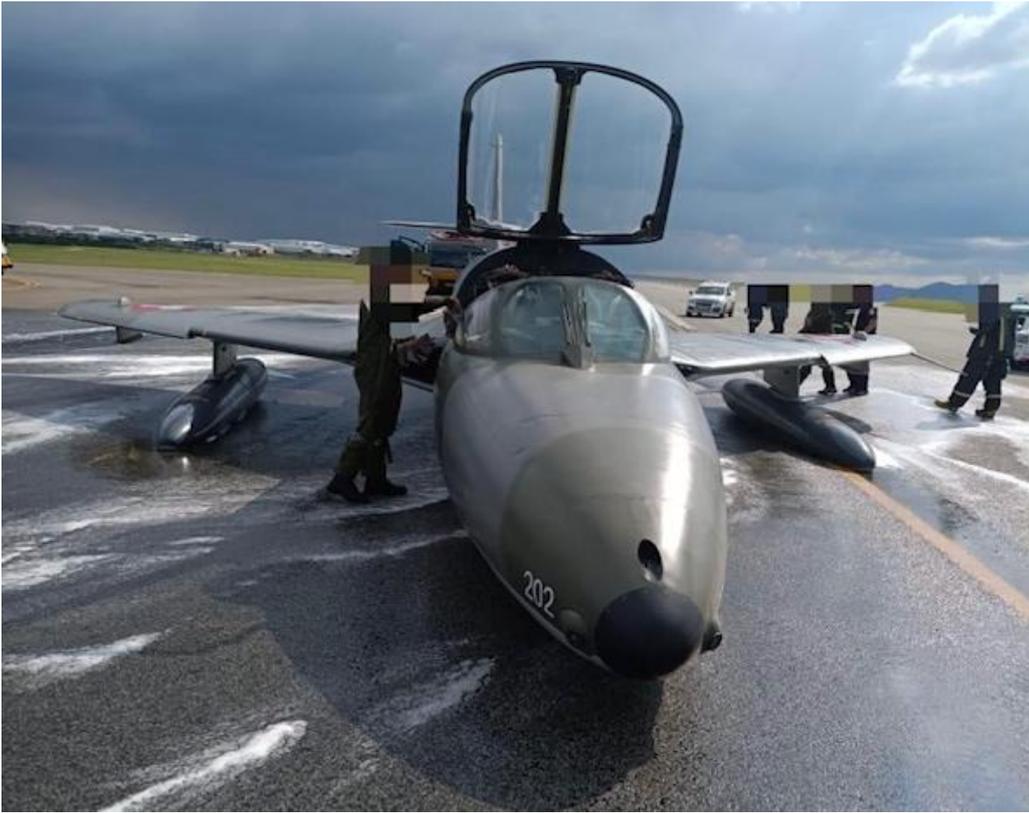
Figure 1: The front view of the aircraft after the accident. (Source: FALA ARFF)

The pilot omitted to extend the landing gear during final approach for landing on Runway 07 and, thus, the aircraft touched down on the underbelly and drop-wing fuel tanks.

It is recommended that the Director of Civil Aviation (SACAA) conduct an assessment relating to the pilot's competence as the pilot made a series of poor airmanship decisions that could have adversely affected other traffic. It is also advisable that the pilot undergo threat and error management training via an approved aviation training organisation to ensure that he has the knowledge to recognise risks and associated consequences as well as act promptly to prevent adverse outcomes.

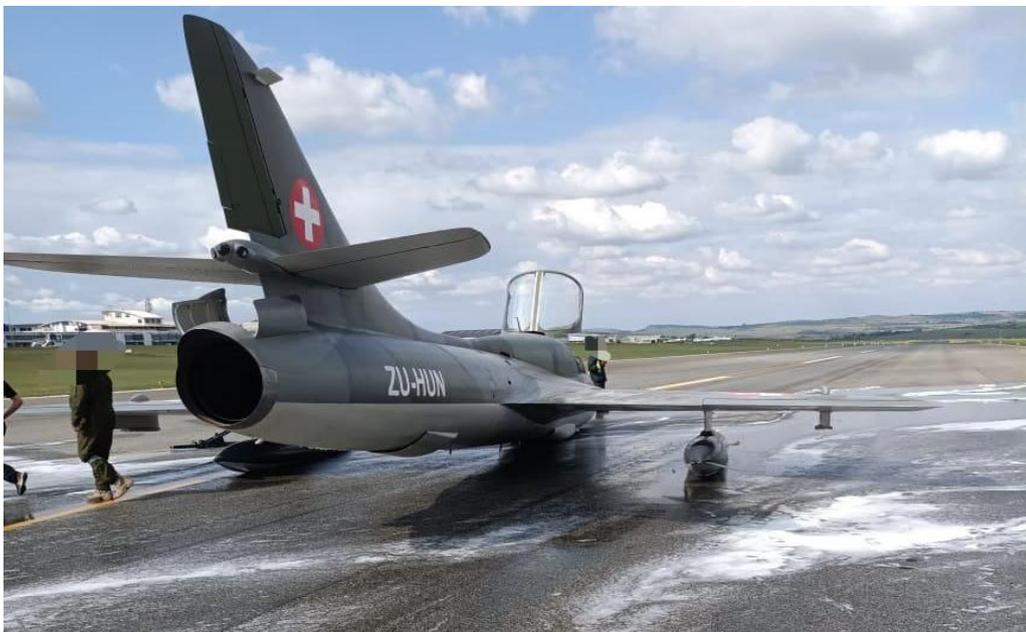
Figure 2: The rear view of the aircraft post-accident. (Source: FALA ARFF)

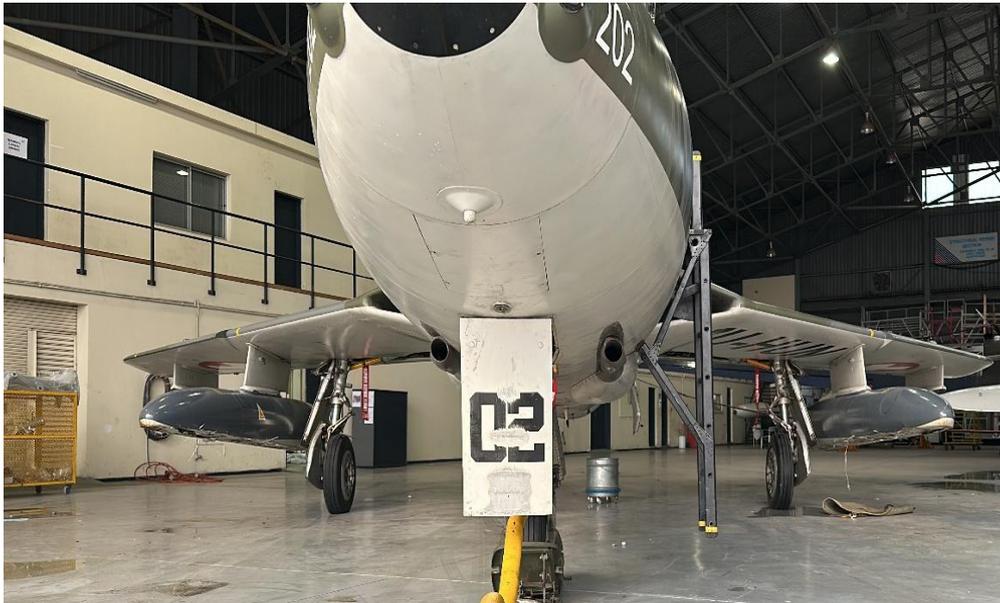
Figure 3: The aircraft after it was recovered to the hangar. (Source: Pilot)
