**LIMITED OCCURRENCE INVESTIGATION REPORT – FINAL**

| <b>Reference Number</b> | CA18/2/3/10540 | | | | | | |
| Registration | ZU-LBD | | | | | | |
| Make; Model; S/N | Shadow Lite CC, Jabiru J430 (Serial Number: 940) | | | | | | |

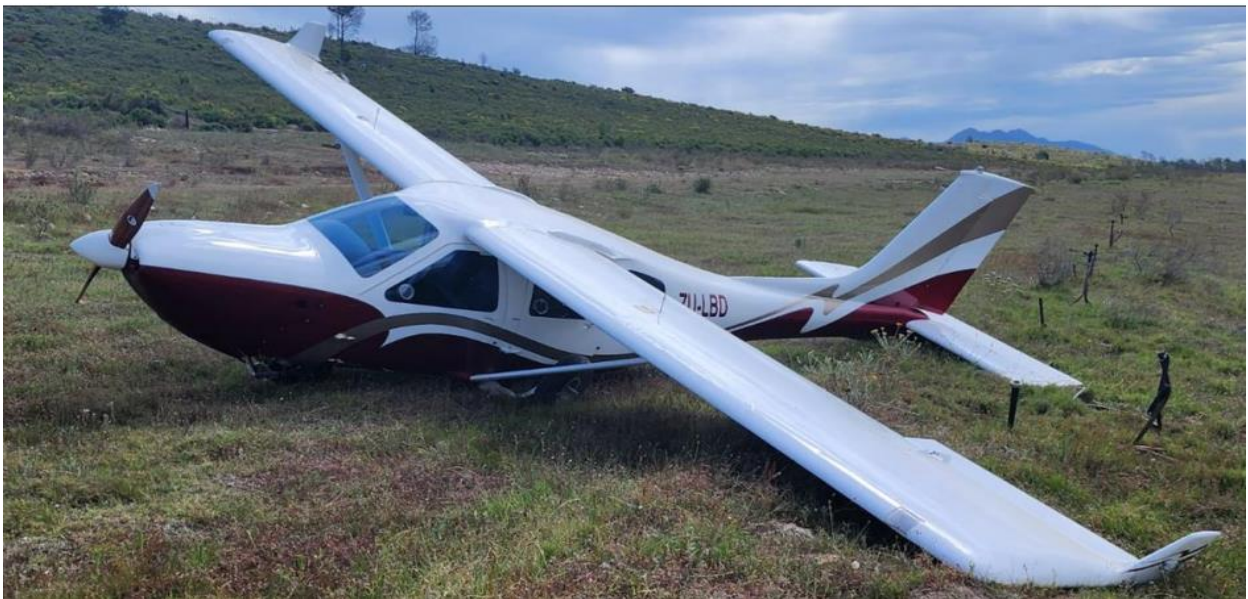
The pilot lost directional control and the aircraft veered off to the left of the runway before it stopped. The aircraft sustained substantial damage to the nose gear strut, right main gear and propeller blades; the occupants were not injured.

**Figure 2:** The aircraft at the accident site. (Source: Pilot)

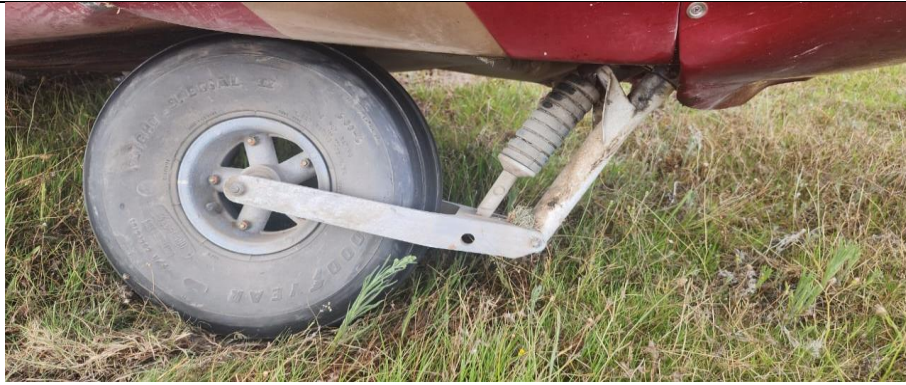
**Figure 3:** The collapsed nose gear strut. (Pilot)

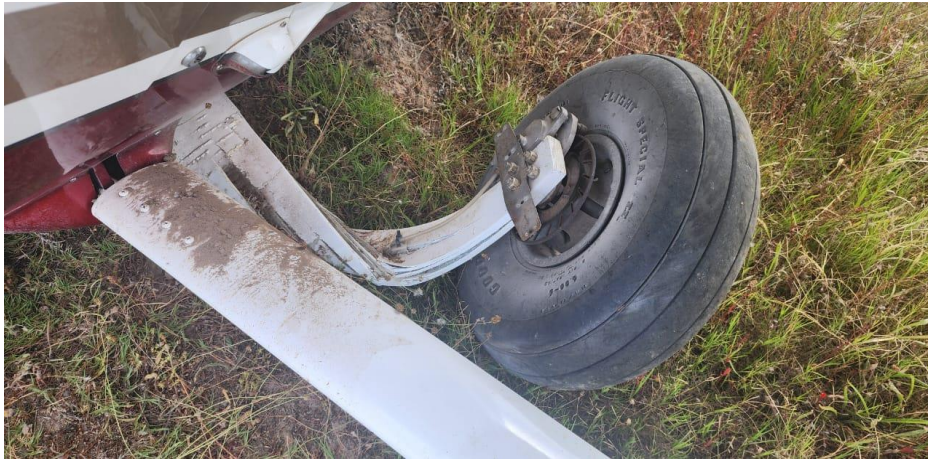
**Figure 4:** The collapsed right main landing gear. (Pilot)

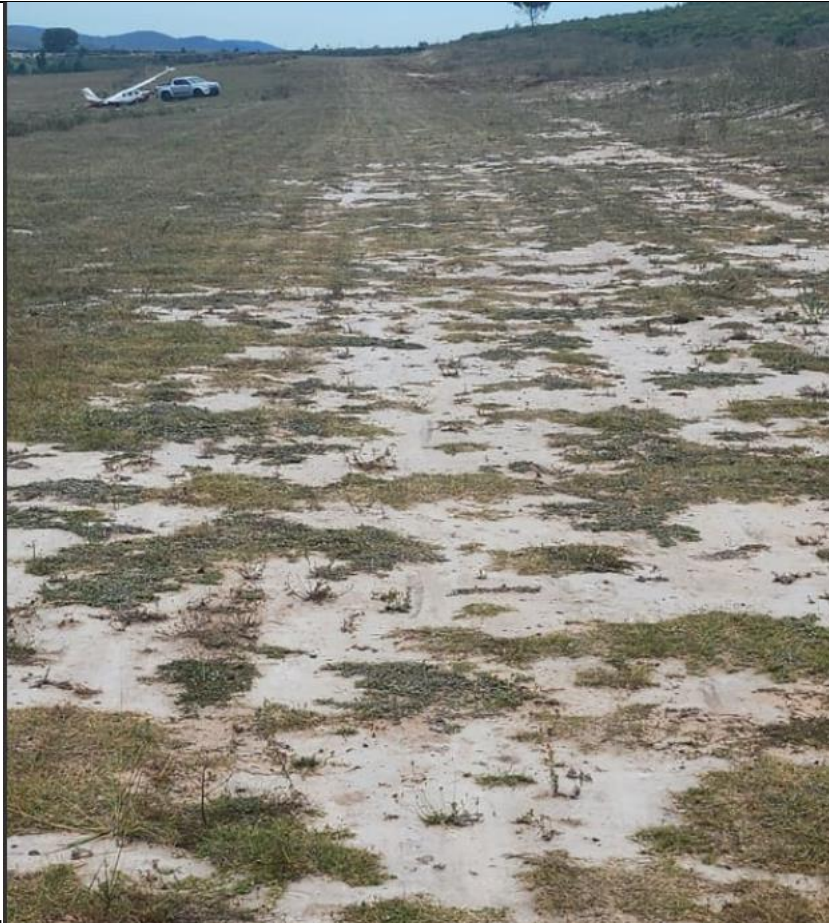
On the day of the accident, the grass was dry, which indicated favourable conditions without significant moisture that could affect traction or stability of the aircraft. The overall terrain was flat and even, which provided a suitable runway surface that would not pose challenges to the aircraft during landing or take-off under normal circumstances.

**Figure 5:** The runway surface condition. (Source: Pilot)

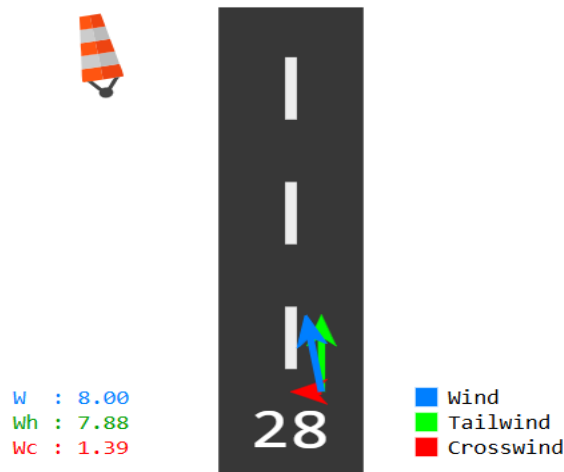
**Figure 6:** An illustration of wind component during landing. (Source: <https://e6bx.com/wind-components/>)

5. The wind component indicated that the aircraft landed tailwind condition, which could have increased the landing speed by 8 kts and affected the pilot's ability to decelerate the aircraft effectively.
