AIRCRAFT ACCIDENT REPORT AND EXECUTIVE SUMMARY

Reference:		CA18/2/3/10541	
Aircraft Registration	ZS-LUG	Date of Accident	1 January 2025		Time of Accident	0605Z	
Type of Aircraft	Piper PA-36-285 Pawnee Brave		Type of Operation		Agricultural Operations (Part 137)		
Pilot-in-command Licence Type	Commercial Pilot Licence (CPL) A		Age	37	Licence Valid	Yes	
Pilot-in-command Flying Experience	Total Flying Hours		5 200.9	Hours on Type	35.4		
Last Point of Departure	Kirkwood Airstrip, north-west of Port Elizabeth, Eastern Cape Province						
Next Point of Intended Landing	Kirkwood Airstrip, north-west of Port Elizabeth, Eastern Cape Province						
Damage to Aircraft	Substantial						
Location of the accident site with reference to easily defined geographical points (GPS readings if possible)							
Runway 22 at Kirkwood Airstrip, approximately 30 nautical miles (nm) north-west of Port Elizabeth Airport (FAPE) at Global Positioning System (GPS) co-ordinates determined to be 33°25'49" South 025°23'48" East, at an elevation of 450 feet (ft)

Reference Number : CA18/2/3/10541
Occurrence Category : Category 2
Type of Operation : Agricultural Operations (Part 137)
Name of Operator : Van Den Berg

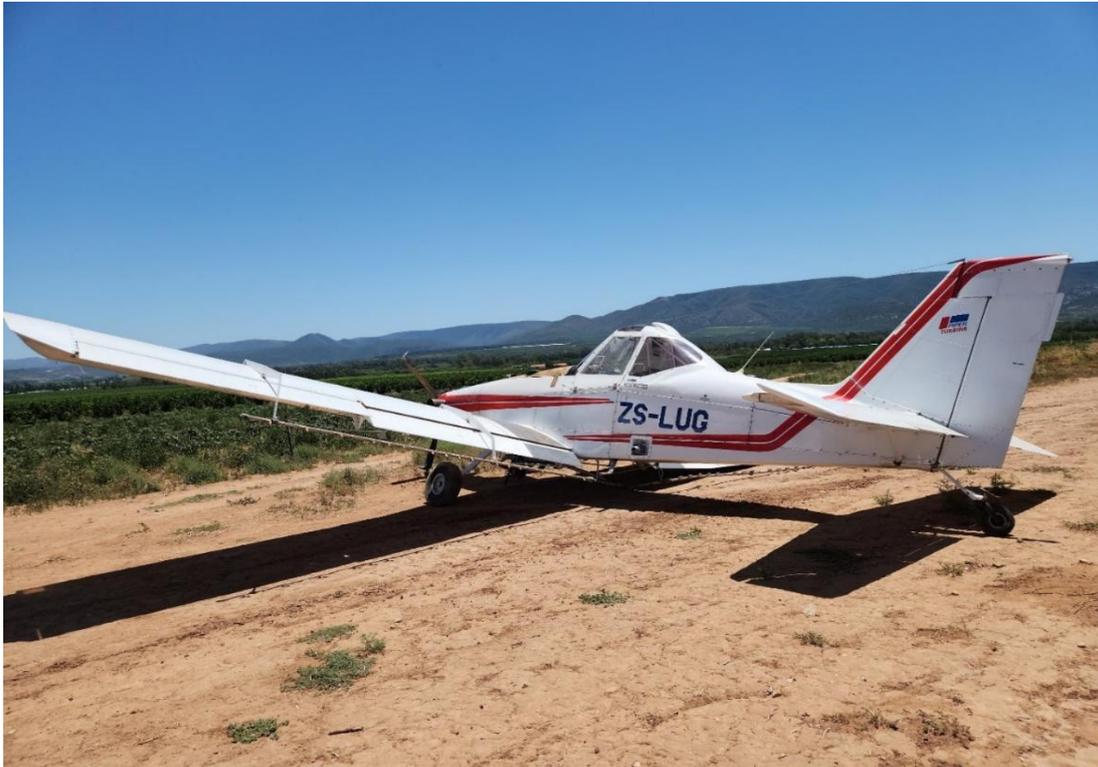
- 1.1.4. The aircraft swung to the right and came to a stop on the runway facing east. The pilot shut down the engine and disembarked from the aircraft without assistance; he was uninjured. The aircraft sustained damage to the right main landing gear, right wing, propeller and the spray gear.

Figure 2: The ZS-LUG resting on the gravel runway. (Source: Pilot)

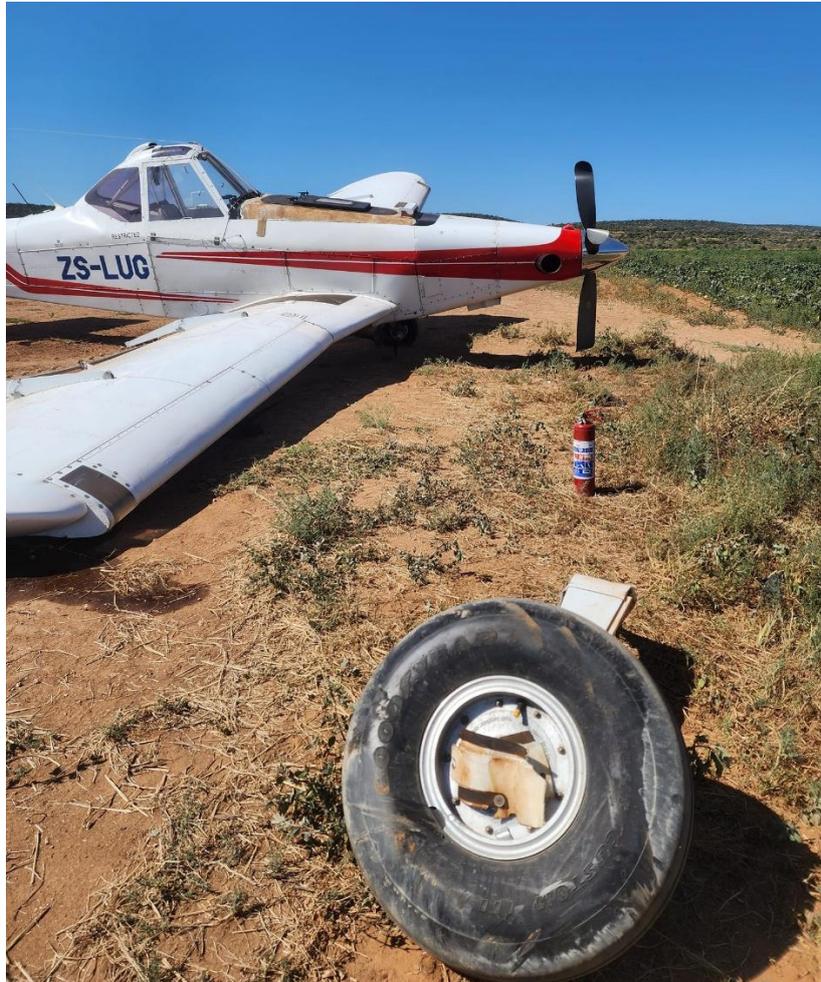
1.12.1. The aircraft landed on Runway 22 at Kirkwood Airstrip after completing seven successful spray runs. During the landing roll, the right main landing gear separated from the fuselage. The aircraft swung to the right and came to rest on the right side of the runway.

Figure 3: The separated landing gear strut and the wheel assembly in the foreground. (Source: Pilot)

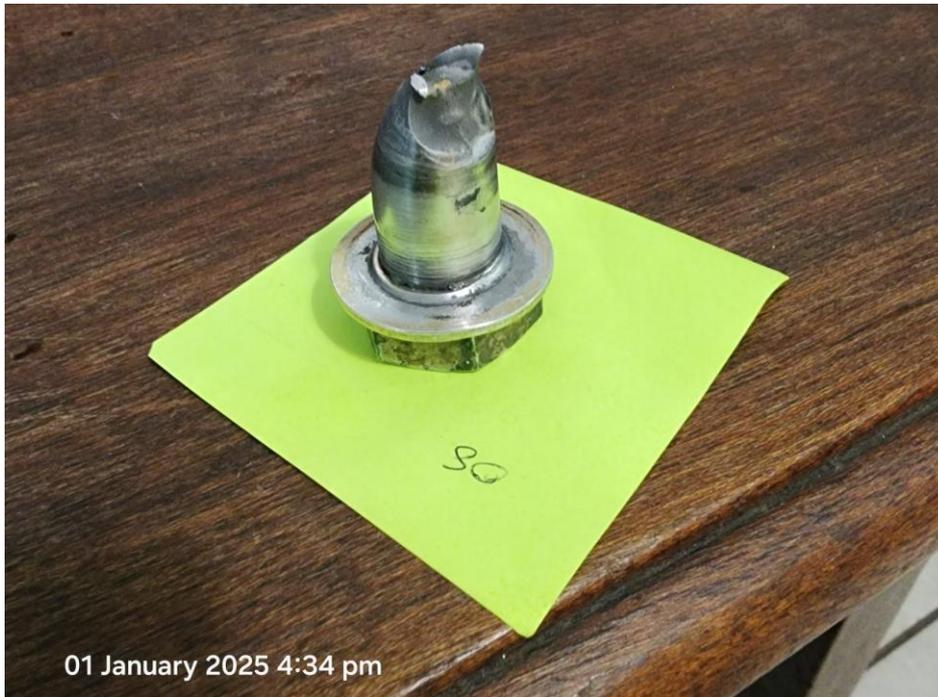
1.16.1. A runway inspection post-accident revealed that a bolt had sheared off during the landing roll on Runway 22.

Figure 4: The failed bolt. (Source: Operator)

- 2.2.3 It is possible that the bolt had worn off over time due to the landing forces exerted on the gear. The pre-flight inspection could not reveal the wear on the bolt due to its concealed location. According to the POH and the Service Manual, the failed bolt is an on-condition item that is to be inspected at 50-hour intervals.

3.3.1. The bolt that secured the right main landing gear on the under fuselage sheared off during the landing roll on Runway 22 and caused the gear to separate. This resulted in the right-wing tip and the propeller contacting the ground; subsequently, the aircraft swung to the right.

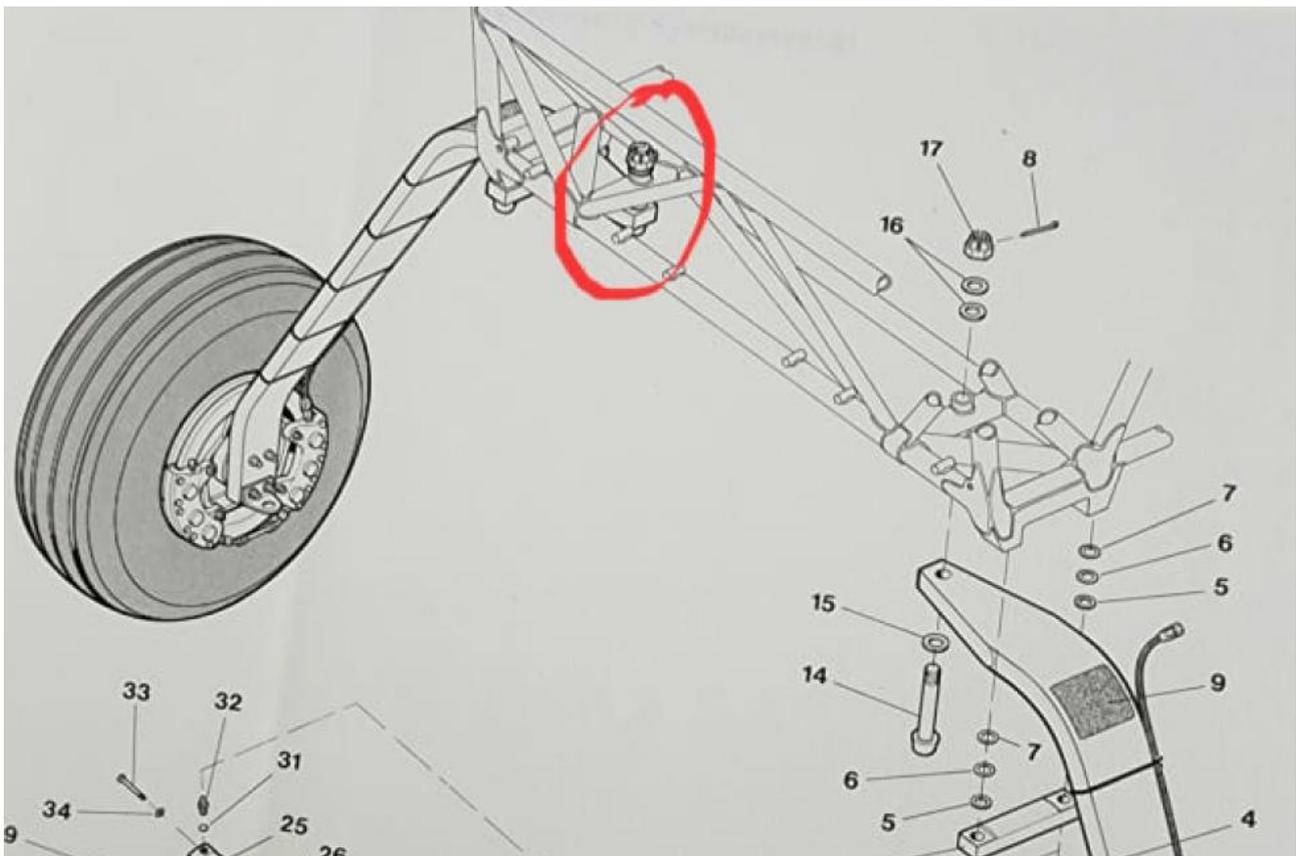
Diagram 1: The Illustrated Parts Catalogue (IPC) shows the sheared bolt as item 14. (Source: IPC)
