**LIMITED OCCURRENCE INVESTIGATION REPORT – FINAL**

<b>Reference Number</b>	CA18/2/3/10542						
<b>Classification</b>	Accident	<b>Date</b>	08 January 2025		<b>Time</b>	0545Z	
<b>Type of Operation</b>	Private (Part 94)						
<b>Location</b>							
Place of Departure	Cape St Francis (FACF), Eastern Cape Province		Place of Intended Landing		Rustenburg Aerodrome (FARG), North West Province		
Place of Occurrence	On Runway 28 at Cape St Francis Aerodrome (FACF), Eastern Cape Province						
GPS Co-ordinates	Latitude	34°11'.26"S	Longitude	24°49'.91"E	Elevation	134 ft	
<b>Aircraft Information</b>							
Registration	ZU-IXU						
Make; Model; S/N	Jabiru J430 (Serial Number: 0006)						
Damage to Aircraft	Substantial			Total Aircraft Hours	105		
<b>Pilot-in-command</b>							
Licence Type	Private Pilot Licence (PPL) Aeroplane		Gender	Male		Age	56
Licence Valid	Yes	Total Hours	166.5		Total Hours on Type	99.0	
Total Hours 30 Days	9.4		Total Flying on Type Past 90 Days	14.2

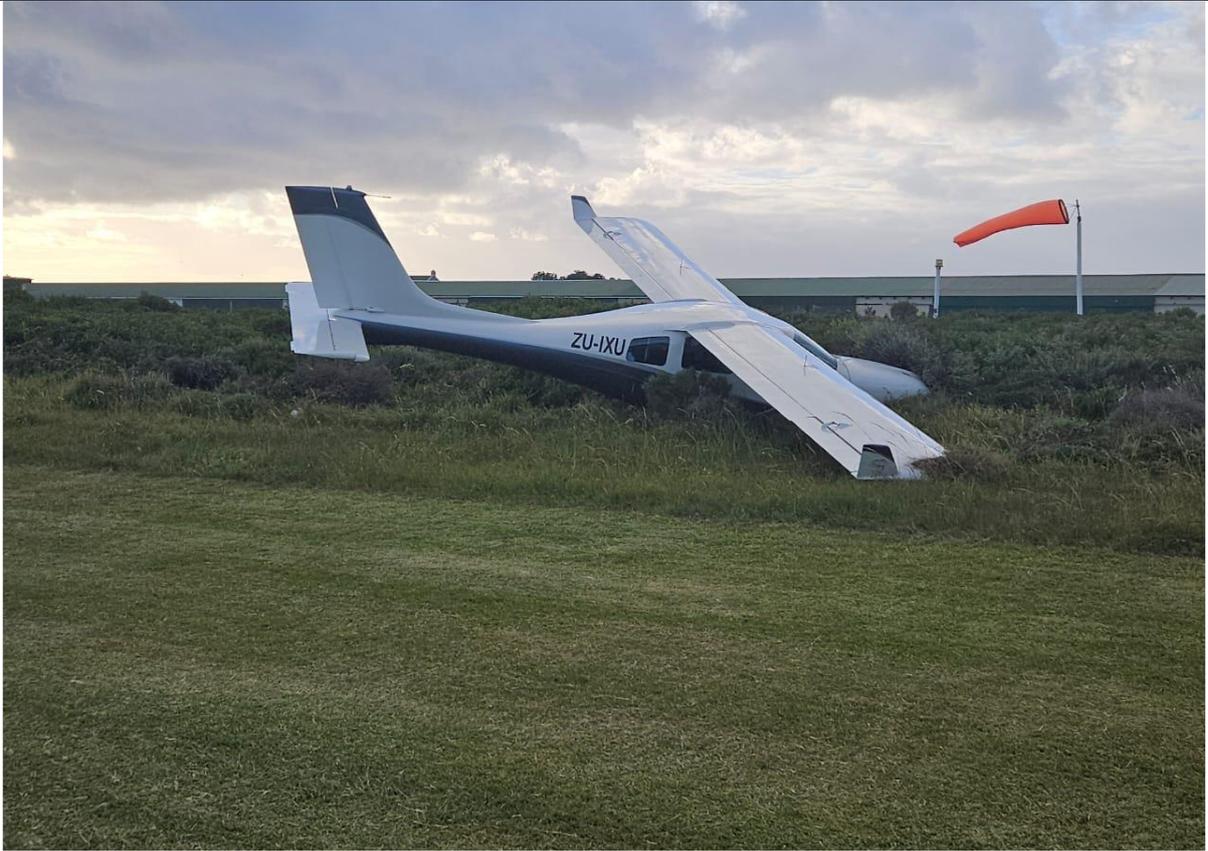
The pilot stated that during the take-off roll, the aircraft accelerated down the runway at an indicated airspeed (IAS) of approximately 50 kts; however, he lost directional control of the aircraft, and it veered off to the left. He then tried to correct the direction by engaging the right rudder pedal, but this action was not sufficient to redirect the aircraft back onto the centre of the runway. Consequently, the aircraft exited the runway and careered onto the grass area. During this sequence, the nose gear strut collapsed, and the propeller struck the ground. The aircraft sustained substantial damage to the propeller, nose wheel and the right under carriage. None of the occupants was injured.

**Figure 2:** The final resting position of the aircraft after the accident. (Source: Pilot)

3.1 The pilot lost directional control of the aircraft during the take-off roll due to failure to compensate for the engine torque effect. The pilot's action was not sufficient to stop the aircraft from veering off the runway.

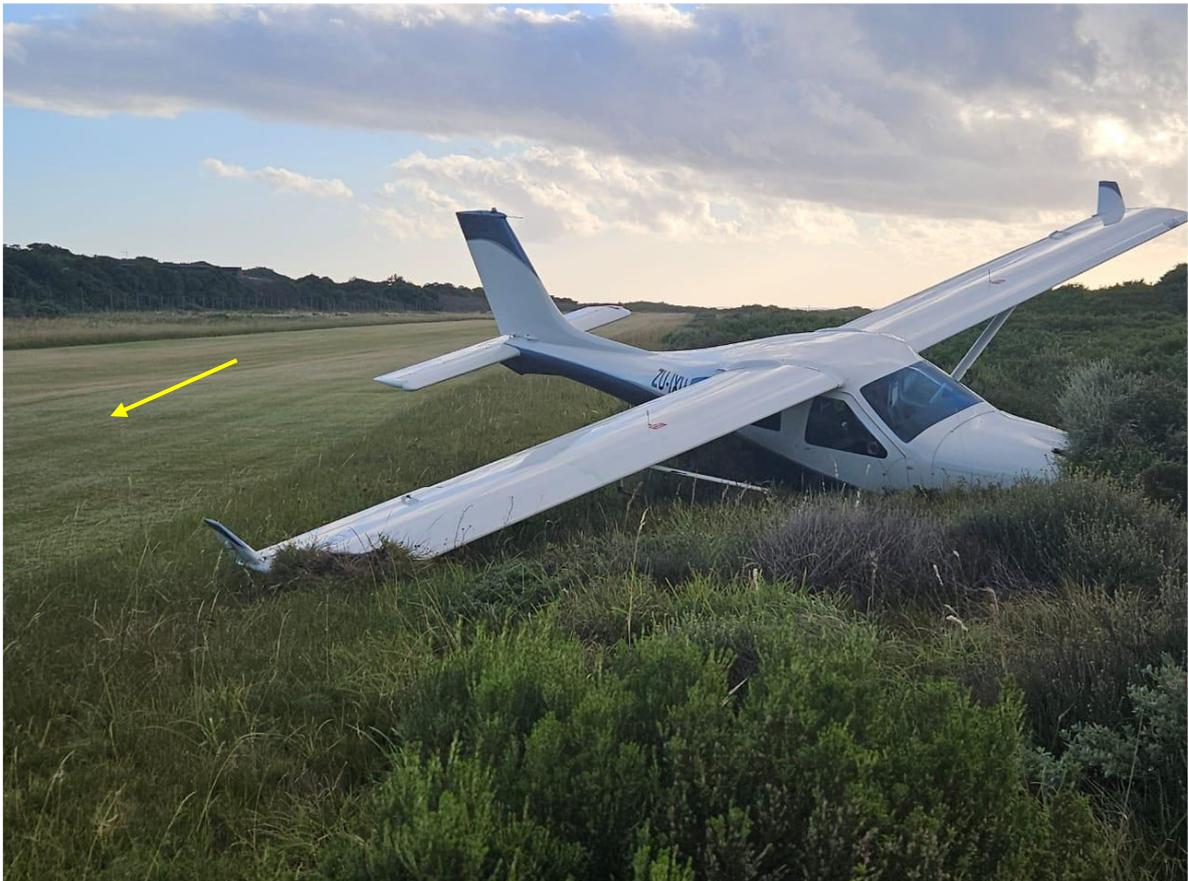
**Figure 3:** The yellow arrow shows the direction of take-off. (Source: Pilot)
