**LIMITED OCCURRENCE INVESTIGATION REPORT – FINAL**

| <b>Reference Number</b> | CA18/2/3/10543 | | | | | | |
| Registration | ZS-RMD | | | | | | |
| Make; Model; S/N | Robinson; R44 Raven I (Serial number: 0812) | | | | | | |

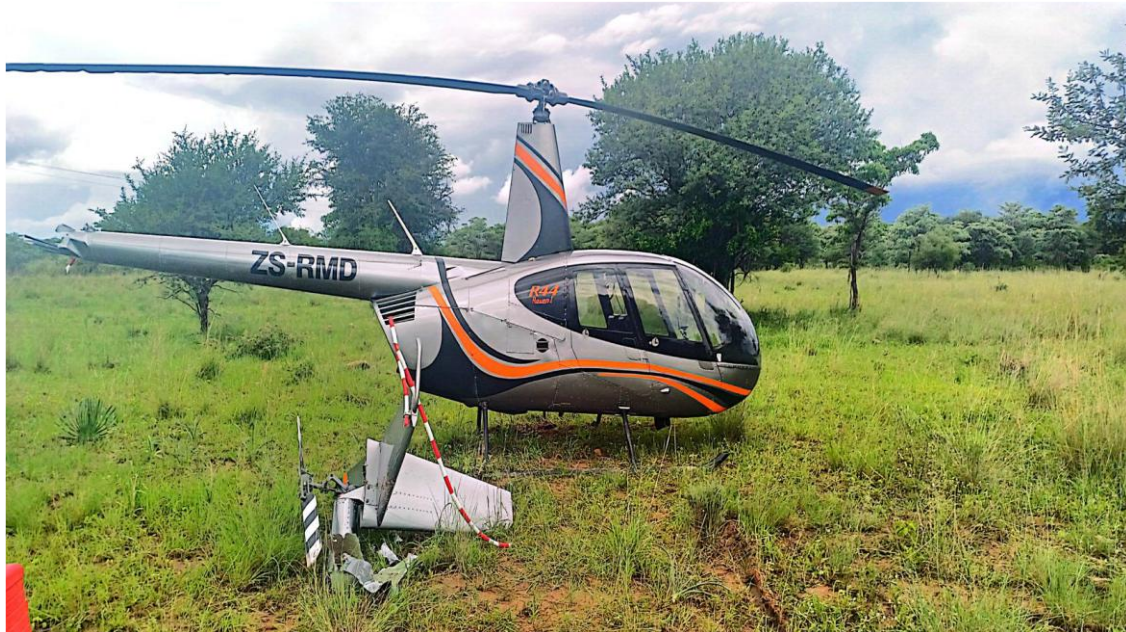
| <p>On Sunday afternoon, 12 January 2025, a pilot and two passengers on-board a Robinson R44 helicopter with registration ZS-RMD took off on a private flight from Witklip Farm to Leeudrift Farm near Vaalwater, both located in Limpopo province. Visual meteorological conditions (VMC) by day prevailed at the time of the flight which was conducted under the provisions of Part 91 of the Civil Aviation Regulations (CAR) 2011 as amended.</p> <p>The pilot reported that they took off from Leeudrift Farm at approximately 1340Z to refuel at Witklip Farm, which is located approximately 5 nautical miles (nm) north-east of Vaalwater. The flight to Witklip Farm took 6 minutes, and it was uneventful. At around 1405Z, the helicopter's main and auxiliary fuel tanks were refuelled to a little less than half the capacity on each tank. The pilot stated that the helicopter lifted off and headed north-easterly. At approximately 300 feet (ft) above ground level (AGL) at a speed of 20 knots (kts) whilst transitioning, the pilot turned the aircraft to face east. As the helicopter transitioned, it lost revolutions per minute (RPM) and he decided to conduct a precautionary landing. During landing, the helicopter impacted the muddy ground hard and skidded forward for about 5 metres. The left landing gear skid impacted a 30cm high tree stump; as a result, the helicopter's nose lowered and the tail boom lifted with the main rotor still turning at a high speed. As a result, the main rotor severed the tail boom. Subsequently, the helicopter yawed approximately 90 degrees counterclockwise before the pilot could shut down the engine and pull the main rotor brake. The occupants were uninjured; they evacuated the helicopter without assistance. The helicopter sustained damage to the left skid, main rotor and tail boom.</p> | | | | | | | |

Figure 1: The helicopter post-accident. (Source: Pilot)

8. The pilot turned the helicopter downwind shortly after lift-off at low speed and low altitude, and the engine lost RPM. The pilot decided to land the helicopter, however, it landed hard on the muddy ground and skidded for 5m. The left skid impacted a tree stump. The tail boom went up and was severed by the main rotor.

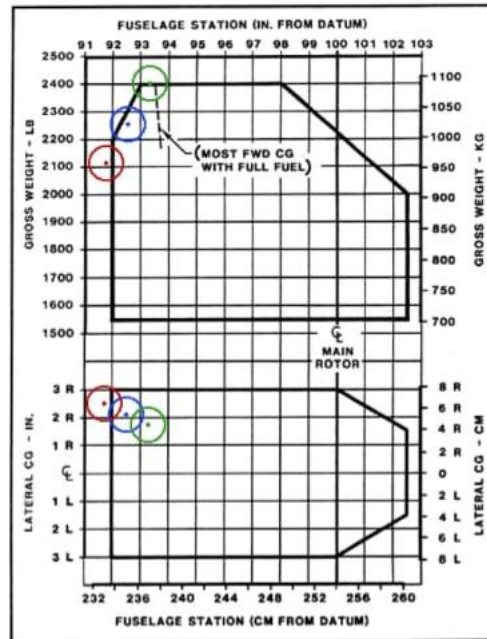
**Chart 1:** Centre-of-gravity chart. (Source: Pilot)

The pilot stated that the calculated weight of the helicopter was 1 035.7 kilograms (2 253.82 pounds). According to the Pilot's Operating Handbook (POH), the maximum take-off weight (MTOW) is 1 088.62 kg. Therefore, the MTOW of ZS-RMD was within limits.

6. The helicopter was within its weight limit, and it had enough fuel for the flight.
7. The helicopter turned whilst within the shaded area of the Velocity vs Height chart (see Diagram 1) above.

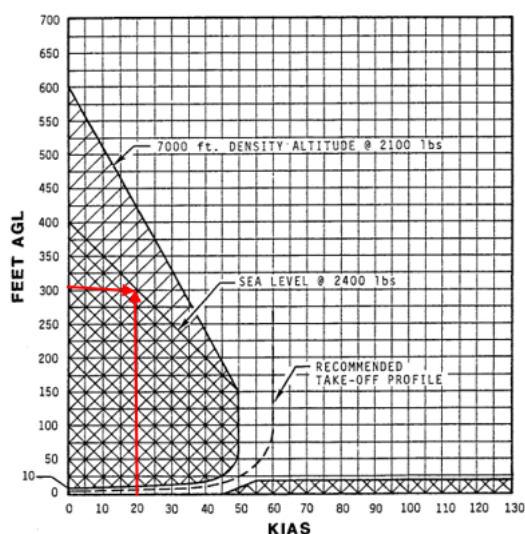
**Chart 2:** Height vs Velocity diagram. (Source: R44 POH)

According to the POH, the shaded area in Diagram 2 should be avoided. The chart indicates that the helicopter must achieve 50kts and above, before any turn or manoeuvre is executed. The shaded area (Diagram 1) indicates velocity and height at which the helicopter was turned at 300ft AGL and at a speed of 20kts.

The pilot stated that he turned the helicopter early at low speed and altitude after lift-off.

| The helicopter landed hard after loss of RPM due to being turned too soon after lift-off at a low speed and altitude. |

*To mitigate these risks, pilots should avoid making downwind turns immediately after take-off and ensure they have sufficient altitude and airspeed before attempting such manoeuvres.*
