**LIMITED OCCURRENCE INVESTIGATION REPORT – DRAFT**

<b>Reference Number</b>	CA18/2/3/10544						
<b>Classification</b>	Accident	<b>Date</b>	11 January 2025		<b>Time</b>	1116Z	
<b>Type of Operation</b>	Private (Part 94)						
<b>Location</b>							
Place of Departure	Morningstar Airfield, Western Cape Province		Place of Intended Landing	Morningstar Airfield, Western Cape Province			
Place of Occurrence	During landing on Runway 02 at Morningstar Airfield, Western Cape Province						
GPS Co-ordinates	Latitude	24°15'51" S	Longitude	028°13'30" E	Elevation	112 ft	
<b>Aircraft Information</b>							
Registration	ZU-EDE						
Make; Model; S/N	Jabiru Aircraft (Pty) Ltd; J430 (Serial Number: 266)						
Damage to Aircraft	Substantial			Total Aircraft Hours	2 132.9		
<b>Pilot-in-command</b>							
Licence Type	Private Pilot Licence		Gender	Male		Age	28
Licence Valid	Yes	Total Hours	162.93		Total Hours on Type	22.6	
Total Hours 30 Days	2.8		Total Hours on Type Past 90 Days	4.6

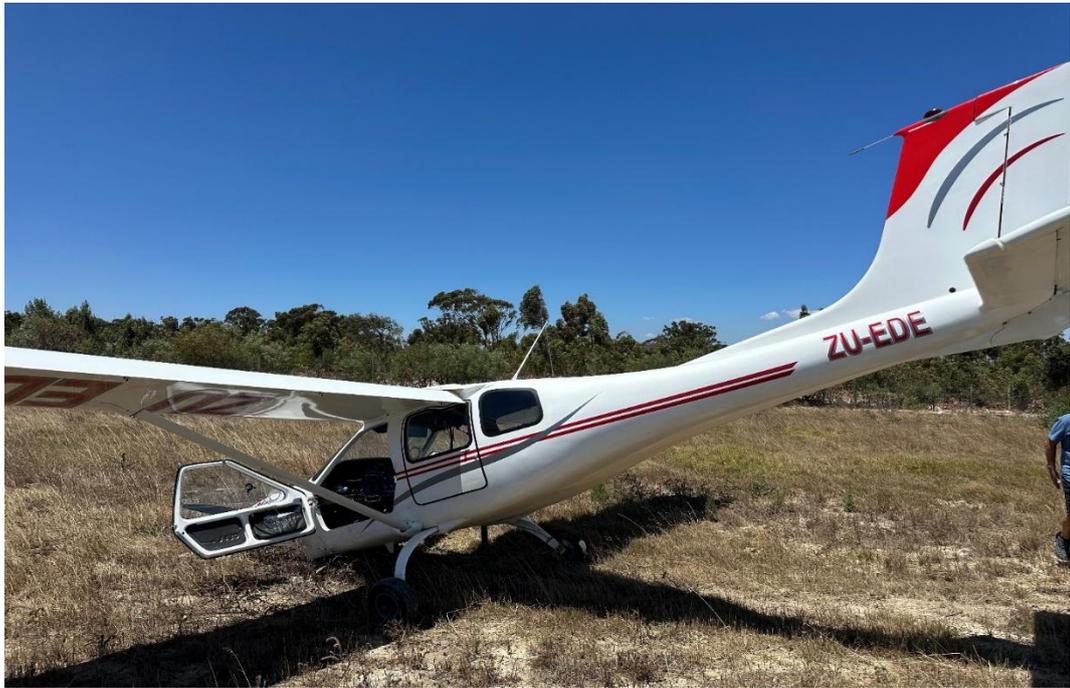
The flaps were set at 30° with the approach airspeed of 65 kts. Before initiating the landing flare at about 10 feet (ft) above the runway, the aircraft encountered a crosswind of 3.86 kts from the left. The pilot increased the engine power to initiate a go-around, but the engine did not respond as expected. Consequently, the aircraft landed hard on the runway and the pilot lost directional control during the landing roll. The aircraft veered off to the right and exited the runway. During the accident sequence, the nose gear strut collapsed and the propeller struck the ground. The pilot switched off the master switch after the aircraft had come to a stop; both the pilot and the passenger were not injured. Post-accident, the pilot examined the aircraft which revealed a delaminated right main landing gear strut due to the hard landing. The aircraft was substantially damaged.

**Figure 2:** The side-view of the aircraft after it had stopped. (Source: Pilot)

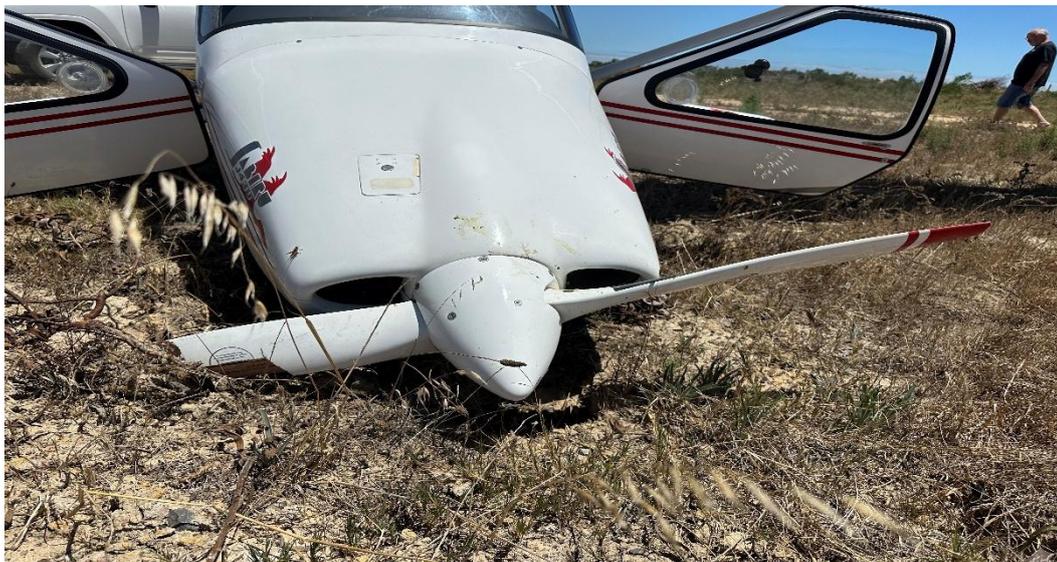
**Figure 3:** The front view of the aircraft with the nose resting on the ground and the damaged propeller.  
(Source: Pilot)

Unstable approach which resulted in the aircraft landing hard on Runway 02. Consequently, the pilot lost directional control of the aircraft, and it veered off to the right.

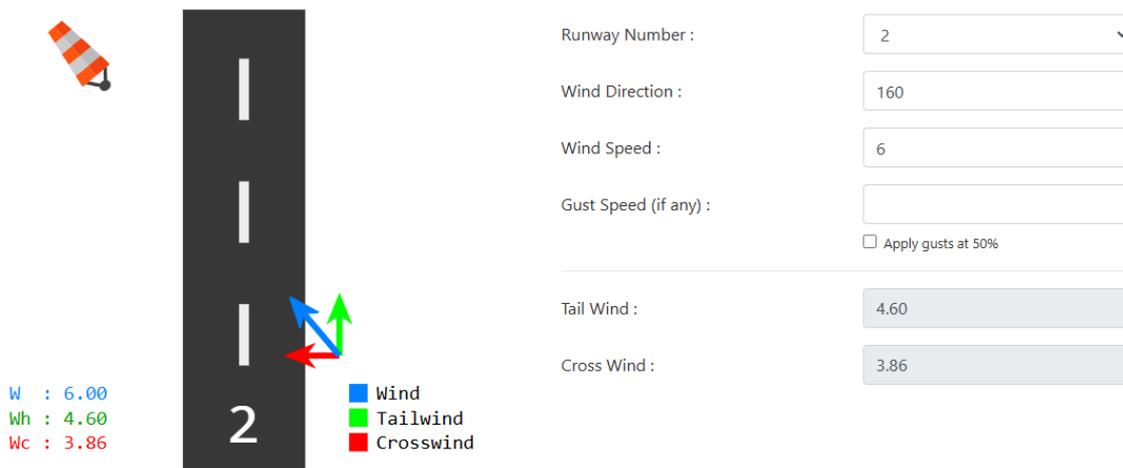
#### Crosswind Calculation

Based on the calculation above, this indicates that the pilot experienced a 4.60 tailwind and 3.86 crosswind upon landing. This was a direct contribution to the accident.
