**LIMITED OCCURRENCE INVESTIGATION REPORT – FINAL**

| <b>Reference Number</b> | CA18/2/3/10545 | | | | | | |
| <b>Classification</b> | Accident | <b>Date</b> | 18 January 2025 | | <b>Time</b> | 1327Z | |
| Registration | ZS-WXF | | | | | | |

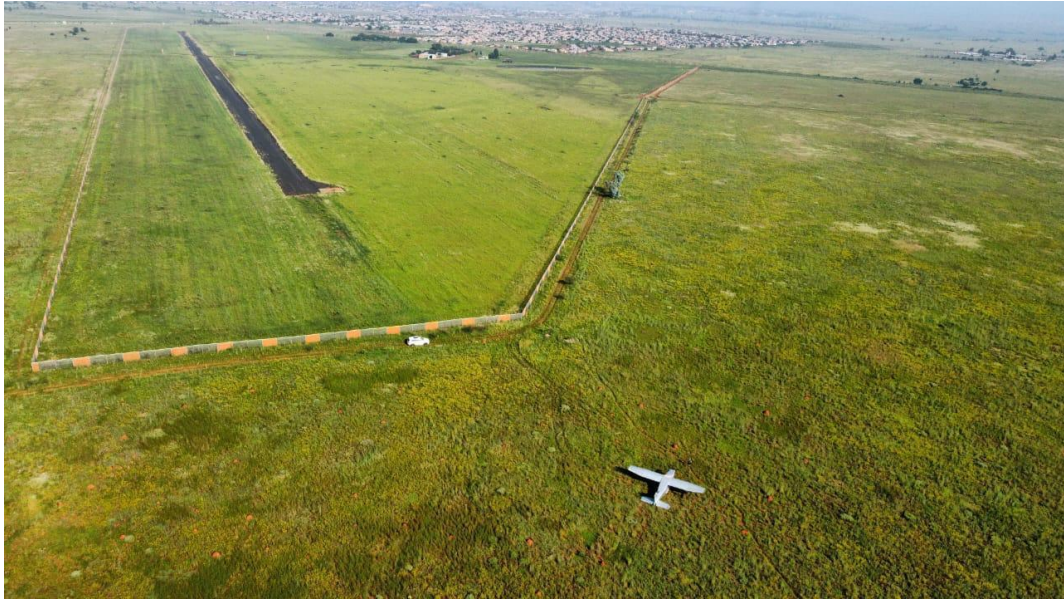
**Figure 1:** An aerial view of the aircraft, 300m short of the threshold of Runway 31. (Source: Pilot)

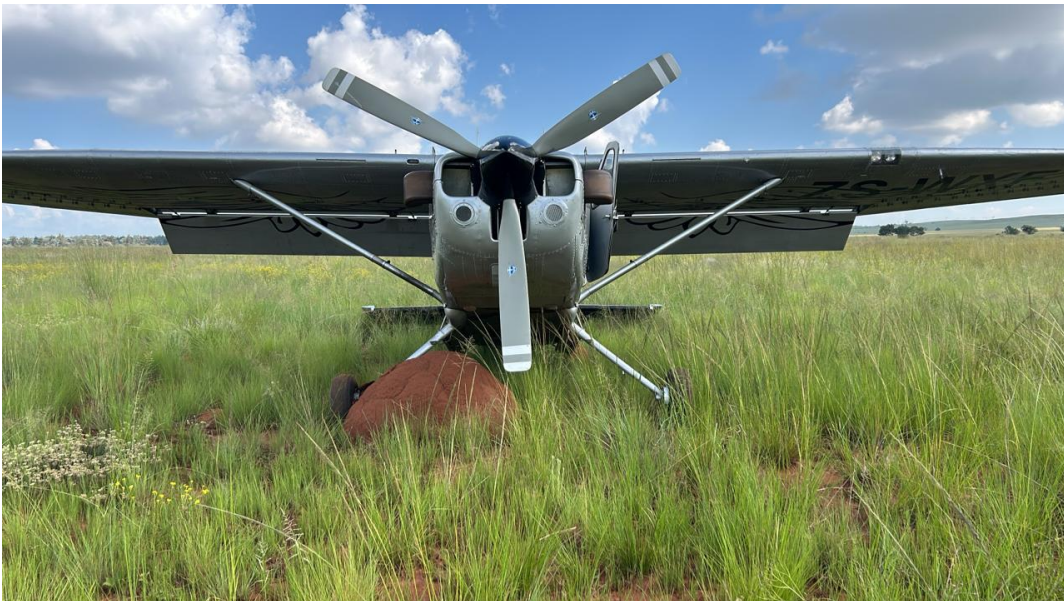
**Figure 2:** The aircraft as it came to a stop against an anthill. (Source: Pilot)

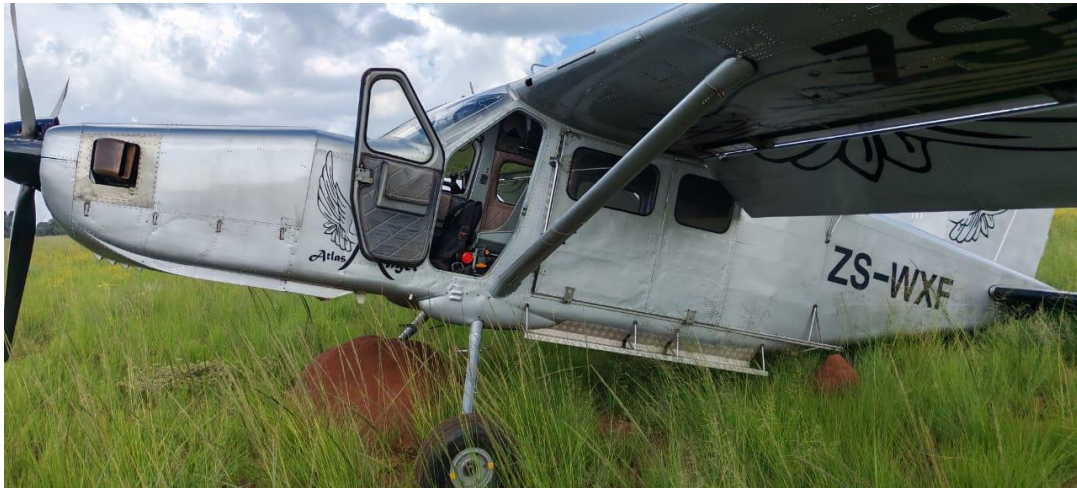
**Figure 3:** The side view of the aircraft after the accident. (Source: Pilot)

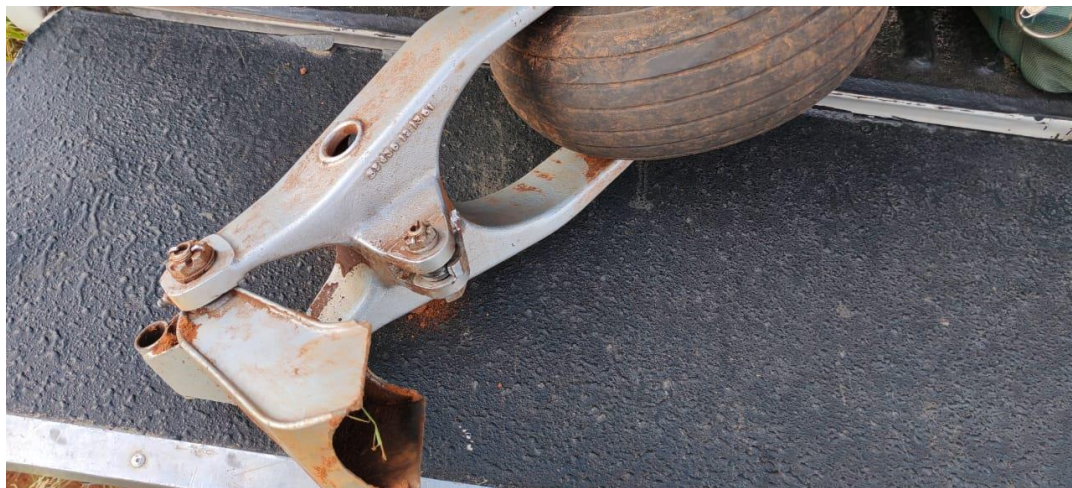
**Figure 4:** The tail wheel assembly that broke off at the welded lug. (Source: Pilot)

| The engine flamed out and stopped due to contaminated fuel which led to the pilot conducting a forced landing. The fuel in the aircraft was obtained from the bowser which was not inspected for contamination prior to replenish the aircraft. The tail wheel assembly broke off during the landing roll. | |

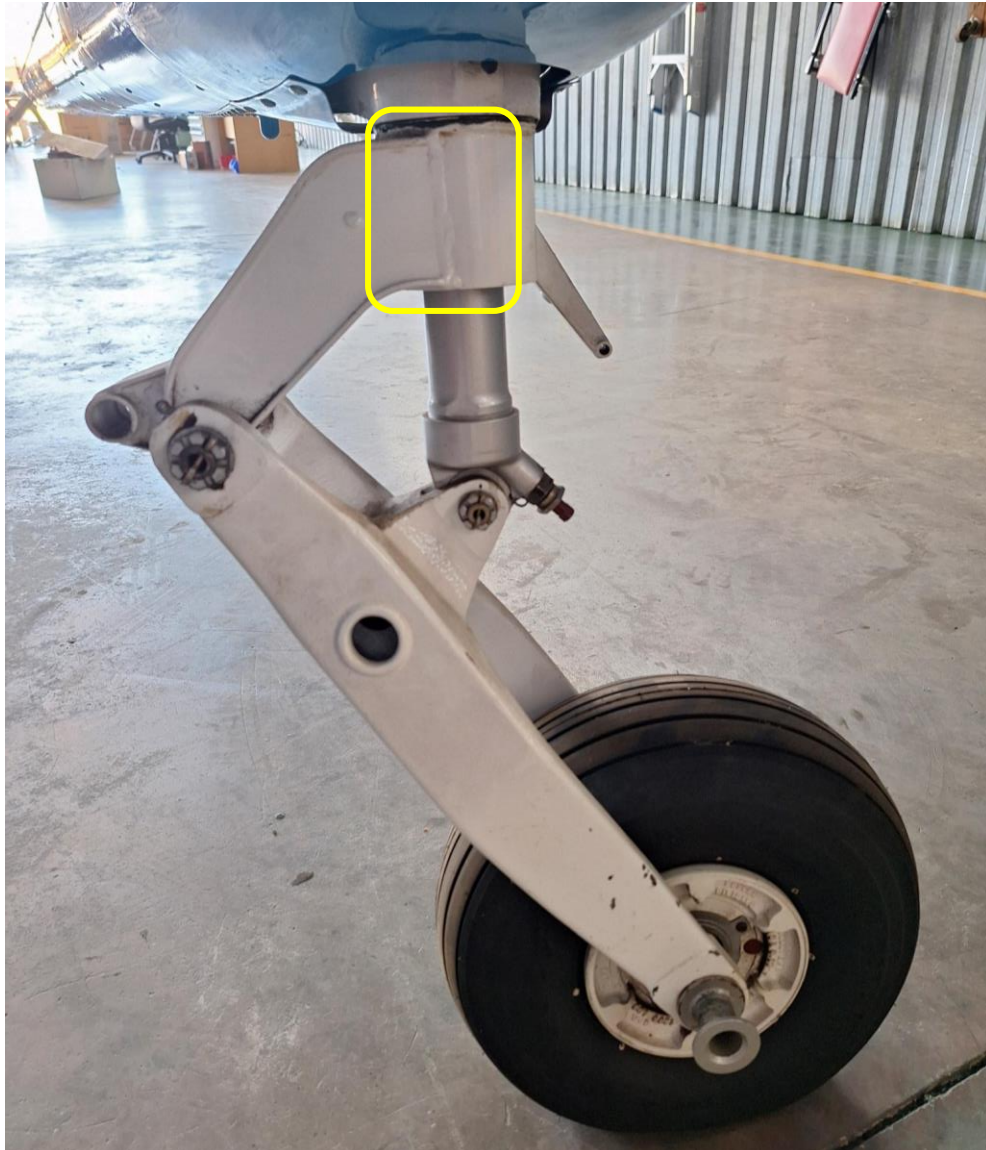
**Figure 5:** Tail wheel assembly of a similar aircraft. The failure occurred on the welding surface area that is highlighted in yellow.

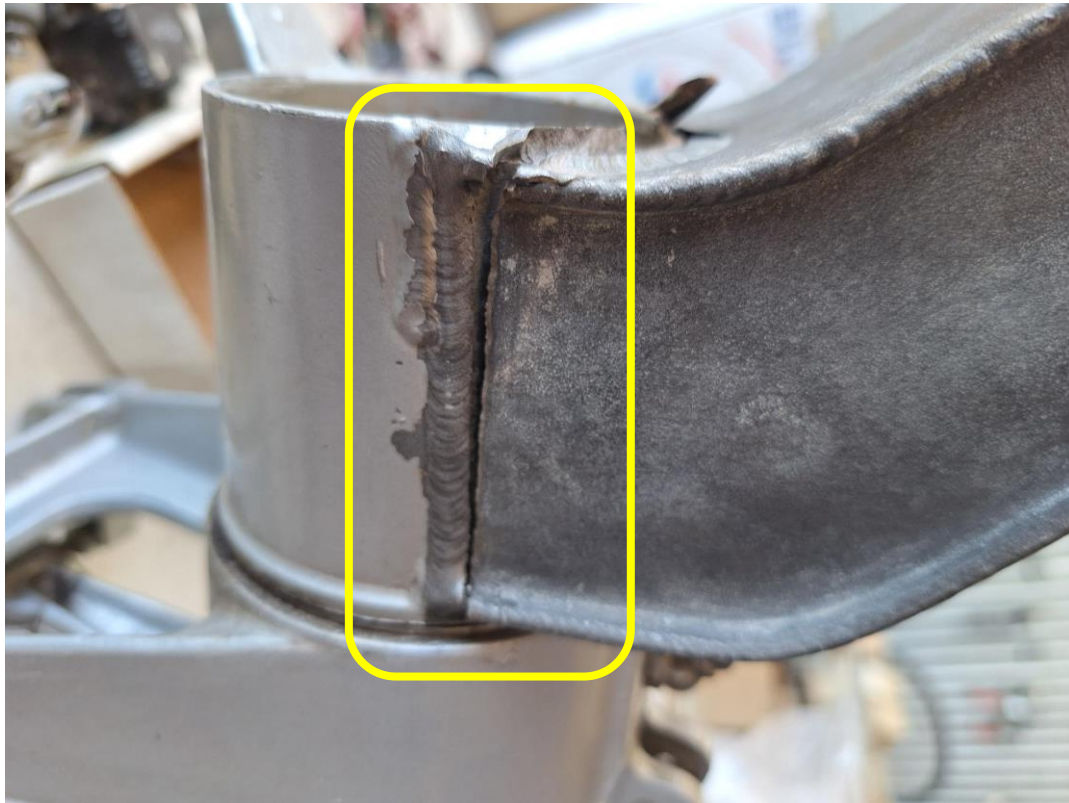
**Figure 6:** The welded area that failed on the tail wheel assembly.  
This is the actual tail wheel assembly that was fitted to the aircraft and failed during the forced landing.

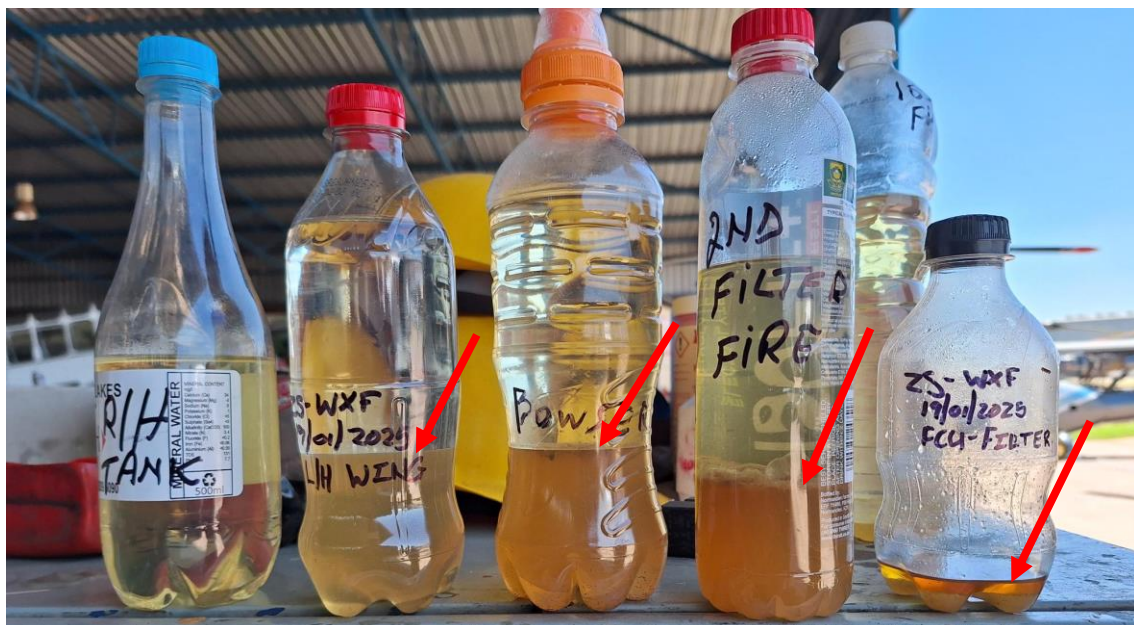
**Figure 7:** The fuel samples taken a day after the accident.  
The red arrows indicate the contamination in the fuel.

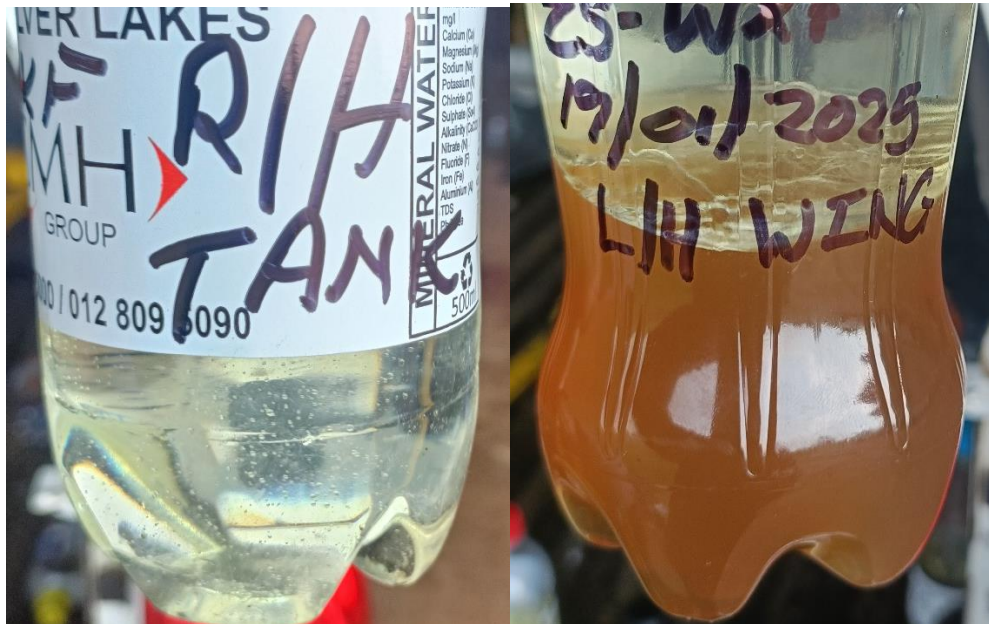
**Figure 8:** Fuel samples from the right- and left-wing tanks respectively. The fuel in the right tank was clean but the left tank contained contaminated fuel. (Source: AMO)

- A. Suspected fuel or fuel contamination problem.
- B. Inspect right hand tank fuel and sample taken. No contamination found.
- C. Left hand fuel tank strainer check and fuel contamination found. Left hand fuel tank header tank check, fuel contamination found.
- D. Main fuel filter checked and fuel contamination found.
- E. Firewall filter checked and fuel contamination found.
- F. Fuel control unit filters checked and fuel contamination found.

- A. Left hand tank and main fuel system cleaned.
- B. Check system for contamination and no contamination where found after cleaning.
- C. Ground Runs carried out and engine operated smoothly.
- D. After ground runs, system where check for contamination and no contamination were found.

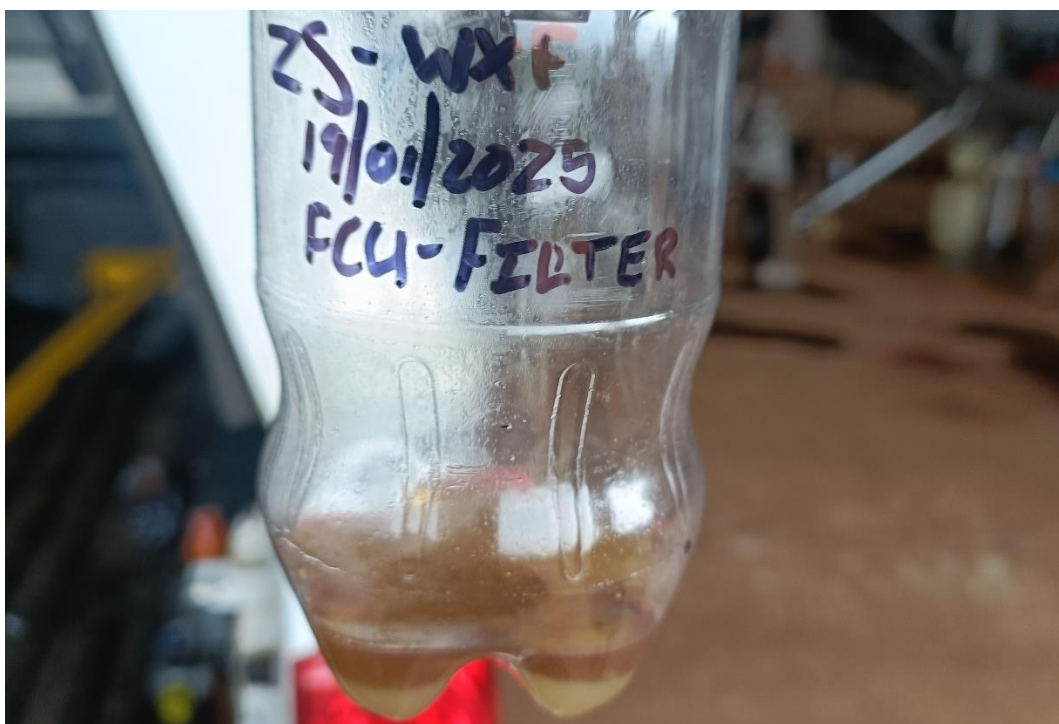
**Figure 9:** Fuel drained from the fuel control unit (FCU) filter, which was contaminated. (Source: AMO)

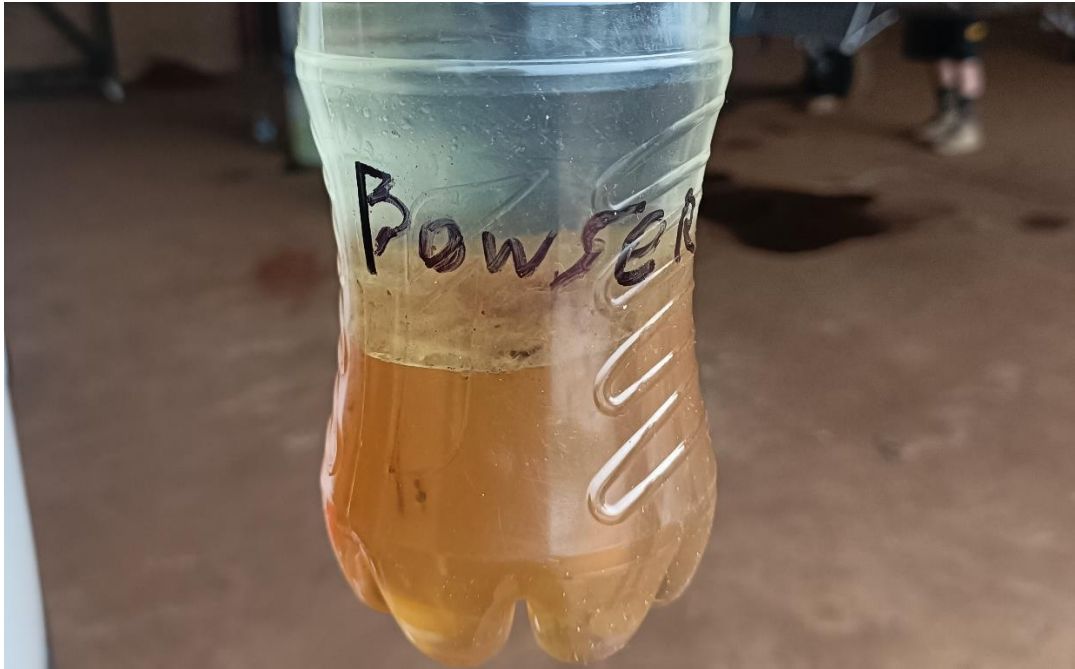
**Figure 10:** Fuel sample from the bowser, which was contaminated. (Source: AMO)

| 6. | The engine flamed out in-flight as a result of fuel contamination after the aircraft was refuelled from the bowser which was not inspected prior to the aircraft being refuelled. |

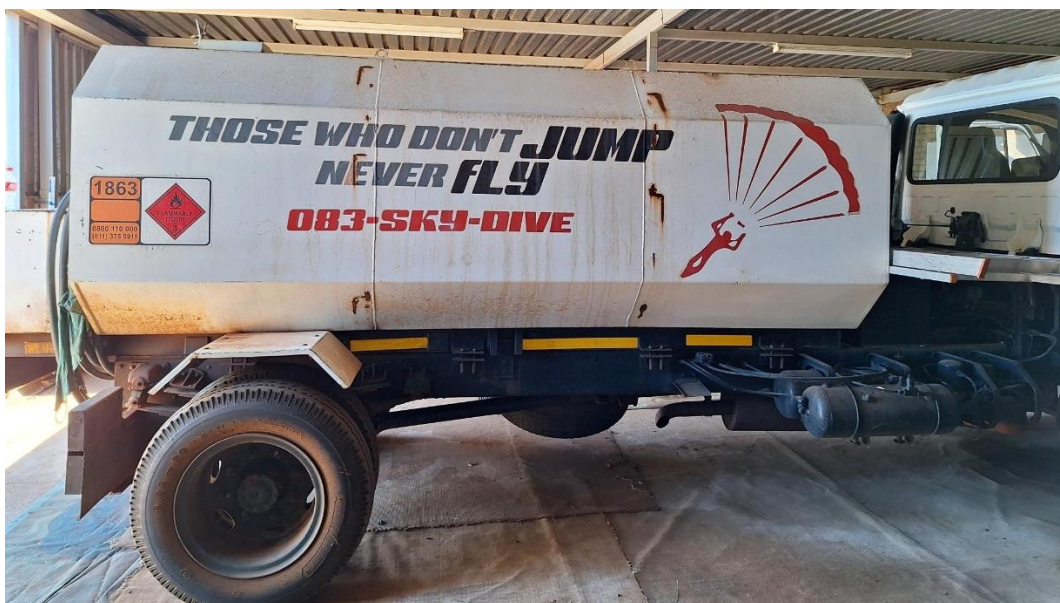
**Figure 11:** The fuel bowser.

During an inspection of the bowser, the investigating team was advised that they do not take fuel samples from the bowser before refuelling the aircraft.

- 3.1 The bowser was the property of the parachute club. There was no documented evidence available of when the filters on the bowser were last replaced. The fuel filters were found clogged and, therefore, unable to prevent contaminated fuel being pumped into the aircraft fuel tanks.
- 3.2 The bowser was not inspected for contamination prior to refuelling the aircraft.

| 1. It is recommended that the Executive AIID issue an official letter to the parachute club that owns the fuel bowser to ensure that the bowser and associated equipment are properly maintained. The service provider's actions of neglecting to maintain the bowser properly must be emphasised. The fact that both filters fitted to the bowser were clogged is indicative of an improper maintenance programme or a lack, thereof. | |

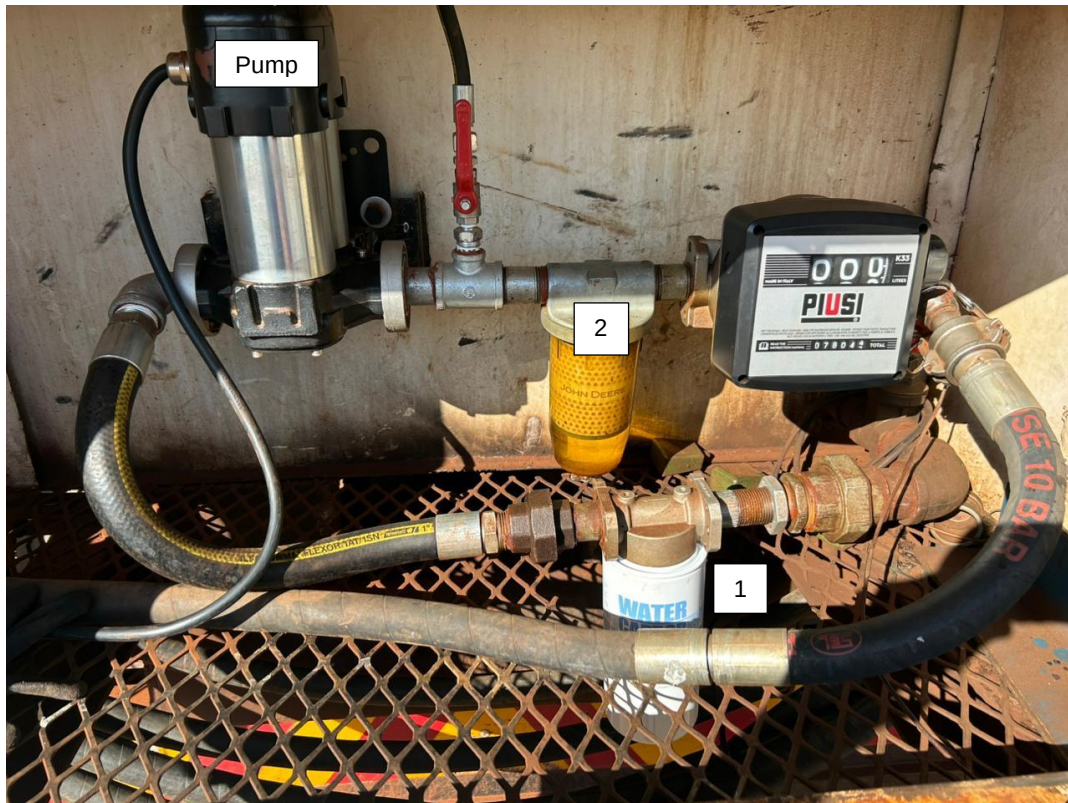
The fuel bowser is equipped with two filters to prevent contaminated fuel from entering the aircraft's fuel tanks (see Figure 12). The first filter in the system (number 1) is a water-captor filter. This filter is, however, not equipped with a water trap at the bottom where fuel can be drained for a sample. The second filter (number 2) is located after the pump and is transparent. This filter has a water trap which allows for a fuel sample.

**Figure 12:** The fuel bowser setup has two filters in the system. Both filters were clogged and, therefore, unable to prevent contaminated fuel from being pumped into the aircraft fuel tanks.
