LIMITED OCCURRENCE INVESTIGATION REPORT – FINAL

Reference Number	CA18/2/3/10547						
Classification	Accident	Date	19 January 2025		Time	1515Z	
Type of Operation	Agricultural Operations (Part 137)						
Location							
Place of Departure	Mokopane Airfield (FAQR), Limpopo Province			Place of Intended Landing	Mokopane Airfield (FAQR), Limpopo Province		
Place of Occurrence	Mokopane Airfield (FAQR) Runway 36, Limpopo Province						
GPS Co-ordinates	Latitude	24°14'02.63" S	Longitude	028°57'55.53" E	Elevation	3 481 ft	
Aircraft Information							
Registration	ZS-KDX						
Make; Model; S/N	Cessna A188B Ag Truck (Serial Number: 188-03068T)						
Damage to Aircraft	Substantial			Total Aircraft Hours	7473.4		
Pilot-in-command							
Licence Type	Commercial Pilot Licence (CPL)		Gender	Male		Age	53
Licence Valid	Yes	Total Hours	4 828.5		Total Hours on Type	1738.2	
Total Hours 30 Days	20.1		Total Flying on Type Past 90 Days	20.1			
People On-board	1 + 0	Injuries	0	Fatalities	0	Other (on ground)	0

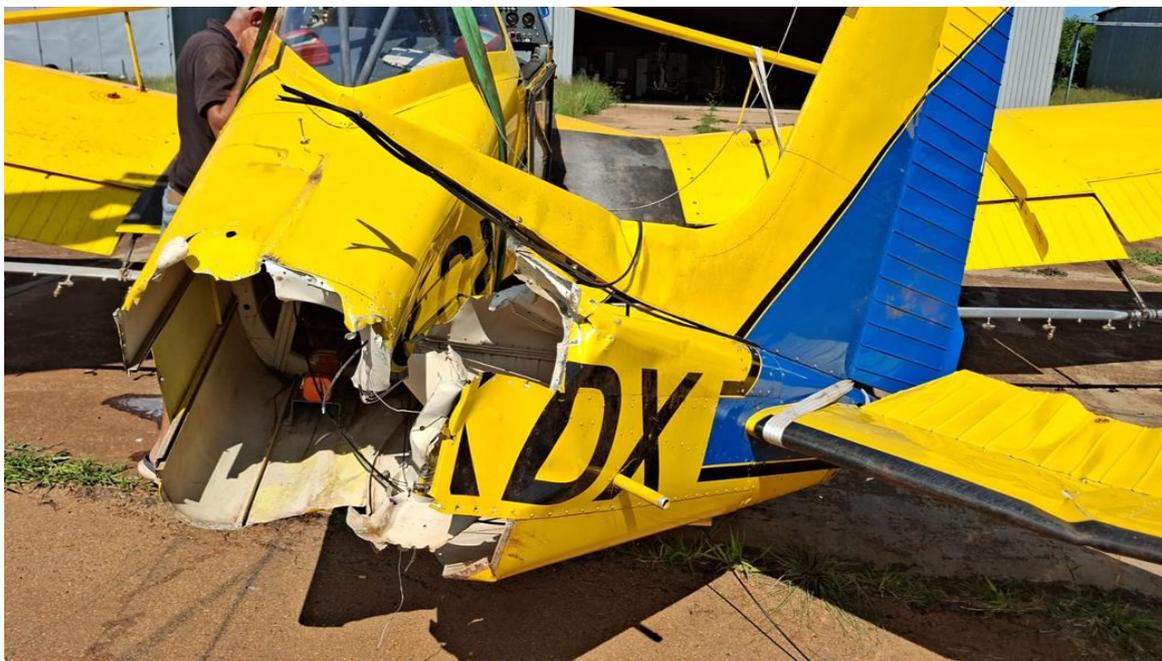
The aircraft sustained substantial damage which included a rippled and bent left wing, bent propeller blades, and the separation of the empennage and tail from the fuselage.

Figure 2: The damaged aircraft after the accident. (Source: Pilot)

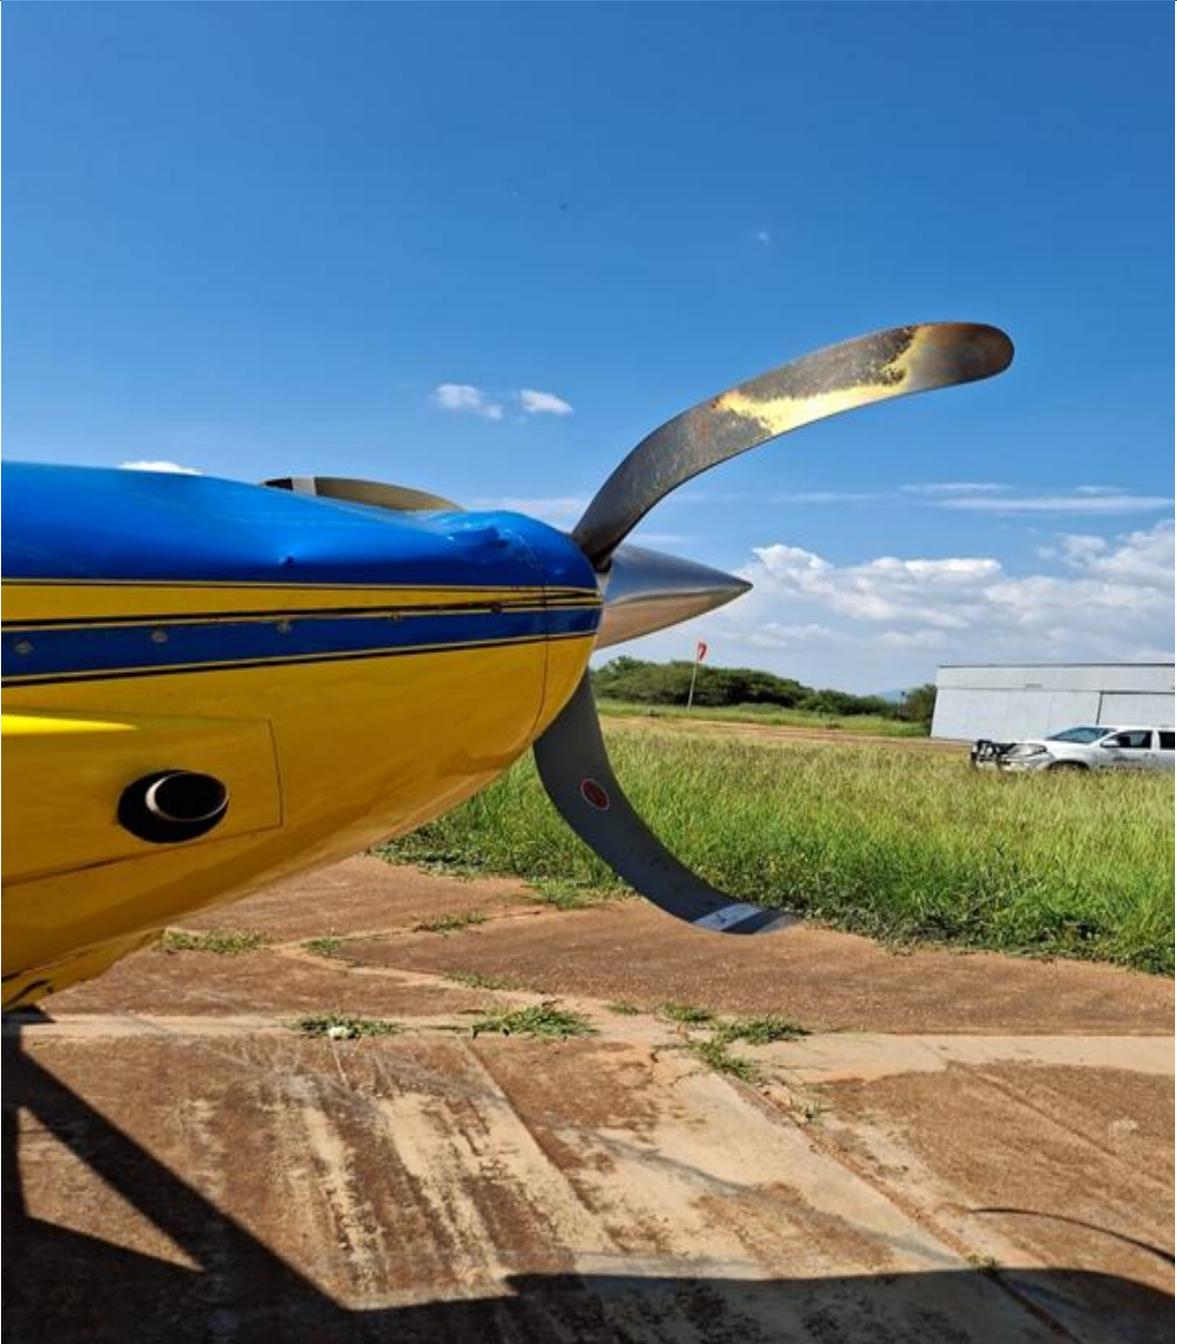
As a result, the propeller blades were bent. The aircraft ground-looped in a clockwise direction and came to rest on the right side of the runway. The pilot was not injured.

Figure 3: The bent propeller blades. (Source: Pilot)

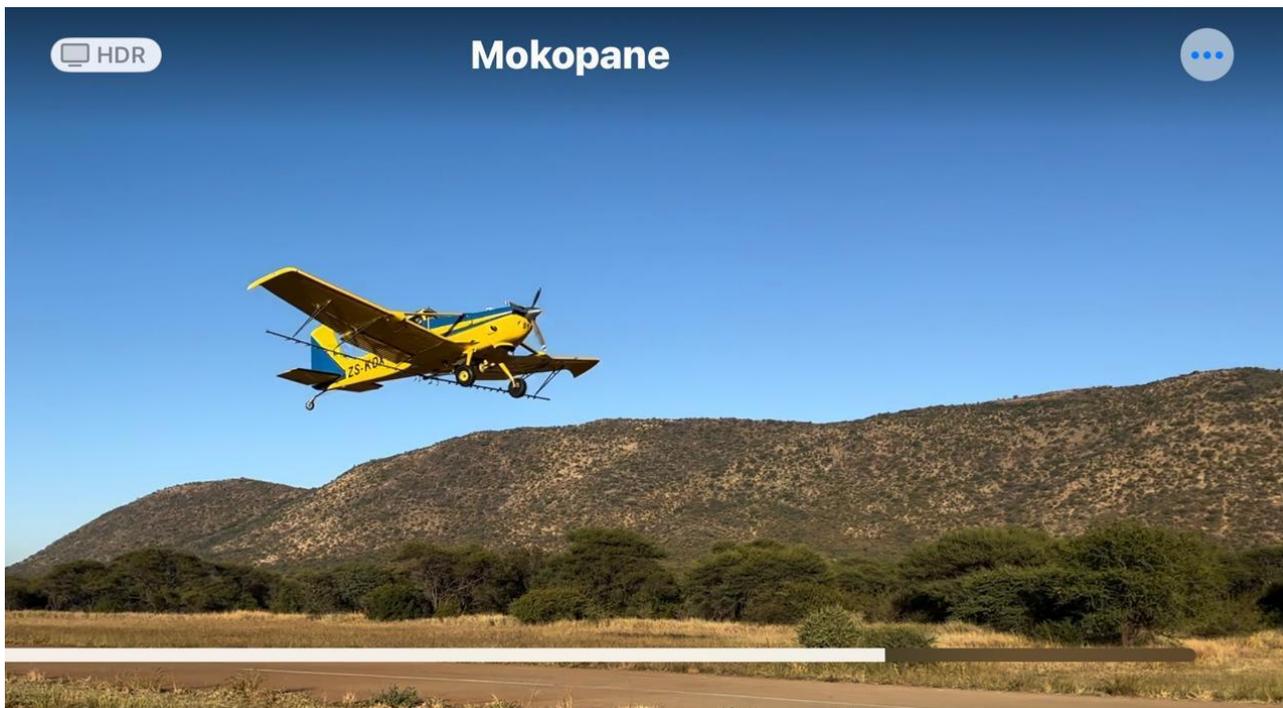
The FAQR is surrounded by a mountainous terrain. The image below shows the aircraft's position at the airfield during take-off in relation to the terrain.

Figure 4: The terrain and the airfield's runway with the aircraft taking off. (Source: Operator Safety Officer)

The pilot reported that during take-off, a sudden change in wind direction and speed caused him to lose control of the aircraft. The weather condition could have been a result of mountain waves.

3.2 It is likely that during take-off, the aircraft was affected by mountain waves which led to the pilot losing control of the aircraft.

The operator at this airfield should issue a safety notice to ensure all pilots are aware of the dangers associated with mountain waves at the airfield.
